Regulatory Information Report

RIRF24077

**Fire resistance test for penetrations through
the horizontal separating element**

Test number: PF24077

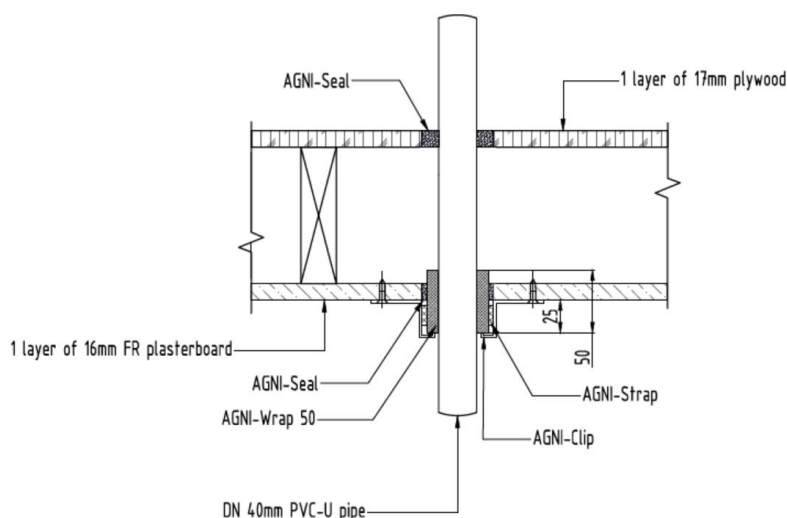
5.1 Specimen 1

Service penetration details	
Service	MARLEY OPTIM DN40 PVC-U DWV Pipe
Service Support	Unistrut structure at 1570mm
Aperture Diameter	54mm
Annular Spacing	5.5mm

Structural adequacy	Not applicable
Integrity	No failure at 60 minutes
Insulation	No failure at 60 minutes

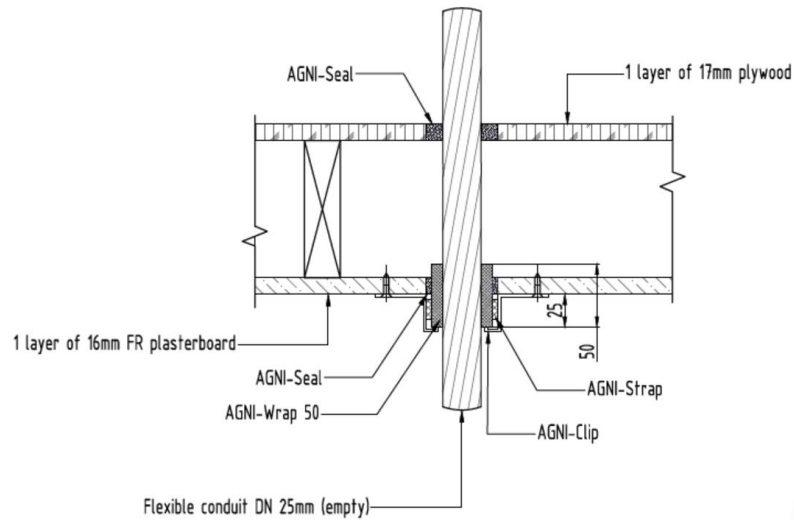
5.2 Specimen 2

Service penetration details	
Service	25mm Flexible Conduit (empty)
Service Support	Unistrut structure at 1570mm
Aperture Diameter	35mm
Annular Spacing	5mm

Structural adequacy	Not applicable
Integrity	No failure at 60 minutes
Insulation	No failure at 60 minutes

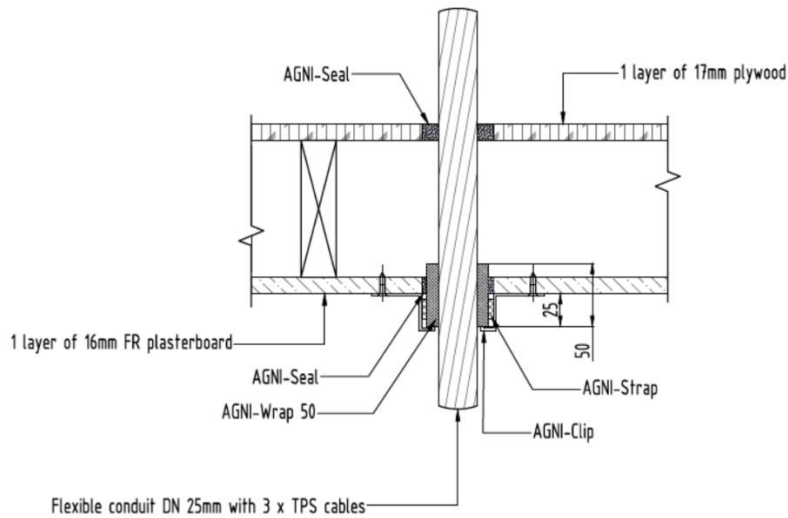
5.3 Specimen 3

Service penetration details	
Service	25mm Flexible Conduit (filled - 3 x TPS Cables)
Service Support	Unistrut structure at 1570mm
Aperture Diameter	35mm
Annular Spacing	5mm

Structural adequacy	Not applicable
Integrity	No failure at 60 minutes
Insulation	No failure at 60 minutes

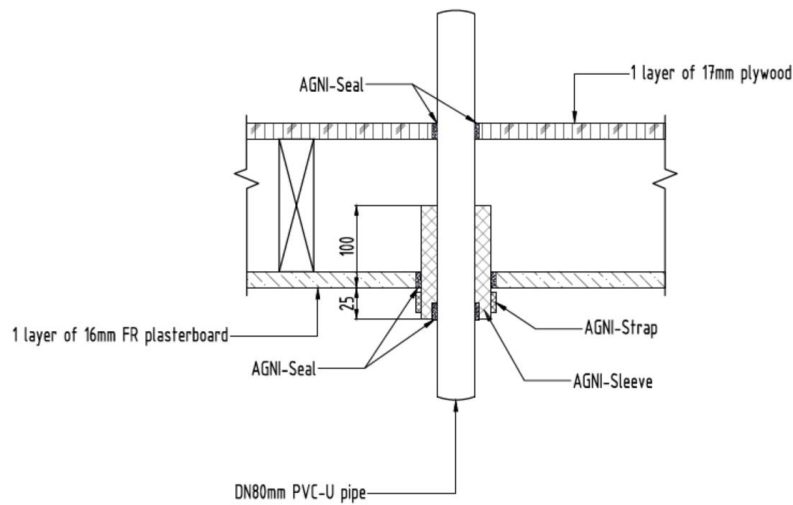
5.4 Specimen 4

Service penetration details	
Service	MARLEY OPTIM DN80 PVC-U DWV Pipe
Service Support	Unistrut structure at 1560mm
Aperture Diameter	102mm
Annular Spacing	10mm

Structural adequacy	Not applicable
Integrity	No failure at 60 minutes
Insulation	No failure at 60 minutes

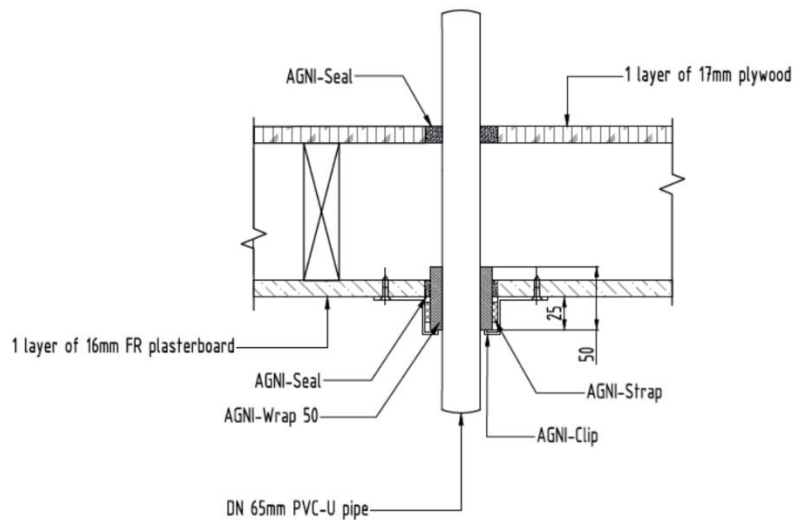
5.5 Specimen 5

Service penetration details	
Service	MARLEY OPTIM DN65 PVC-U DWV Pipe
Service Support	Unistrut structure at 1560mm
Aperture Diameter	86mm
Annular Spacing	8.5mm

Structural adequacy	Not applicable
Integrity	No failure at 60 minutes
Insulation	No failure at 60 minutes

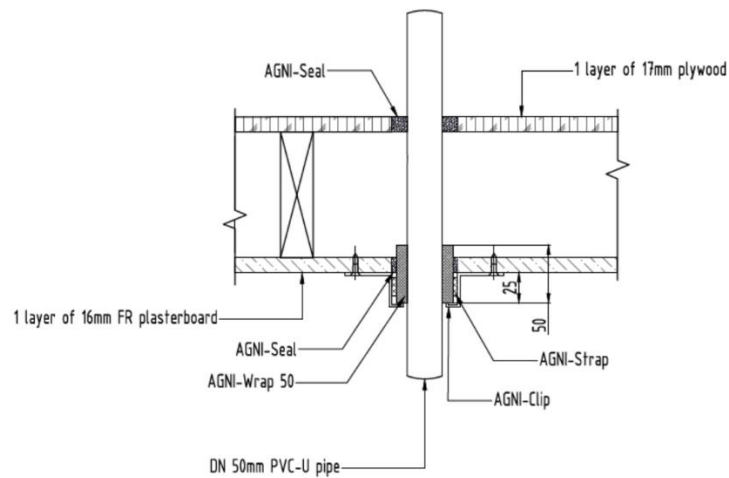
5.6 Specimen 6

Service penetration details	
Service	MARLEY OPTIM DN50 PVC-U DWV Pipe
Service Support	Unistrut structure at 1560mm
Aperture Diameter	65mm
Annular Spacing	4.5mm

Structural adequacy	Not applicable
Integrity	No failure at 60 minutes
Insulation	No failure at 60 minutes

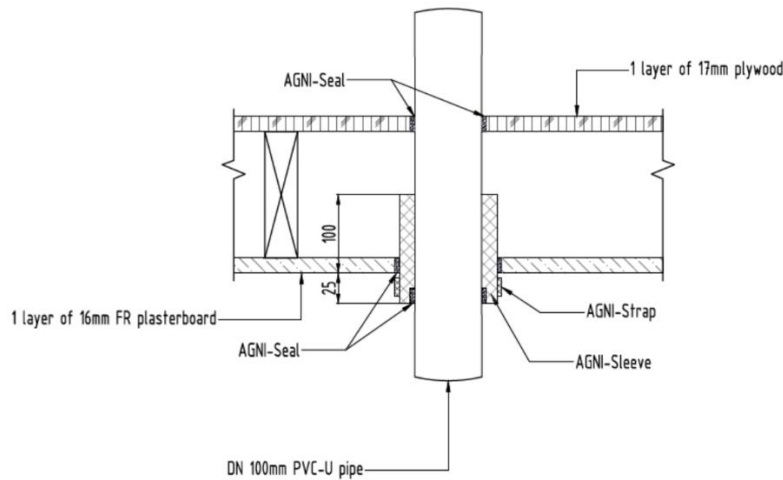
5.7 Specimen 7

Service penetration details	
Service	MARLEY OPTIM DN100 PVC-U DWV Pipe
Service Support	Unistrut structure at 400mm and 1695mm
Aperture Diameter	121mm
Annular Spacing	5.5mm

Structural adequacy	Not applicable
Integrity	46 minutes
Insulation	46 minutes

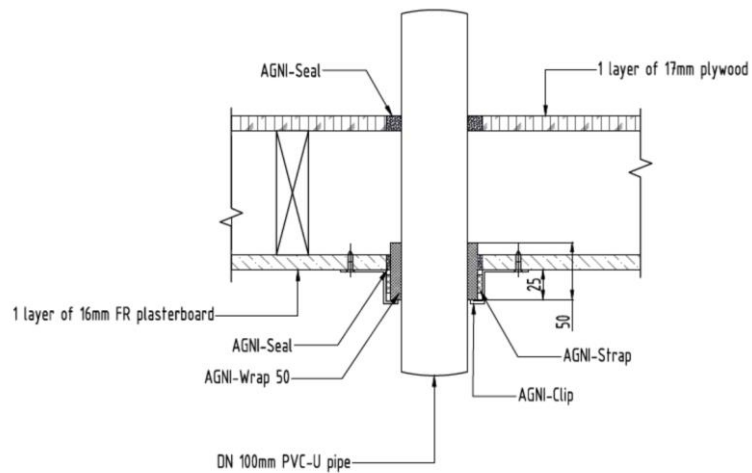
5.8 Specimen 8

Service penetration details	
Service	MARLEY OPTIM DN100 PVC-U DWV Pipe
Service Support	Unistrut structure at 400mm and 1695mm
Aperture Diameter	121mm
Annular Spacing	5.5mm

Structural adequacy	Not applicable
Integrity	47 minutes
Insulation	47 minutes

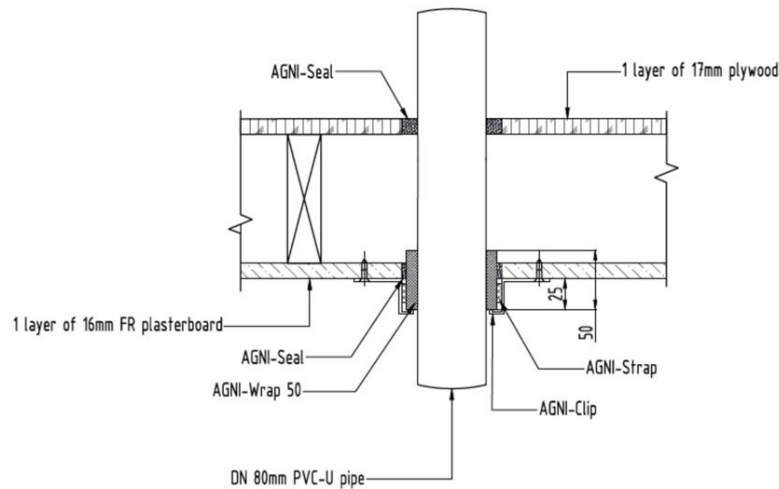
5.9 Specimen 9

Service penetration details	
Service	MARLEY OPTIM DN80 PVC-U DWV Pipe
Service Support	Unistrut structure at 400mm and 1695mm
Aperture Diameter	102mm
Annular Spacing	10mm

Structural adequacy	Not applicable
Integrity	No failure at 60 minutes
Insulation	No failure at 60 minutes
