## Regulatory Information Report

**RIRF24086**

**Fire resistance test for penetrations through a  
vertical separating element (Cross Laminated  
Timber)**

Client:	Agnitek Pty Ltd
Test method:	AS1530.4-2014
Report Date:	03/09/2024
Test number:	RIRF24086

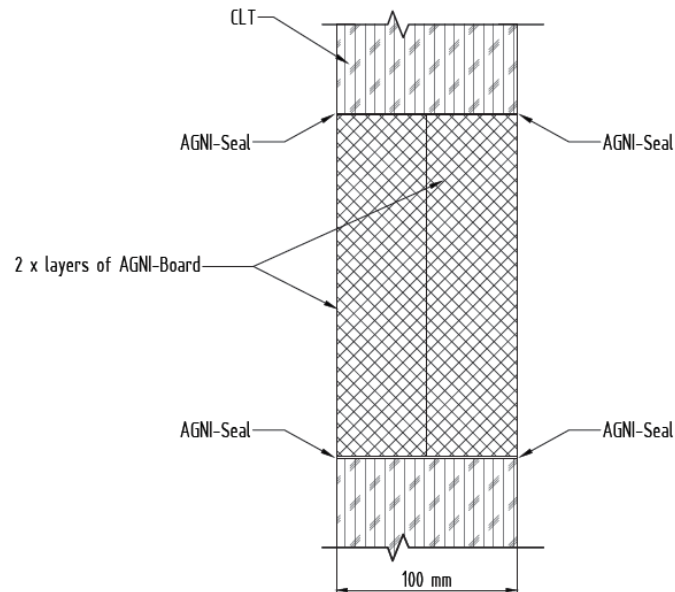
**Figure 4 – Specimen A**

Service penetration details	
Service	Two 50 mm thick AGNI-Boards
Service Support	N/A
Aperture Diameter	350mm x 300mm
Annular Spacing	0mm

Local Fire-stopping system	
Application	Symmetrical – installed on both faces of separating element
System description	Two layers of AGNI-Boards were friction fitted in the aperture. All damages of the AGNI-Board coating were painted with AGNI-Coat. AGNI-Seal was used to seal the joints between the CLT and the boards, ensuring a smooth, flush finish.

Structural adequacy	Not applicable
Integrity	No failure at 72 minutes
Insulation	No failure at 72 minutes

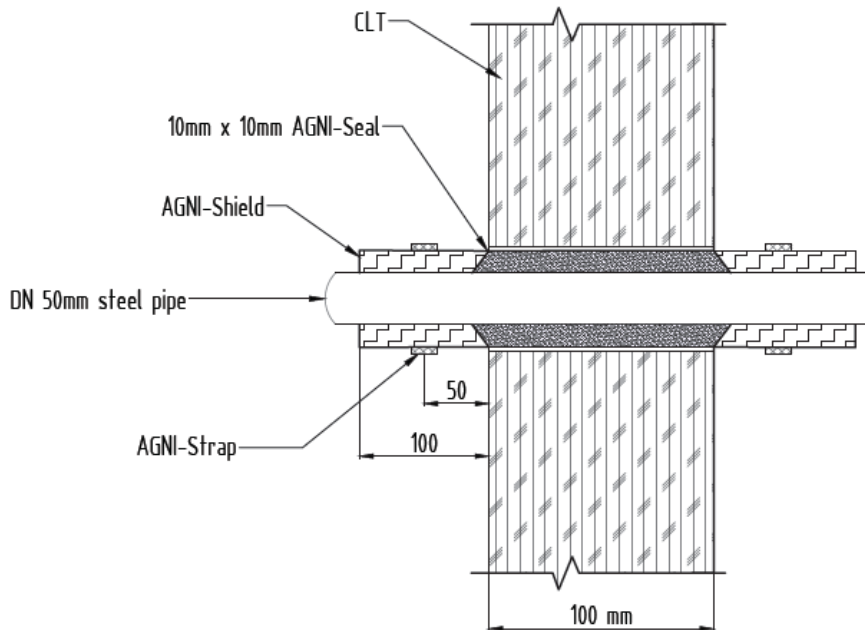
**Figure 9 – Specimen C**

Service penetration details	
Service	50mm Steel Pipe
Service Support	Unistrut structure at 250mm from exposed face and 560mm from unexposed face
Aperture Diameter	68mm
Annular Spacing	Min: 7.5mm, Max: 12.06mm

Local Fire-stopping system	
Application	Symmetrical – installed on both faces of separating element
System description	AGNI-Seal was used to fill the annular gap between the CLT and the pipe to the full depth of CLT with 10x10mm cone on both faces. AGNI-Straps were used to secure the AGNI-Shield on both sides of the wall at 50mm from the wall.

Structural adequacy	Not applicable
Integrity	No failure at 72 minutes
Insulation	No failure at 72 minutes

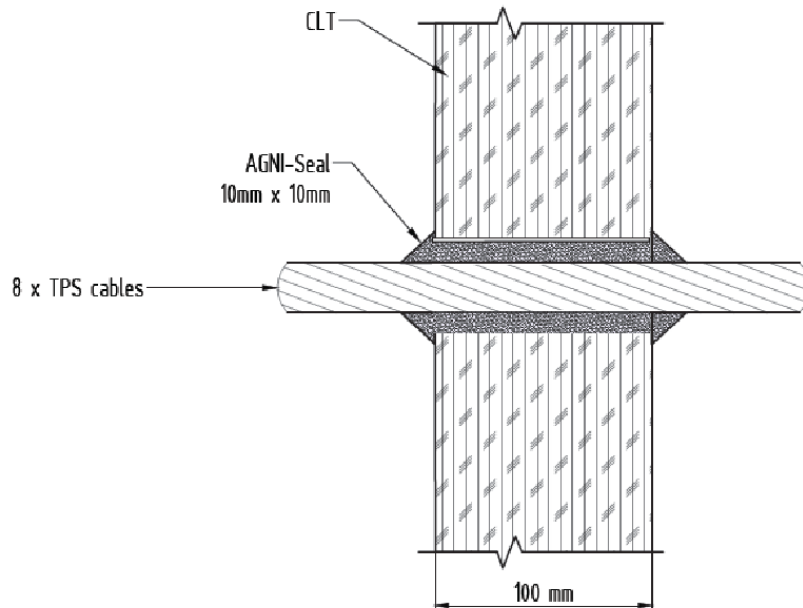
**Figure 11 – Specimen D**

Service penetration details	
Service	Bundle of eight 2.5mm <sup>2</sup> x 2C+ E TPS cables
Service Support	Unistrut structure at 250mm from exposed face and 560mm from unexposed face
Aperture Diameter	55mm
Annular Spacing	Min: 10.34mm, Max: 12.73 mm

Local Fire-stopping system	
Application	Symmetrical – installed on both faces of separating element
System description	AGNI-Seal was used to fill the aperture between the CLT and the service to the full depth of CLT having 10x10mm cone on both sides of the wall.

Structural adequacy	Not applicable
Integrity	No failure at 72 minutes
Insulation	No failure at 64 minutes

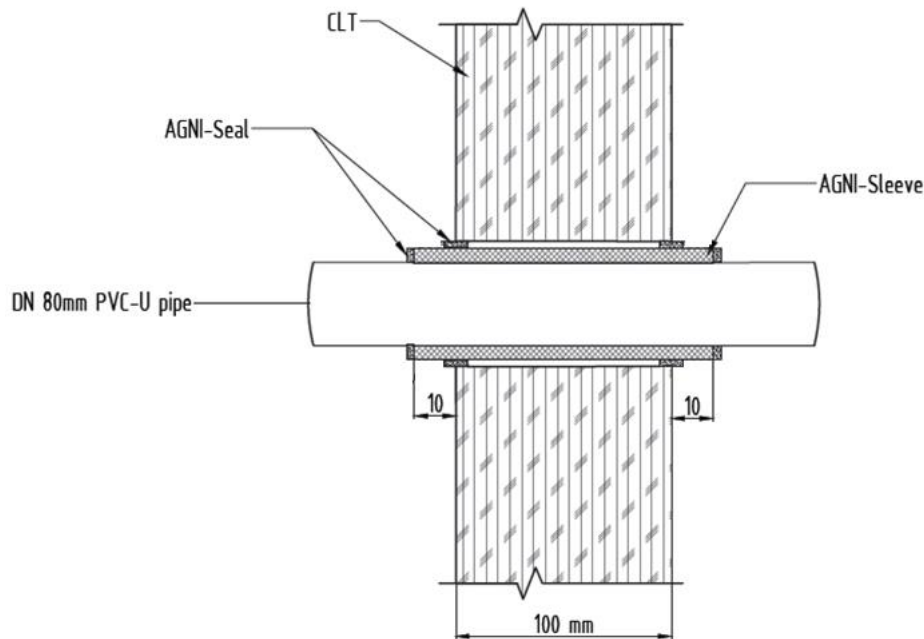
**Figure 13 – Specimen E**

Service penetration details	
Service	DN80 PVC-U DWV Pipe
Service Support	Unistrut structure at 250mm from exposed face; 560mm and 1350mm from unexposed face
Aperture Diameter	102mm
Annular Spacing	Min: 9 mm, Max: 10.5mm

Local Fire-stopping system	
Application	Symmetrical – installed on both faces of separating element
System description	A 120mm wide AGNI-Sleeve was wrapped around the service, extending 10mm beyond the CLT on both sides. The base fabric was removed prior to installation. All joints were sealed with nominal 5mm bead of AGNI-Seal on both sides of the wall.

Structural adequacy	Not applicable
Integrity	No failure at 72 minutes
Insulation	No failure at 72 minutes

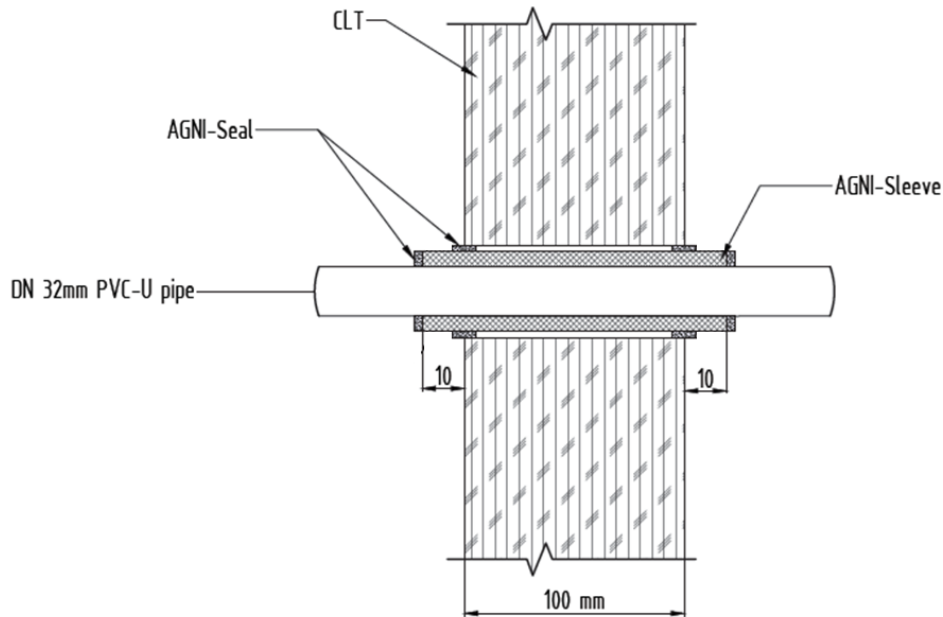
Figure 15 – Specimen F

Service penetration details	
Service	MARLEY OPTIM DN32 PVC-U DWV Pipe
Service Support	Unistrut structure at 250mm from exposed face; 560mm and 1350mm from unexposed face
Aperture Diameter	55mm
Annular Spacing	Min: 7.5, Max: 11.5mm

Local Fire-stopping system	
Application	Symmetrical – installed on both faces of separating element
System description	A 120mm wide AGNI-Sleeve was wrapped around the service, extending 10mm beyond the CLT on both sides. The base fabric was removed prior to installation. All joints were sealed with nominal 5mm bead of AGNI-Seal on both sides of the wall.

Structural adequacy	Not applicable
Integrity	No failure at 72 minutes
Insulation	No failure at 72 minutes

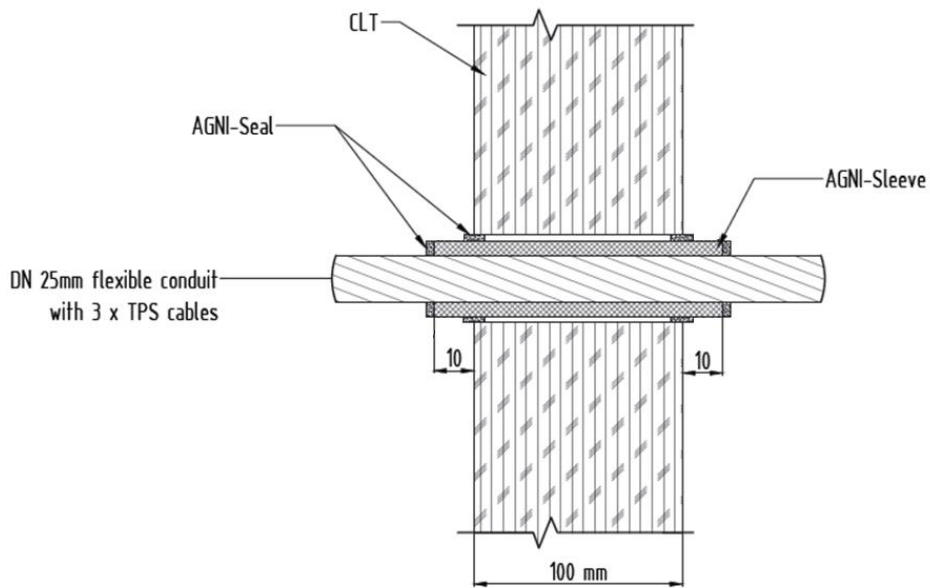
**Figure 17 – Specimen G**

Service penetration details	
Service	25mm UPVC Flexible Conduit with three 2.5mm <sup>2</sup> x 2C+ E TPS cables in the conduit
Service Support	Unistrut structure at 250mm from exposed face; 560mm and 1350mm from unexposed face
Aperture Diameter	36mm
Annular Spacing	Min: 3.74mm, Max: 7.26mm

Local Fire-stopping system	
Application	Symmetrical – installed on both faces of separating element
System description	A 120mm wide AGNI-Sleeve was wrapped around the service, extending 10mm beyond the CLT on both sides. The base fabric was removed prior to installation. All joints were sealed with nominal 5mm bead of AGNI-Seal on both sides of the wall.

Structural adequacy	Not applicable
Integrity	No failure at 72 minutes
Insulation	No failure at 72 minutes

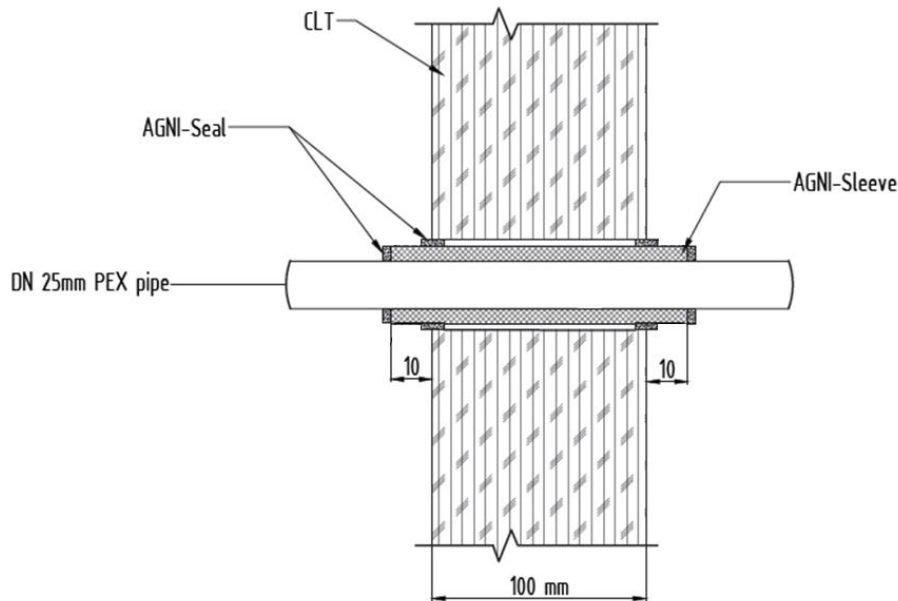
**Figure 19 – Specimen H**

<b>Service penetration details</b>	
Service	25mm Pex Pipe
Service Support	Unistrut structure at 250mm from exposed face; 560mm and 1350mm from unexposed face
Aperture Diameter	36mm
Annular Spacing	Min: 4.35mm, Max: 6.65mm

<b>Local Fire-stopping system</b>	
Application	Symmetrical – installed on both faces of separating element
System description	A 120mm wide AGNI-Sleeve was wrapped around the service, extending 10mm beyond the CLT on both sides. The base fabric was removed prior to installation. All joints were sealed with nominal 5mm bead of AGNI-Seal on both sides of the wall.

Structural adequacy	Not applicable
Integrity	No failure at 72 minutes
Insulation	No failure at 72 minutes

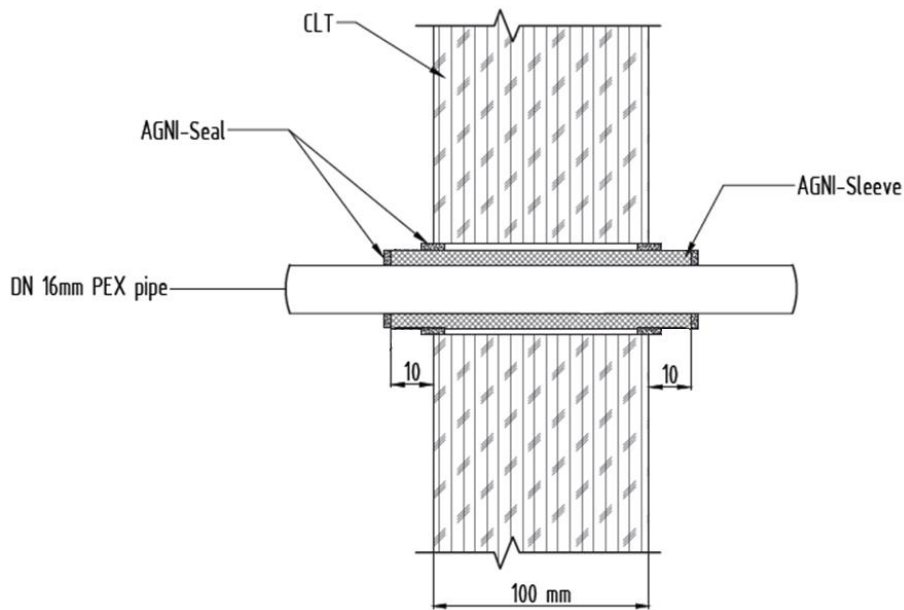
**Figure 21 – Specimen I**

Service penetration details	
Service	16mm Pex Pipe
Service Support	Unistrut structure at 250mm from exposed face; 560mm and 1350mm from unexposed face
Aperture Diameter	27mm
Annular Spacing	Min: 3.77mm, Max: 7.23mm

Local Fire-stopping system	
Application	Symmetrical – installed on both faces of separating element
System description	A 120mm wide AGNI-Sleeve was wrapped around the service, extending 10mm beyond the CLT on both sides. The base fabric was removed prior to installation. All joints were sealed with nominal 5mm bead of AGNI-Seal on both sides of the wall.

Structural adequacy	Not applicable
Integrity	No failure at 72 minutes
Insulation	No failure at 72 minutes
