## **Test report # PF23003**

**Client: Firestop Centre Ltd**

**Fire resistance test for linear gaps in  
horizontal concrete separating element**

**Test method: AS 1530.4:2014**

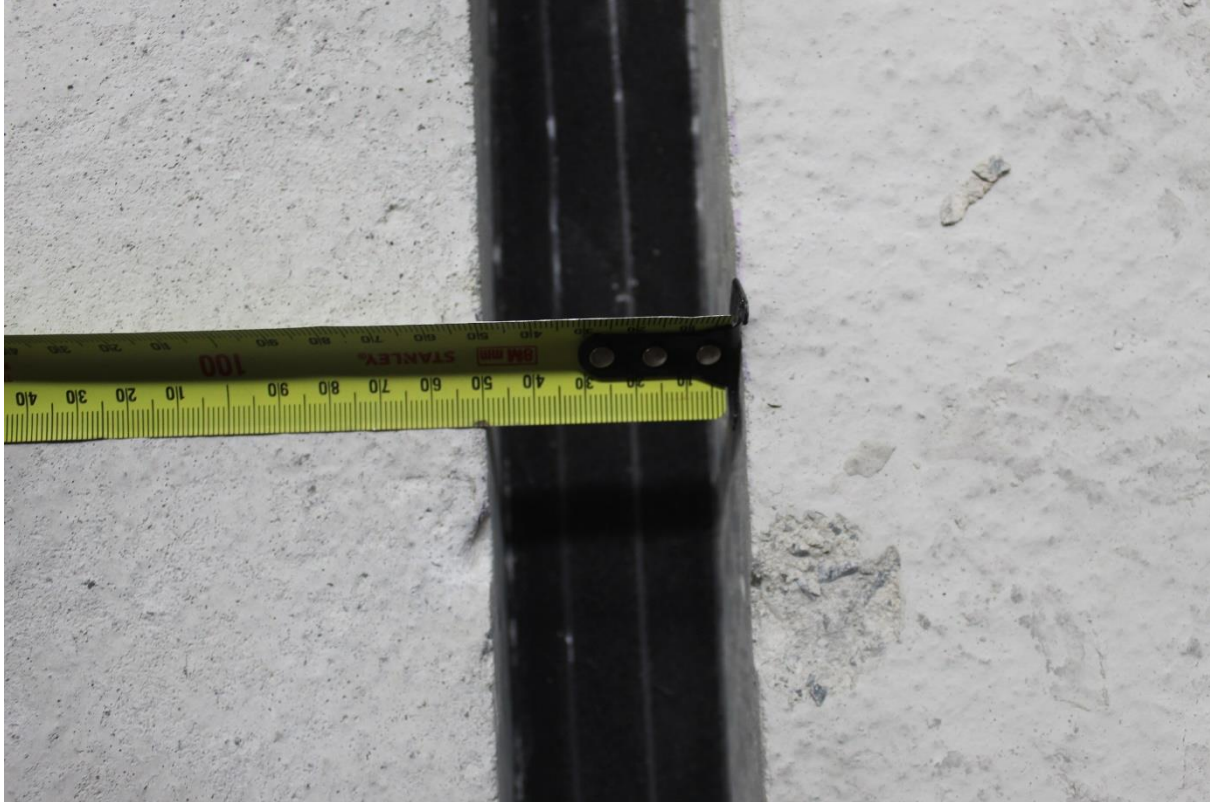
## 11.1 Specimen A

Penetration System		
A	Service	Firestop CGS-50 Compressed Gap Seal
	Joint Details	Gap Seal (2.1)
	Aperture Size	50mm x 150mm
	<b>Local Fire-stopping Protection</b>	
	Application	Asymmetrical
	Protection Used	50mm gap was formed between two concrete panels. The compressed gap seal (2.1) was installed into the gap. The seal was flush with the exposed face of the concrete slab.

Structural adequacy	Not applicable
Integrity	80 min
Insulation	76 min

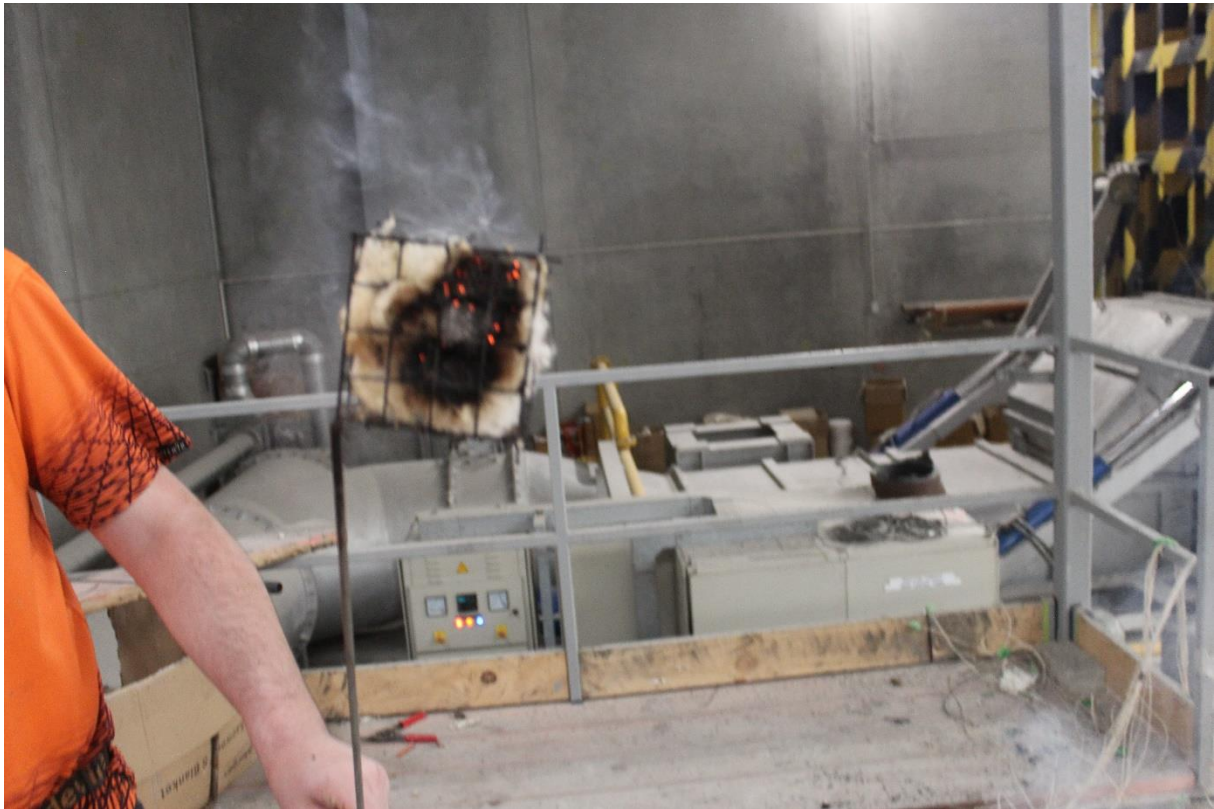
## Specimen A – Integrity failure – 80 Minutes

Time Minutes	Test Face	SPECIMEN	Observations
1	U	A	Visible smoke between specimen joint
5	U	A	Large increase in amount of smoke
9	U	A	Cotton pad test for 30 seconds above specimen A - PASS
12	U	A	Visible activation of intumescent
58	U	A	Cotton pad test for 30 seconds above specimen A - PASS
76	U	A	Small visible red spot in seal
80	U	A	Cotton pad test for 30 seconds above red spot - FAIL
85			TEST DISCONTINUED

Specimen A - Small visible red spot in seal – 76 Minutes
