TEST REPORT

PF23012

**Fire resistance test for Inspection Hatch
installed in a vertical separating element**

Client:	Firestop Centre Ltd
Test method:	AS1530.4-2014
Report Date:	18/03/2024
Test number:	PF24012

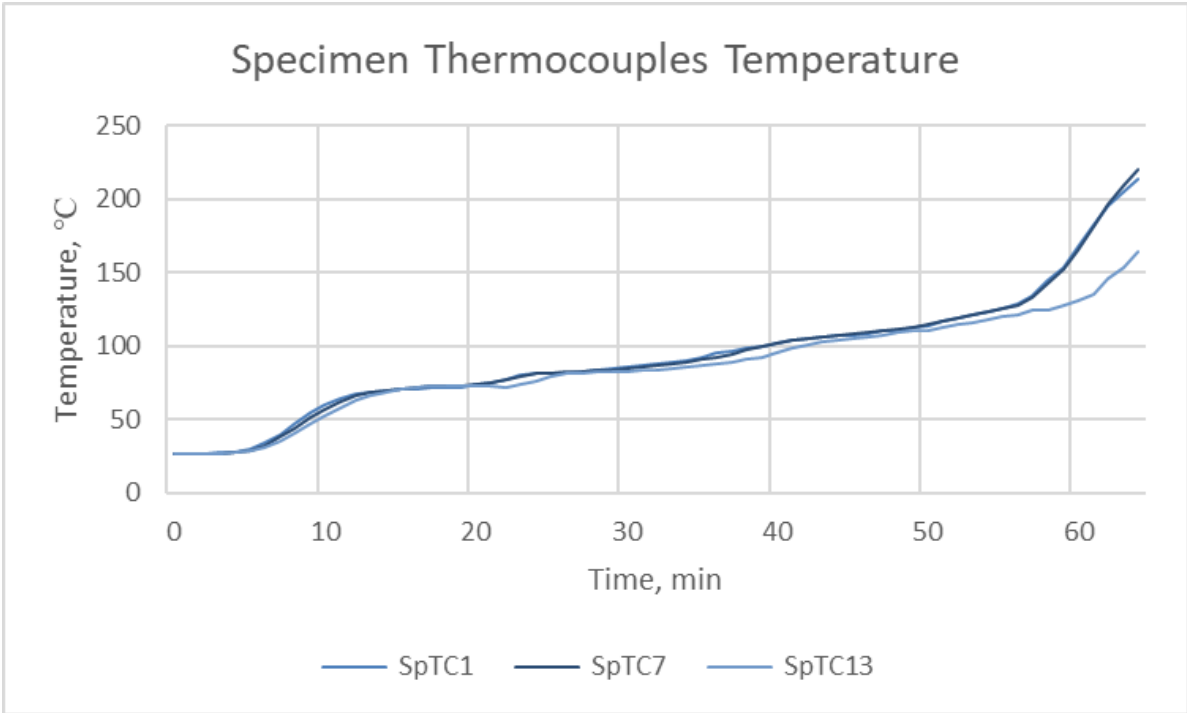
Structural adequacy	Not applicable
Integrity	No Failure at 64 minutes
Insulation	Failure at 63 minutes

**Figure 5 – Thermocouples readings 365mm from center of left half of SE*
*SpTC1&SpTC7 exceeded the insulation failure criteria at 63minutes**

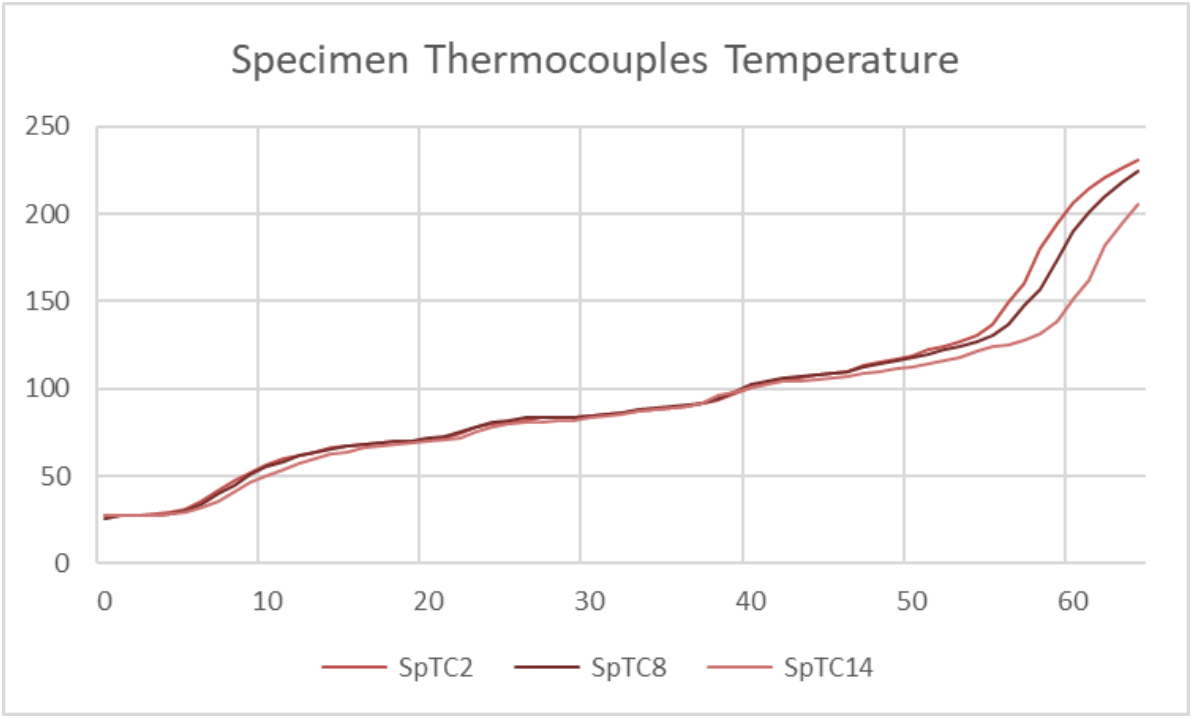
Structural adequacy	Not applicable
Integrity	No Failure at 64 minutes
Insulation	Failure at 60 minutes

Figure 7 – Thermocouples readings on SE, 25mm from edge of Inspection Hatch Cover Plate*

***SpTC2 exceeded the insulation failure criteria at 60minutes**

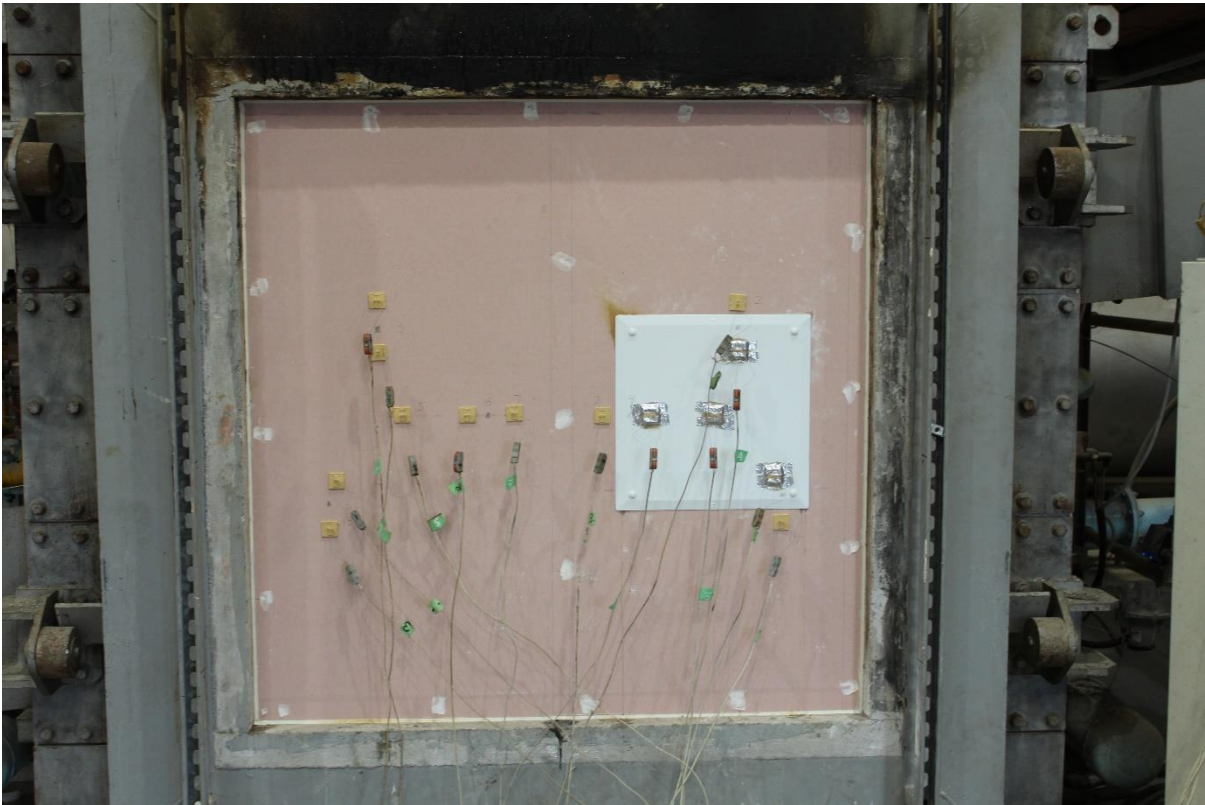
Figure 11 – Unexposed face at 30 minutes

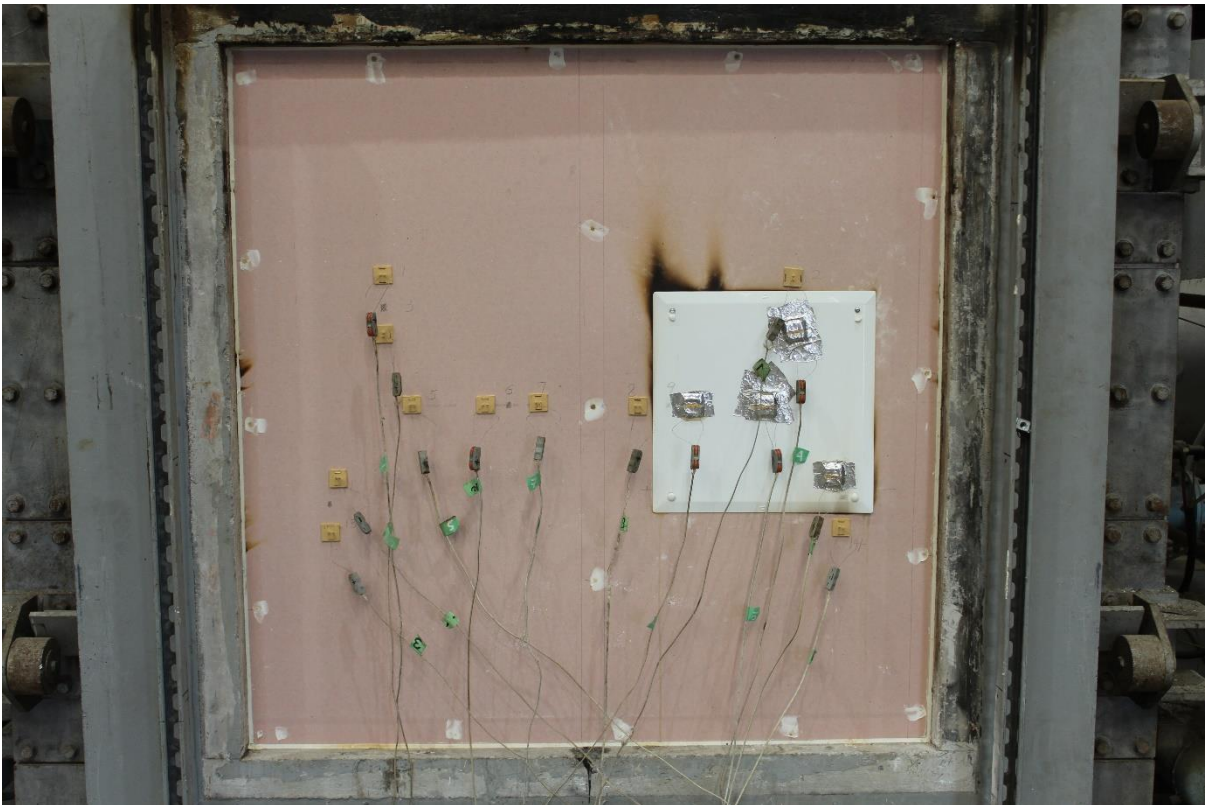
Figure 12 – Unexposed face after the test

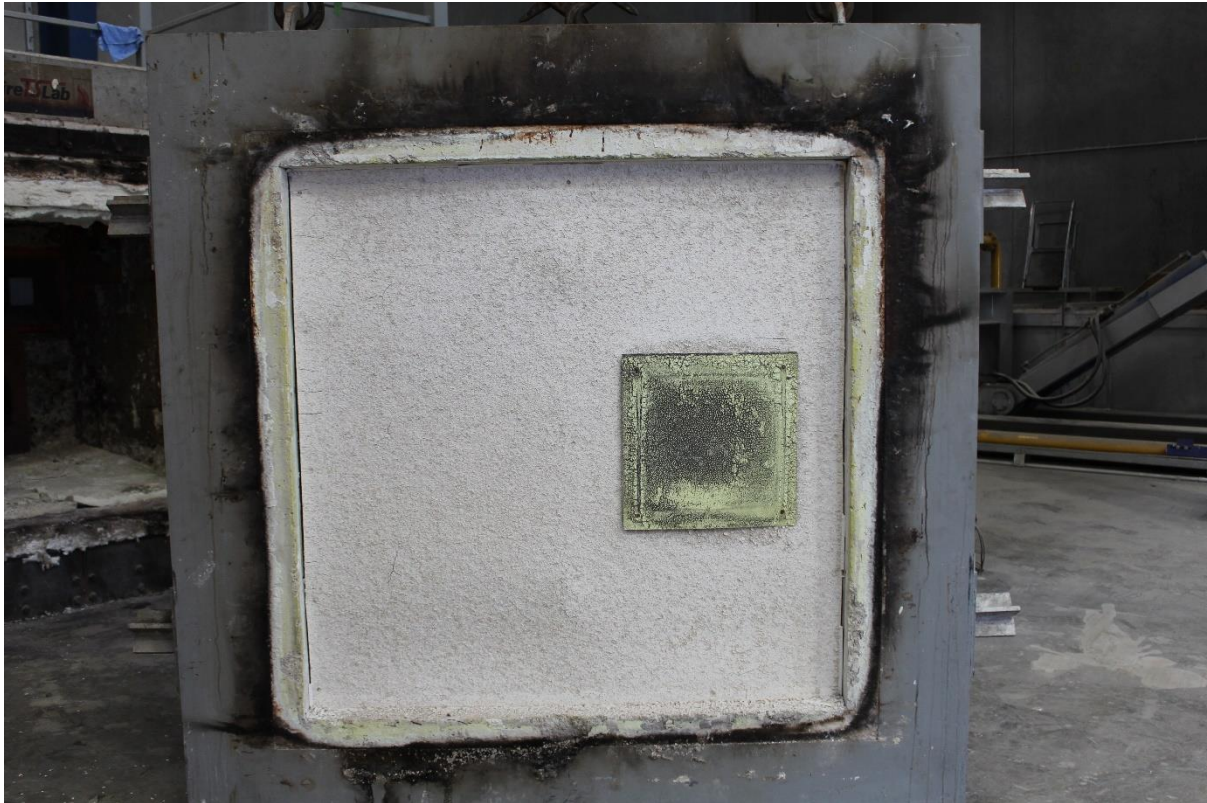
Figure 13 – Exposed face after the test
