Test report # PF21046

Client: RLA Polymers Pty Ltd

Fire resistance tests for wall penetrations

Test method: AS 1530.4:2014

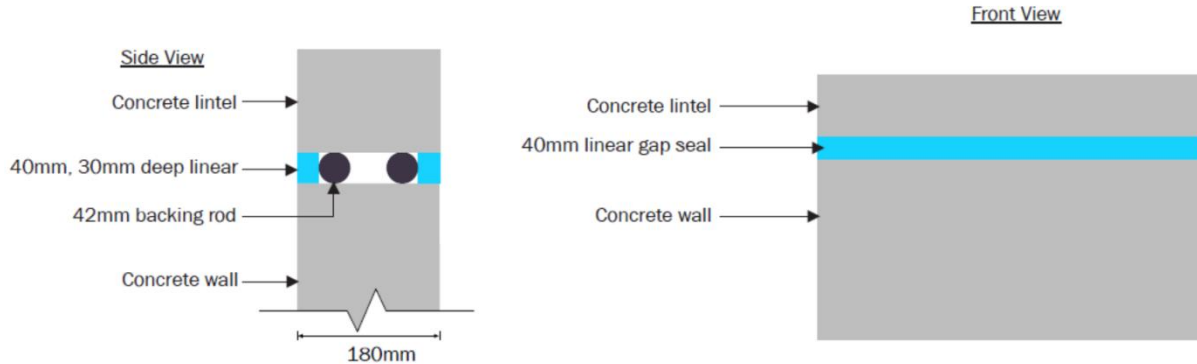
10.1 Specimen A

Penetration System		
A	Service	40mm linear joint
	Orientation	Horizontal
	Service Details	Concrete lintel (1.2), Concrete slab 1 (1.3), Concrete slab 2 (1.4), Concrete slab 3 (1.5), Sealant (3.1)
	Aperture Size	Width / Height (W/H): 1200mm x 40mm
	Local Fire-stopping Protection	
	Application	Symmetrical
Protection Used	Polystyrene backing rod was placed in aperture from both faces, recessed 30mm (nominal). A bead of mastic was placed on top of the backing rod, flush with the concrete slabs.

Structural adequacy	Not applicable
Integrity	No failure at 360 min
Insulation	No failure at 360 min

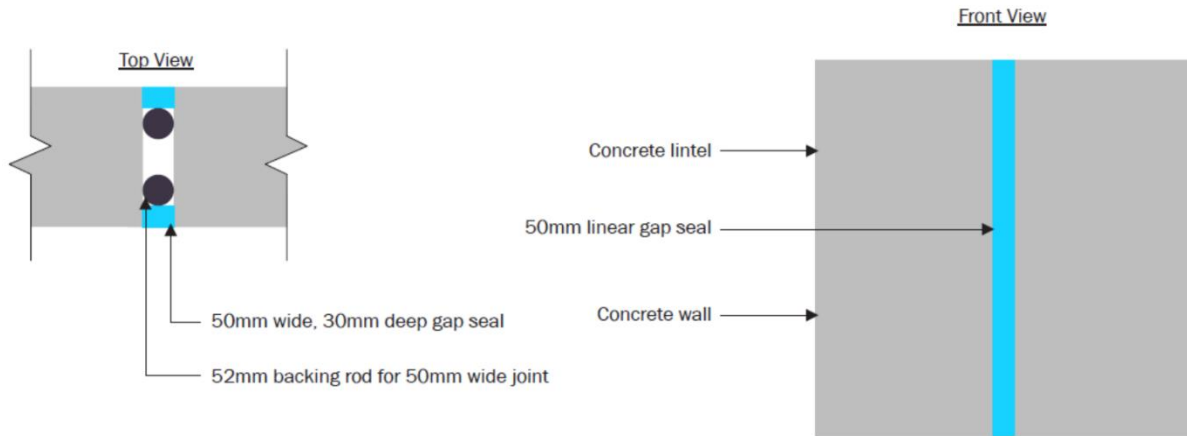
10.2 Specimen B

Penetration System		
B	Service	50mm linear joint
	Orientation	Vertical
	Service Details	Concrete slab 1 (1.3), Concrete slab 2 (1.4) Sealant (3.1)
	Aperture Size	Width / Height (W/H): 50mm x 1000mm
	Local Fire-stopping Protection	
	Application	Symmetrical
Protection Used	Polystyrene backing rod was placed in aperture from both faces, recessed 30mm (nominal). A bead of mastic was placed on top of the backing rod, flush with the concrete slabs.

Structural adequacy	Not applicable
Integrity	No failure at 360 min
Insulation	No failure at 360 min

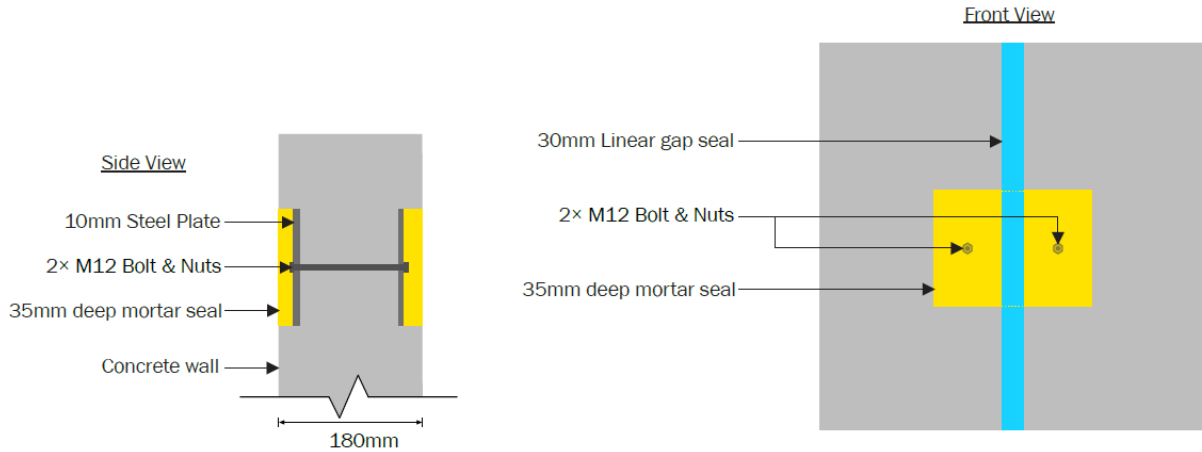
10.3 Specimen C

Penetration System		
C	Service	Stitch Plate Gap Seal
	Orientation	Horizontal
	Service Details	Concrete lintel (1.2), Concrete slab 1 (1.3), Concrete slab 2 (1.4), Concrete slab 3 (1.5), Sealant (3.1)
	Aperture Size	Width / Height (W/H): 1200mm x 30mm
	Local Fire-stopping Protection	
	Application	Symmetrical
	Protection Used	Polystyrene backing rod was placed in aperture from both faces, above and below the stitch plate, recessed 20mm (nominal). Polystyrene backing tape was placed on top of the stitch plate to ensure the depth was 35mm (nominal). A bead of mastic was placed on top of the backing rod, and on top of the stitch plate, flush with the concrete slabs. This resulted in a gap seal of 20mm along the length of the aperture, and a depth of 35mm along the stitch plate.

Structural adequacy	Not applicable
Integrity	No failure at 360 min
Insulation	No failure at 360 min

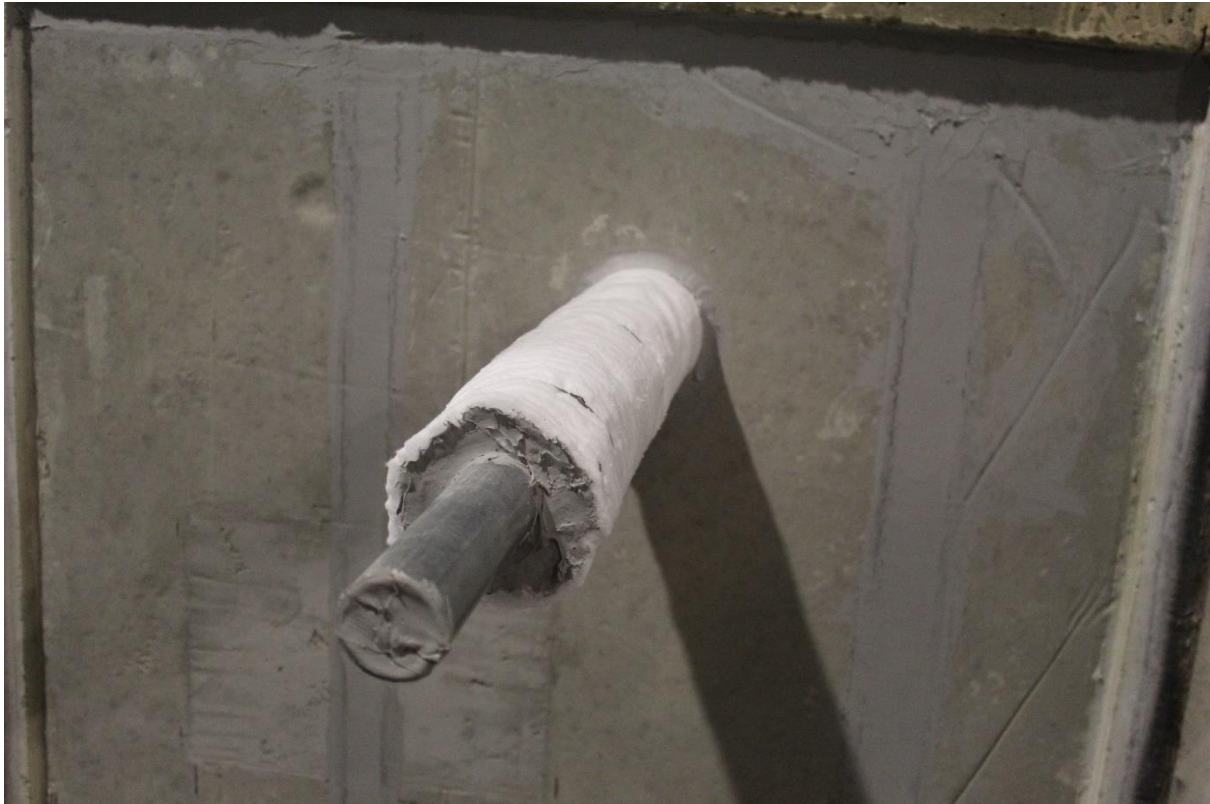
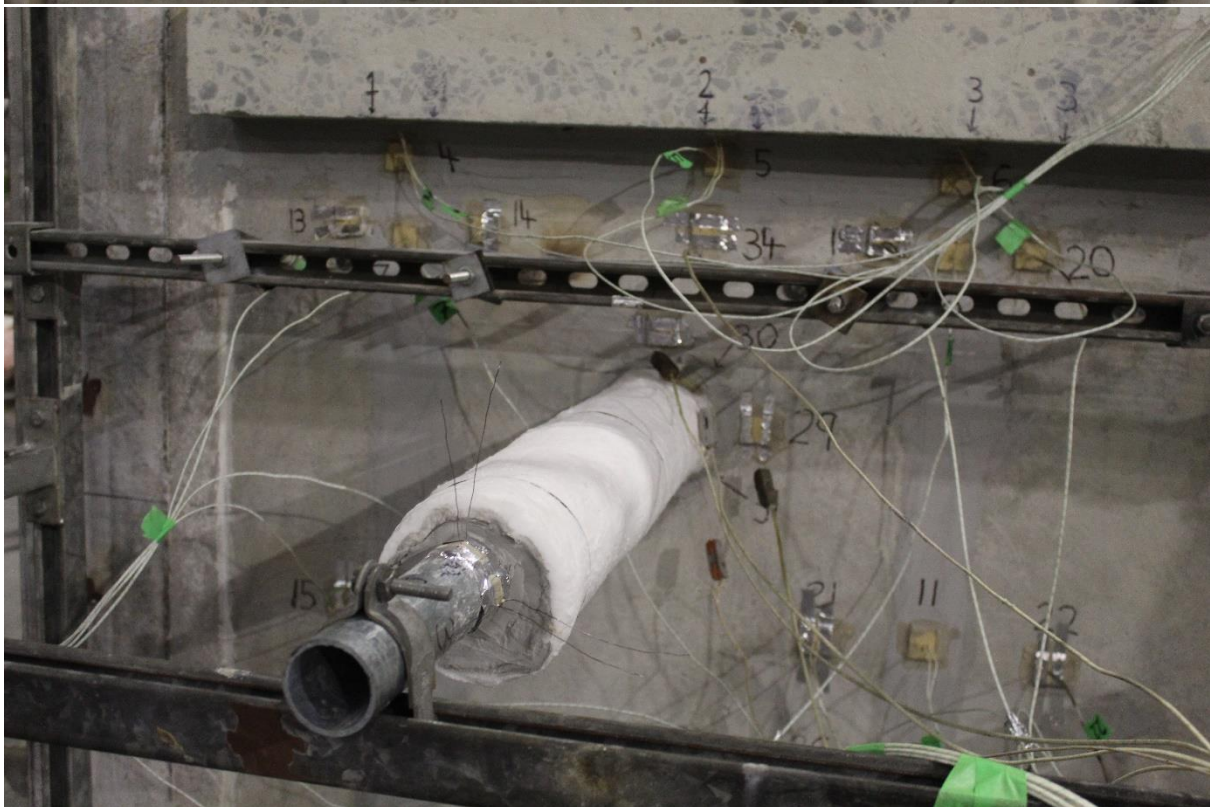
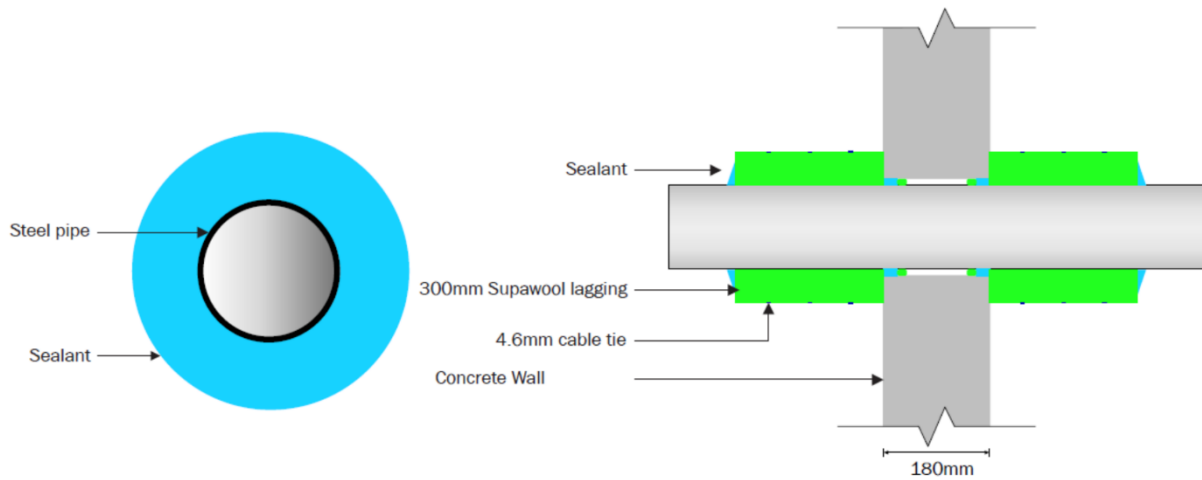
10.4 Specimen D

Penetration System		
D	Service	40DN Steel Pipe
	Service Details	Pipe (2.1), Sealant (3.1), Concrete slab 2 (1.4), Ceramic Fibre Blanket (5.1), Cable ties (4.3)
	Service Support	Unistrut structure at 500mm
	Aperture Size	72.27mm
	Annular Spacing	Min: 6mm, Max: 20mm
Local Fire-stopping Protection		
	Application	Symmetrical, capped from exposed face only
	Protection Used	<p>The steel pipe (2.1) was passed through the aperture, extending 850mm from both faces.</p> <p>Ceramic fibre backing was installed in the aperture, recessed 30mm (nominal) from both faces. Sealant (3.1) was applied to the apertures, flush with the separating element. A length of Ceramic fibre was cut and wrapped around the service 2 ¼ times. The ceramic fibre was secured using cable ties (4.3), and extended 610mm from both faces. A 25mm (nominal) radius bead of sealant was applied between the concrete slab and ceramic fibre. Sealant was applied between the end of the ceramic fibre and the pipe to fill any remaining gaps.</p>

Structural adequacy	Not applicable
Integrity	No failure at 360 min
Insulation	No failure at 360 min

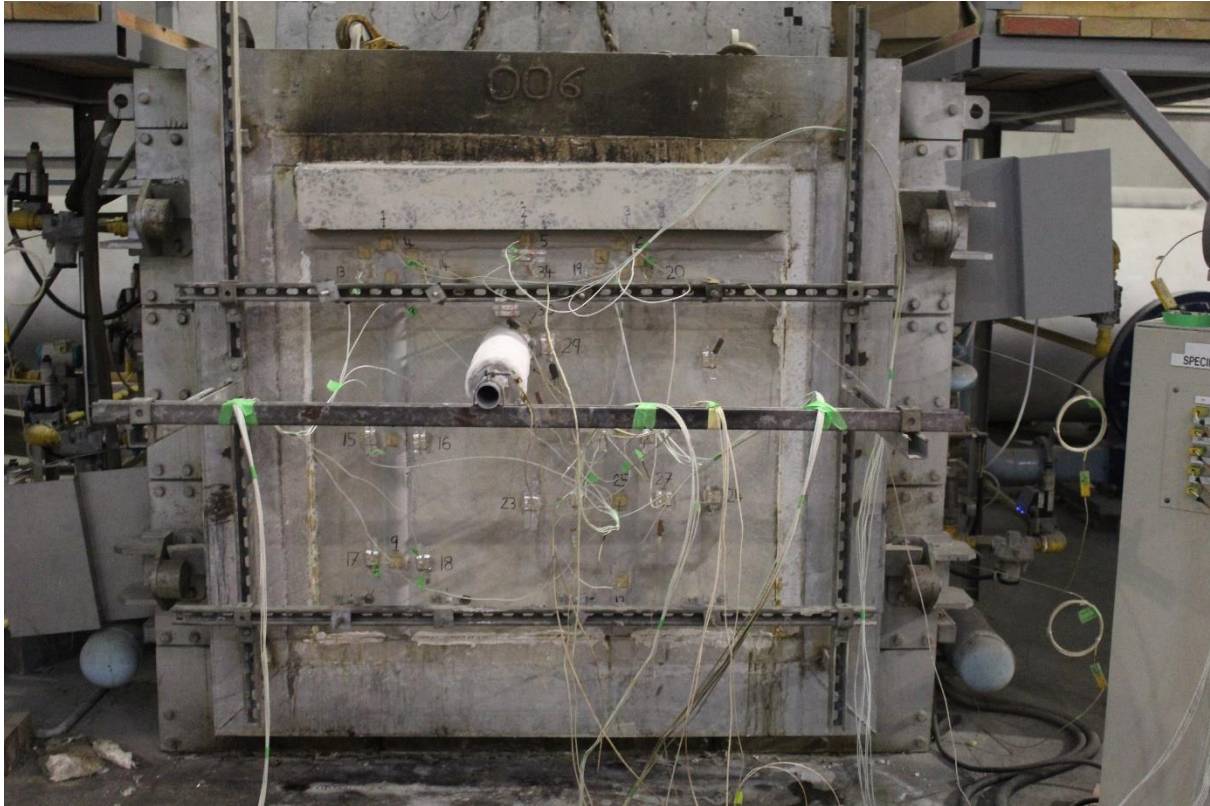
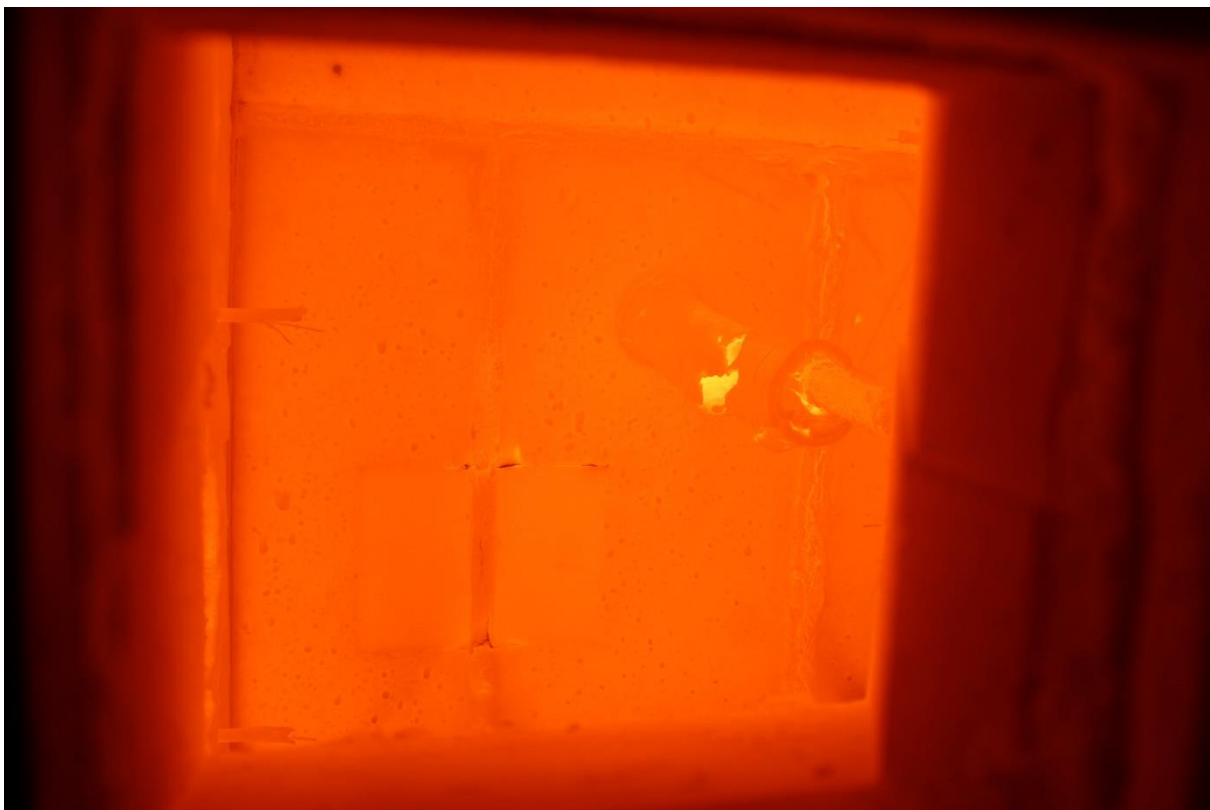
360 minutes:

330	U	A	Minor visible gas in mastic
330	E	D	Pipe wrap is deteriorating with visible break underneath
350	E	D	The break in the wrap has opened up further
360	E/U	ALL	No notable changes
360			TEST DISCONTINUED
