# Regulatory Information Report

**RIRF24008**

**Fire resistance test for control joints in the  
vertical separating element**

Test method: AS1530.4-2014

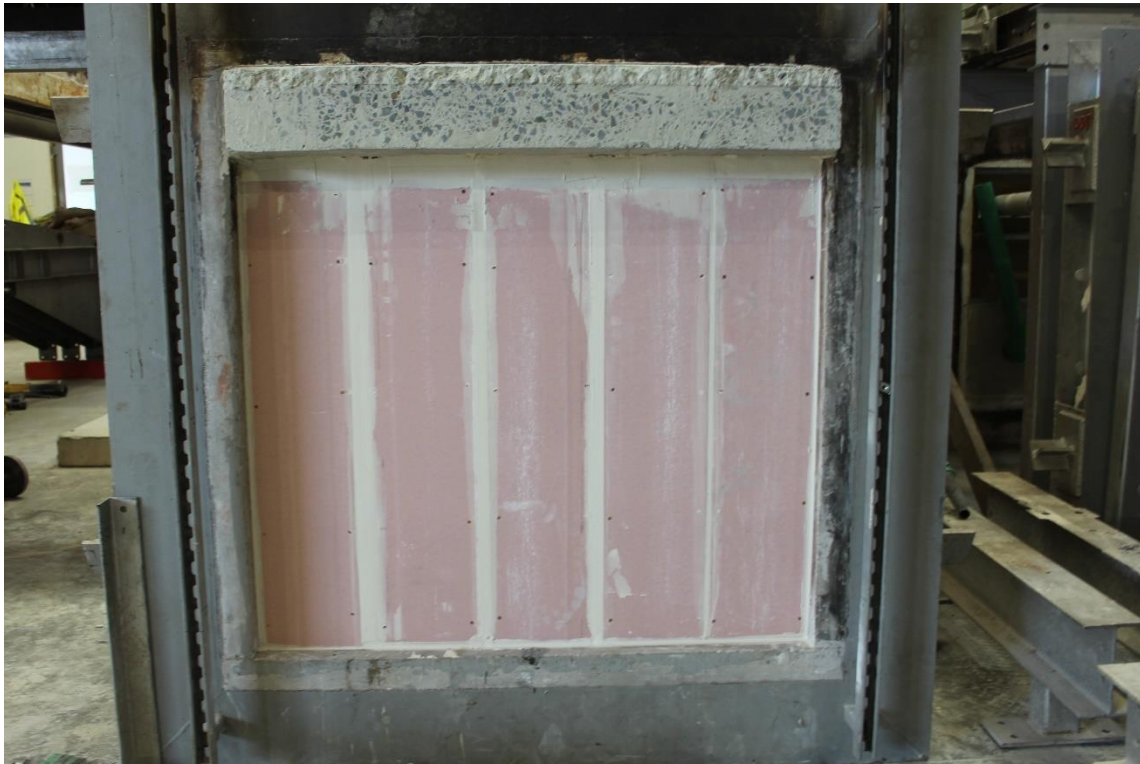
**Figure 1 – Unexposed face prior to test commencement**

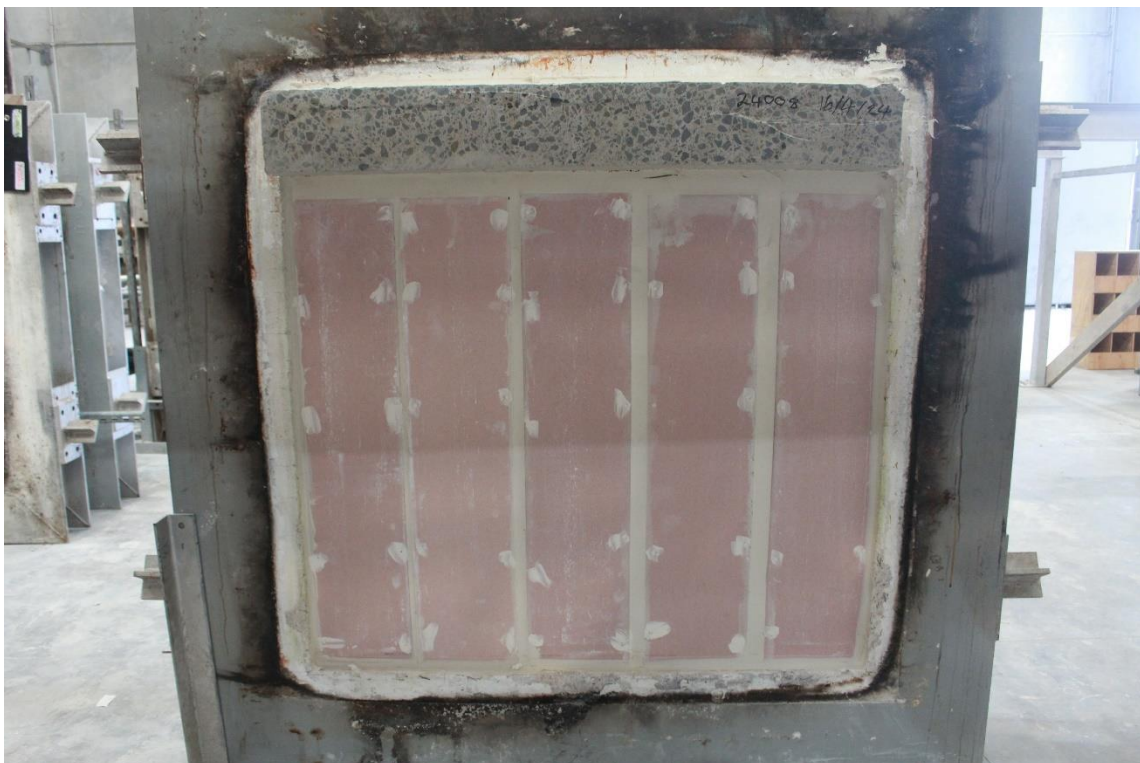
**Figure 12 – Exposed face prior to test commencement**
