# Regulatory Information Report

**RIRF24073**

**Fire resistance test for penetrations through  
the horizontal separating element**

Test method: AS1530.4-2014

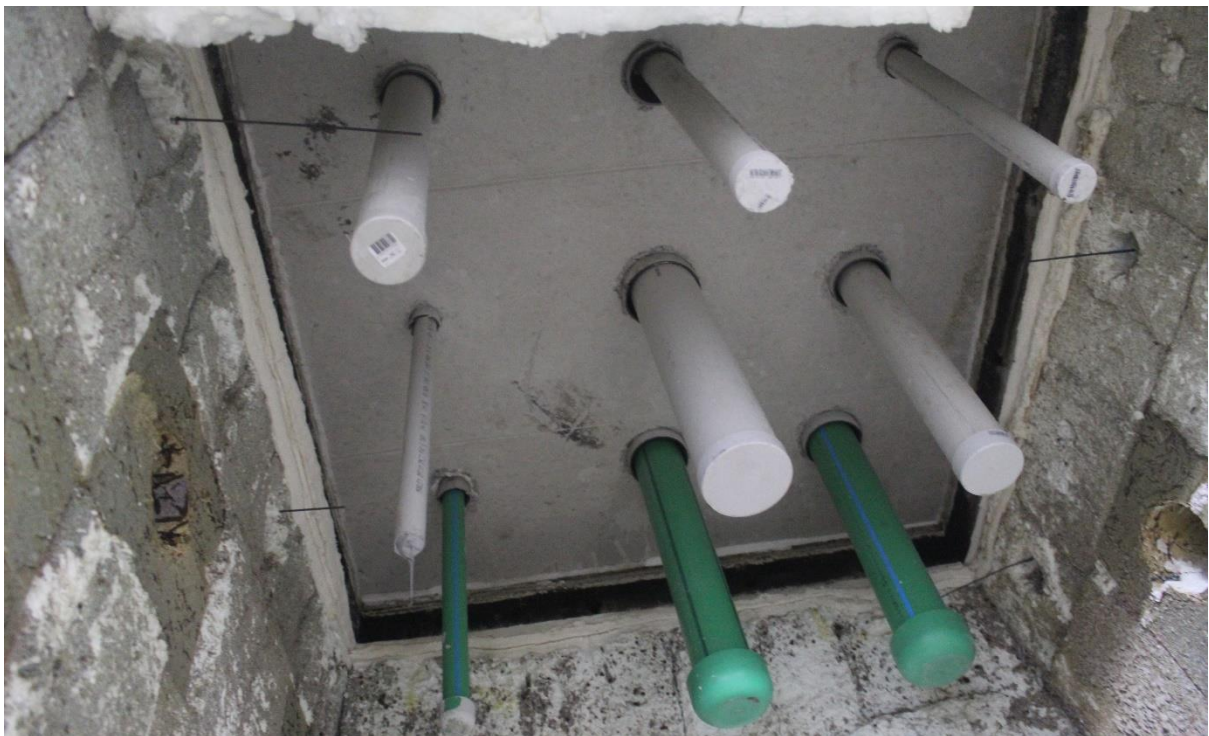
**Figure 22 – Exposed face prior to test commencement**

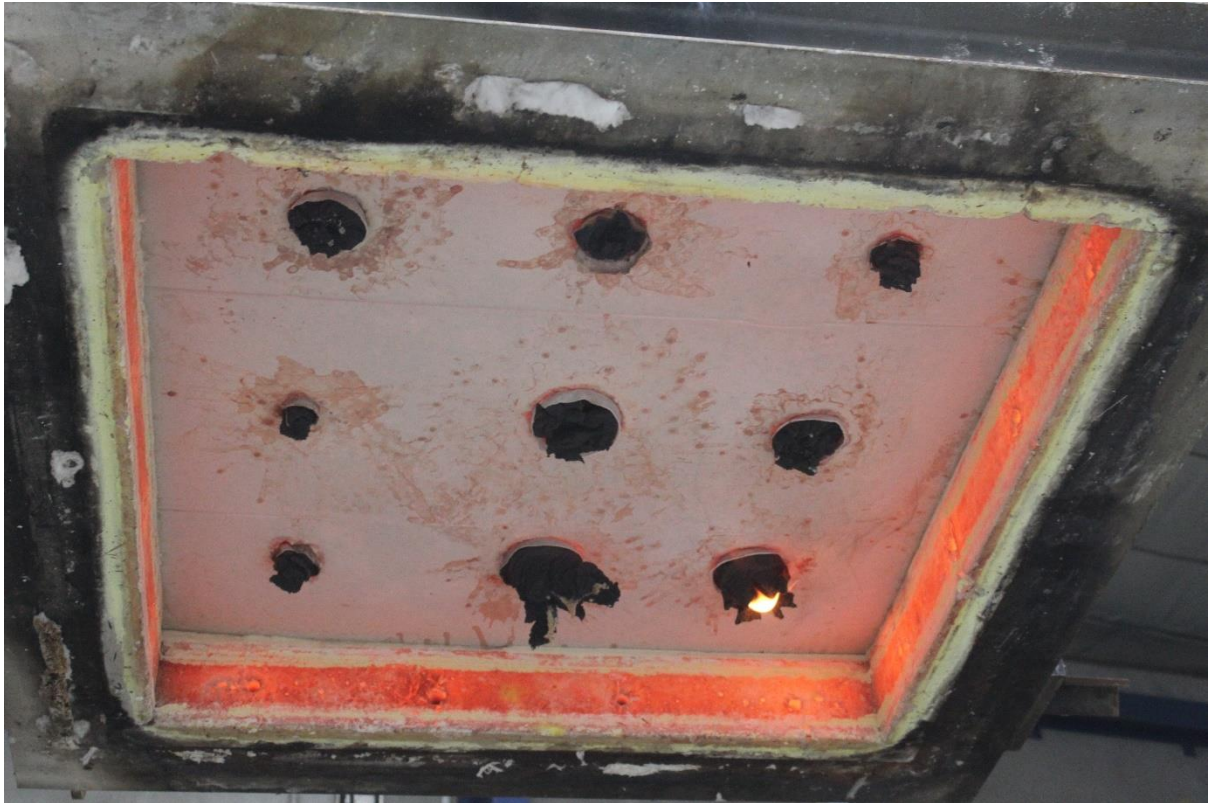
**Figure 27 – Exposed face after the test**
