Regulatory Information Report

RIRF24082

**Fire resistance test for penetrations through a
vertical separating element**

Test method: AS1530.4-2014

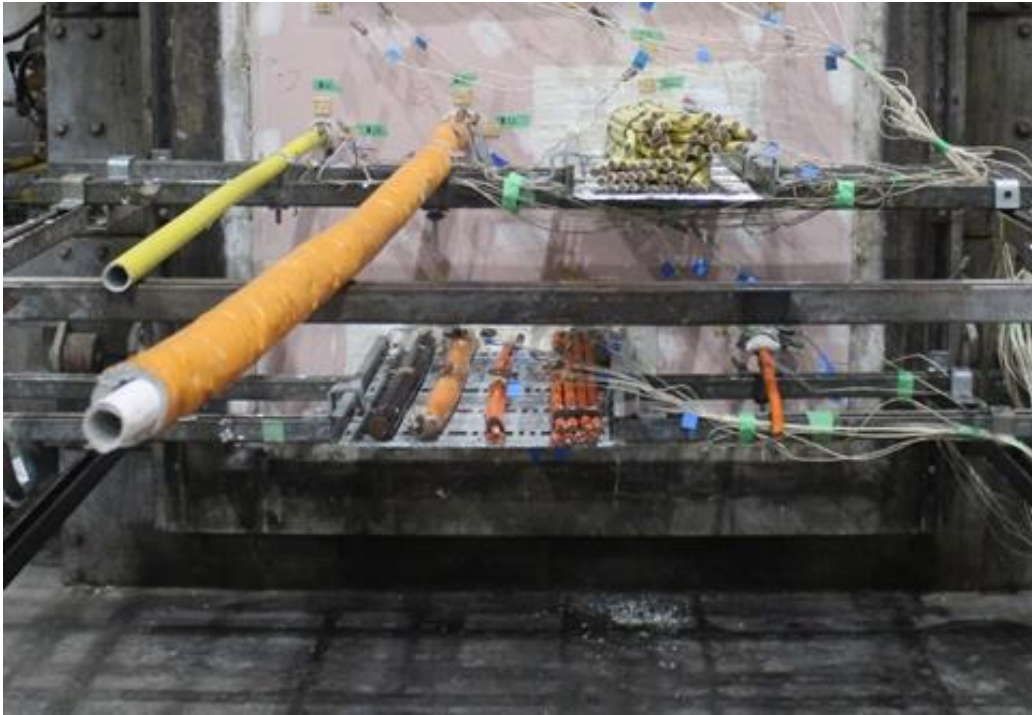
Figure 1 – Unexposed face prior to test commencement

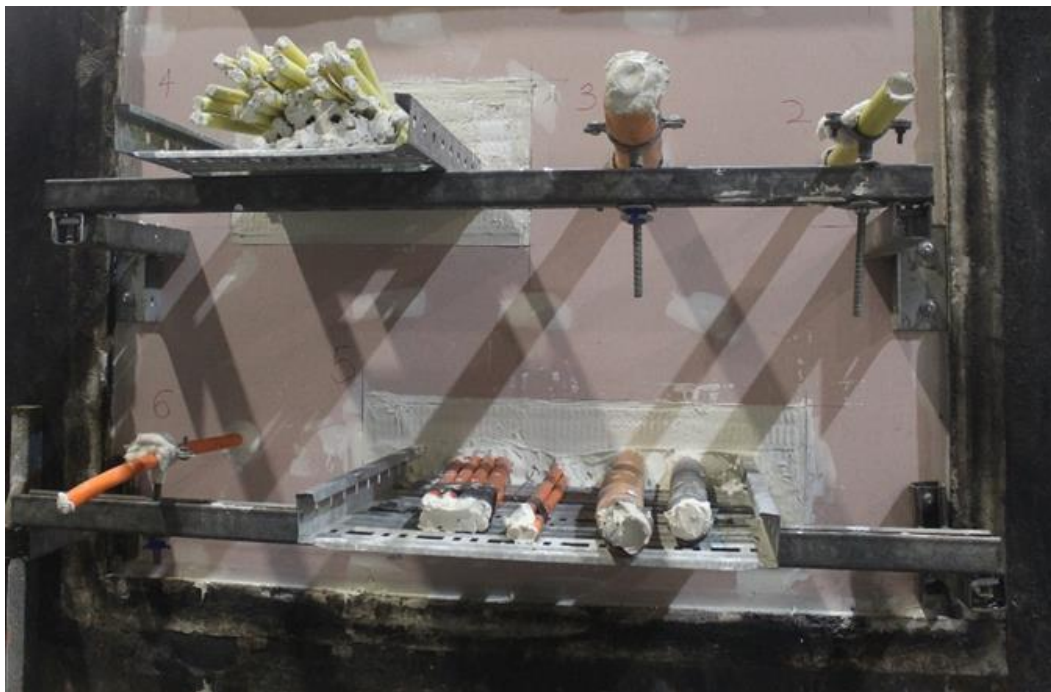
Figure 2 – Exposed face prior to test commencement
