# Regulatory Information Report

**RIRF24069**

**Fire resistance test for penetrations through  
the vertical separating element**

Client:	Agnitek Pty Ltd
Test method:	AS1530.4-2014
Report Date:	26/07/2024
Test number:	PF24069

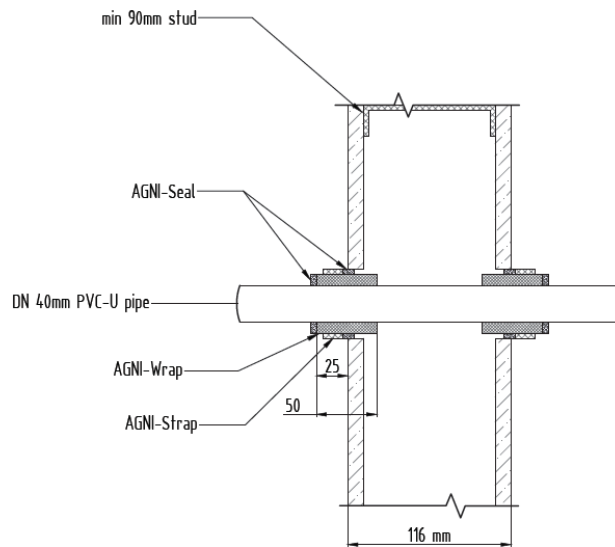
### 5.1 Specimen 1

Service penetration details	
Service	DN40 PVC-U DWV Pipe
Service Support	Unistrut structure at 530mm and 1515mm on non-fire side
Aperture Diameter	55mm
Annular Spacing	Min: 5.5mm, Max: 6.5mm

Local Fire-stopping system	
Application	Symmetrical – installed on both faces of separating element
System description	50mm AGNI-Wrap secured around pipe with no overlap, using a cable tie. AGNI-Wrap inserted in annular space, extending 25mm (nominal) into aperture. AGNI-Seal sealed AGNI-Wrap and separating element joint. 5mm (nominal) AGNI-Seal installed between AGNI-Wrap and pipe.

Structural adequacy	Not applicable
Integrity	No failure at 70 minutes
Insulation	No failure at 70 minutes

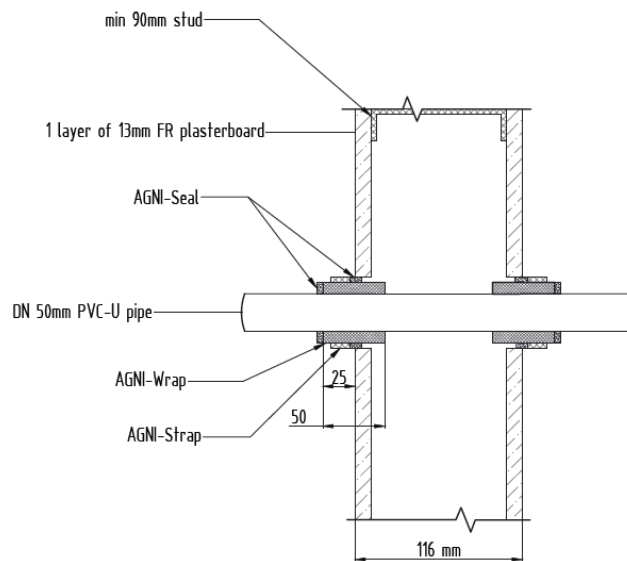
## 5.2 Specimen 2

Service penetration details	
Service	DN50 PVC-U DWV Pipe
Service Support	Unistrut structure at 530mm and 1515mm on non-fire side Steel Track at 300mm on fire side
Aperture Diameter	65mm
Annular Spacing	4.5mm

Local Fire-stopping system	
Application	Symmetrical – installed on both faces of separating element
System description	50mm AGNI-Wrap secured around pipe with no overlap, using a cable tie. AGNI-Wrap inserted in annular space, extending 25mm (nominal) into aperture. AGNI-Seal sealed AGNI-Wrap and separating element joint. 5mm (nominal) AGNI-Seal installed between AGNI-Wrap and pipe.

Structural adequacy	Not applicable
Integrity	No failure at 70 minutes
Insulation	No failure at 70 minutes

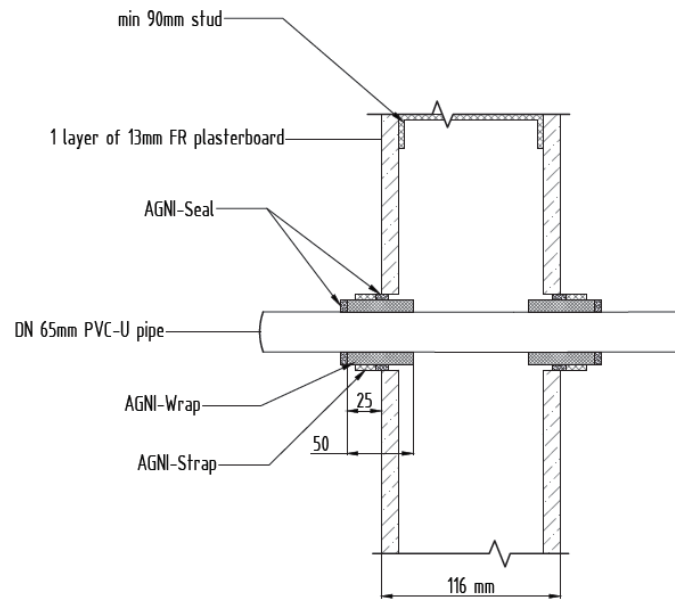
### 5.3 Specimen 3

Service penetration details	
Service	DN65 PVC-U DWV Pipe
Service Support	Unistrut structure at 530mm and 1515mm on non-fire side Steel Track at 300mm on fire side
Aperture Diameter	86mm
Annular Spacing	Min: 8mm, Max: 9mm

Local Fire-stopping system	
Application	Symmetrical – installed on both faces of separating element
System description	50mm AGNI-Wrap secured around pipe with no overlap, using a cable tie. AGNI-Wrap inserted in annular space, extending 25mm (nominal) into aperture. AGNI-Seal sealed AGNI-Wrap and separating element joint. 5mm (nominal) AGNI-Seal installed between AGNI-Wrap and pipe.

Structural adequacy	Not applicable
Integrity	No failure at 70 minutes
Insulation	68 minutes

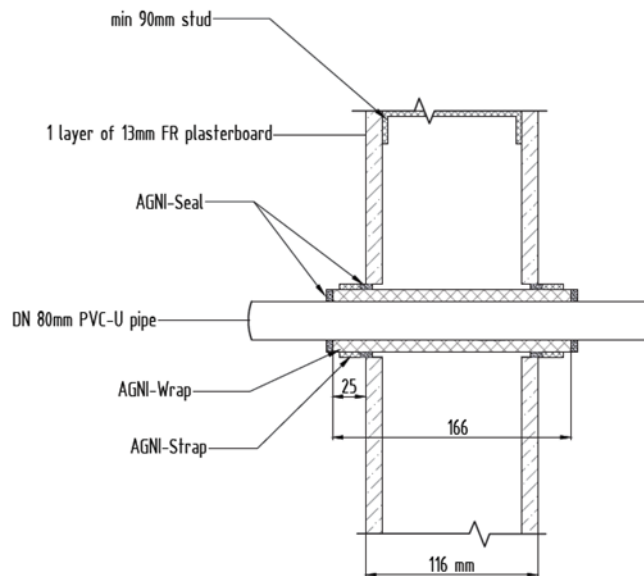
## 5.4 Specimen 4

Service penetration details	
Service	DN80 PVC-U DWV Pipe
Service Support	Unistrut structure at 530mm and 1515mm on non-fire side Steel Track at 300mm on fire side
Aperture Diameter	94mm
Annular Spacing	Min: 3.5mm, Max: 8mm

Local Fire-stopping system	
Application	Symmetrical – installed passing through separating element
System description	166mm AGNI-Sleeve inserted through aperture, extending 25mm (nominal) from both sides of separating element, secured around pipe using a cable tie from each side. AGNI-Seal sealed AGNI-Sleeve and separating element joint. 5mm (nominal) AGNI-Seal installed between AGNI-Sleeve and pipe.

Structural adequacy	Not applicable
Integrity	No failure at 70 minutes
Insulation	No failure at 70 minutes

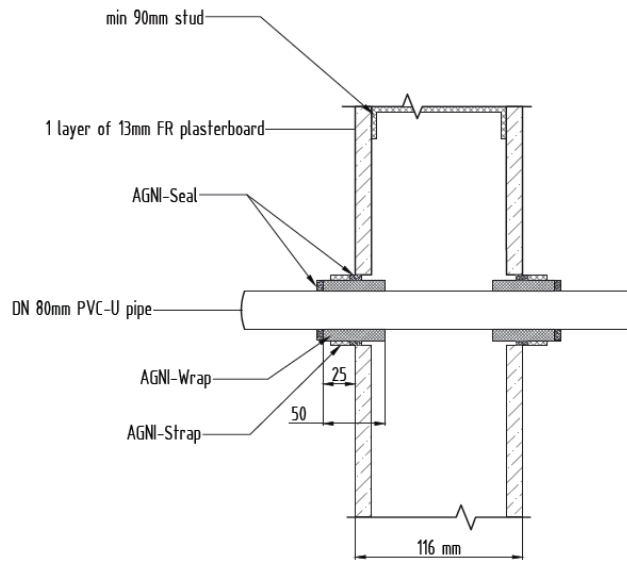
## 5.5 Specimen 5

Service penetration details	
Service	DN80 PVC-U DWV Pipe
Service Support	Unistrut structure at 530mm and 1515mm on non-fire side Steel Track at 300mm on fire side
Aperture Diameter	94mm
Annular Spacing	Min: 3.5mm, Max: 8mm

Local Fire-stopping system	
Application	Symmetrical – installed on both faces of separating element
System description	50mm AGNI-Wrap secured around pipe with no overlap, using a cable tie. AGNI-Wrap inserted in annular space, extending 25mm (nominal) into aperture. AGNI-Seal sealed AGNI-Wrap and separating element joint. 5mm (nominal) AGNI-Seal installed between AGNI-Wrap and pipe.

Structural adequacy	Not applicable
Integrity	No failure at 70 minutes
Insulation	62 minutes

Time min	Test face	SP#	OBSERVATIONS/REMARKS
53	U	5	Cotton pad test applied for 30 seconds over the red glowing in aperture – PASS
55	U	5	Cotton pad test applied for 30 seconds over the red glowing in aperture – PASS
59	U	5	Cotton pad test applied for 30 seconds over the red glowing in aperture – PASS
70			Test Discontinued

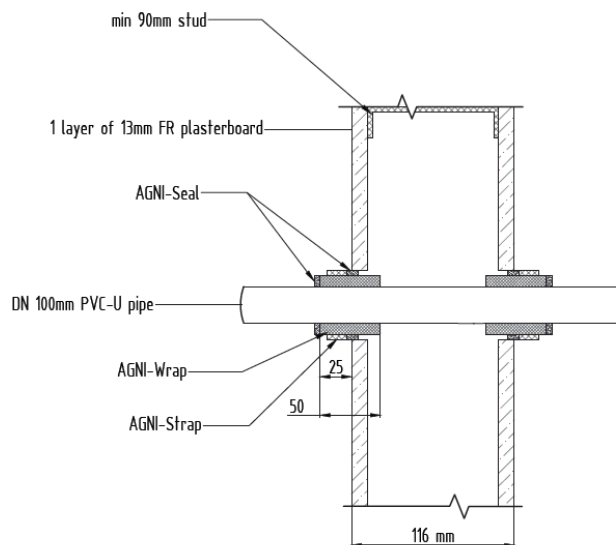
## 5.6 Specimen 6

Service penetration details	
Service	DN100 PVC-U DWV Pipe
Service Support	Unistrut structure at 530mm and 1515mm on non-fire side Steel Track at 300mm on fire side
Aperture Diameter	120mm
Annular Spacing	Min: 4mm, Max: 6mm

Local Fire-stopping system	
Application	Symmetrical – installed on both faces of separating element
System description	50mm AGNI-Wrap secured around pipe with no overlap, using a cable tie. AGNI-Wrap inserted in annular space, extending 25mm (nominal) into aperture. AGNI-Seal sealed AGNI-Wrap and separating element joint. 5mm (nominal) AGNI-Seal installed between AGNI-Wrap and pipe.

Structural adequacy	Not applicable
Integrity	No failure at 70 minutes
Insulation	54 minutes

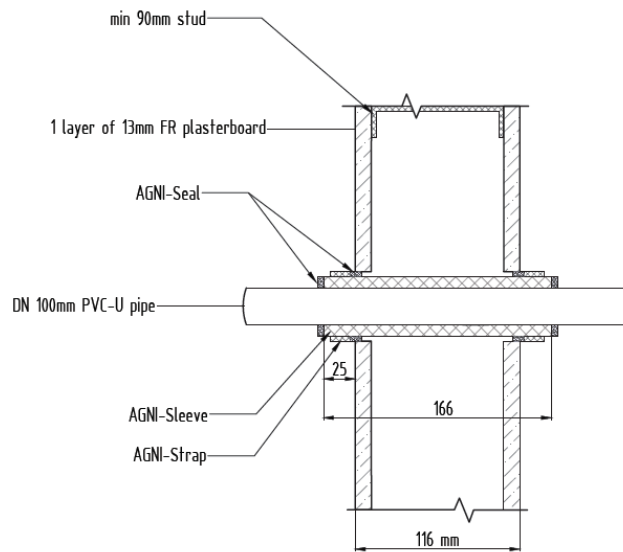
## 5.7 Specimen 7

Service penetration details	
Service	DN100 PVC-U DWV Pipe
Service Support	Unistrut structure at 530mm and 1515mm on non-fire side Steel Track at 300mm on fire side
Aperture Diameter	120mm
Annular Spacing	Min: 4.5mm, Max: 5.5mm

Local Fire-stopping system	
Application	Symmetrical – installed passing through separating element
System description	166mm AGNI-Sleeve inserted through aperture, extending 25mm (nominal) from both sides of separating element, secured around pipe using a cable tie from each side. AGNI-Seal sealed AGNI-Sleeve and separating element joint. 5mm (nominal) AGNI-Seal installed between AGNI-Sleeve and pipe.

Structural adequacy	Not applicable
Integrity	No failure at 70 minutes
Insulation	No failure at 70 minutes

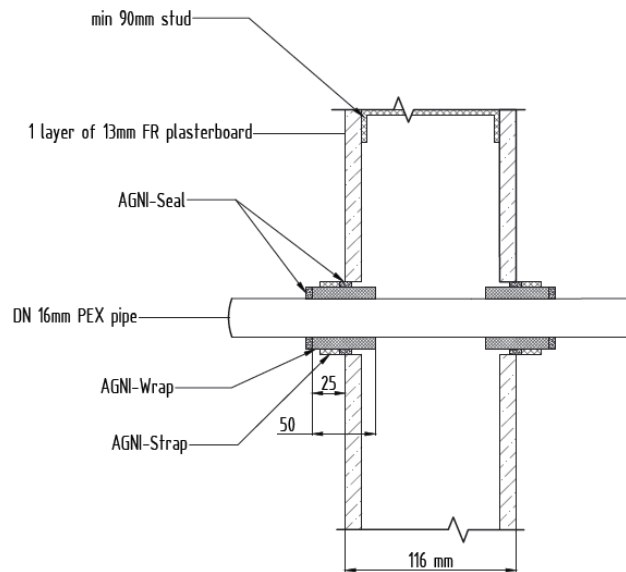
## 5.8 Specimen 8

Service penetration details	
Service	16mm PEX Pipe
Service Support	Unistrut structure at 530mm and 1515mm on non-fire side Steel Track at 300mm on fire side
Aperture Diameter	26mm
Annular Spacing	Min: 3.5mm, Max: 6.5mm

Local Fire-stopping system	
Application	Symmetrical – installed on both faces of separating element
System description	50mm AGNI-Wrap secured around pipe with no overlap, using a cable tie. AGNI-Wrap inserted in annular space, extending 25mm (nominal) into aperture. AGNI-Seal sealed AGNI-Wrap and separating element joint. 5mm (nominal) AGNI-Seal installed between AGNI-Wrap and pipe.

Structural adequacy	Not applicable
Integrity	No failure at 70 minutes
Insulation	69 minutes

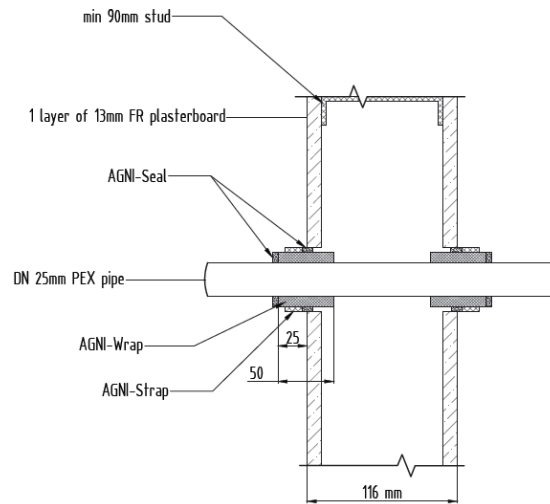
## 5.9 Specimen 9

Service penetration details	
Service	25mm PEX Pipe
Service Support	Unistrut structure at 530mm and 1515mm on non-fire side Steel Track at 300mm on fire side
Aperture Diameter	35mm
Annular Spacing	Min: 4.5mm, Max: 5.5mm

Local Fire-stopping system	
Application	Symmetrical – installed on both faces of separating element
System description	50mm AGNI-Wrap secured around pipe with no overlap, using a cable tie. AGNI-Wrap inserted in annular space, extending 25mm (nominal) into aperture. AGNI-Seal sealed AGNI-Wrap and separating element joint. 5mm (nominal) AGNI-Seal installed between AGNI-Wrap and pipe.

Structural adequacy	Not applicable
Integrity	No failure at 70 minutes
Insulation	No failure at 70 minutes

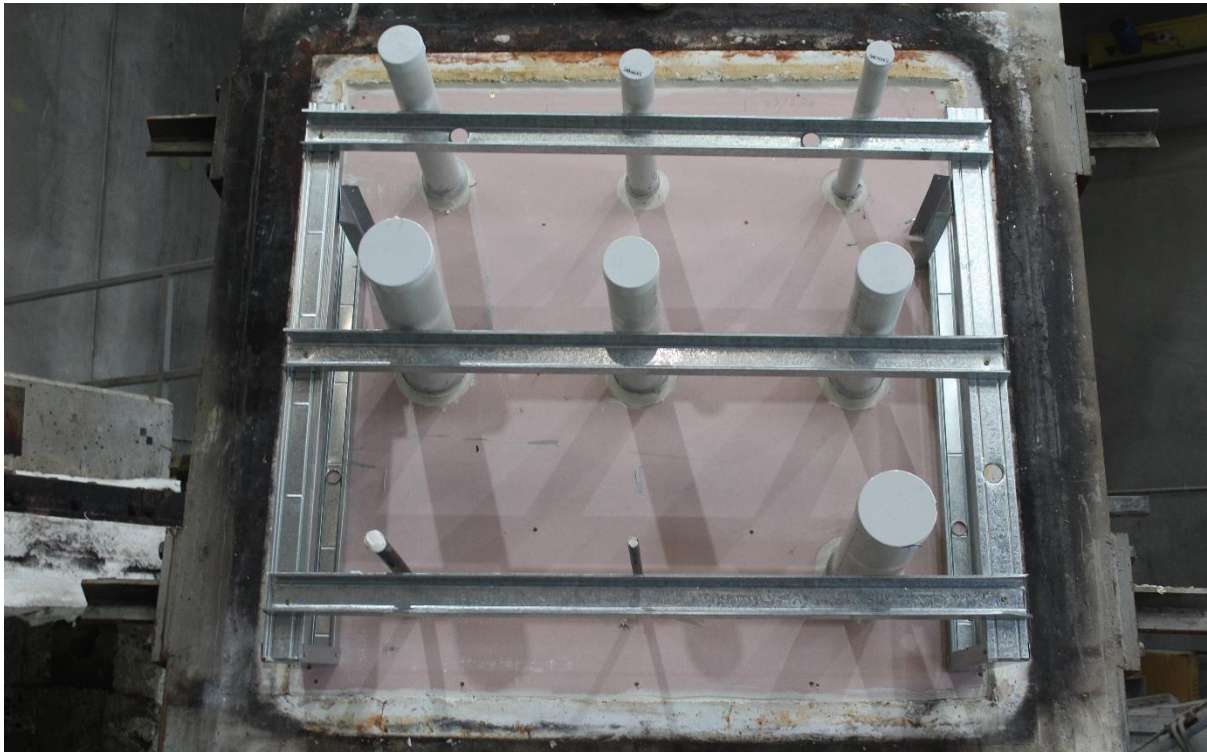
**Figure 12 – Exposed face prior to test commencement**

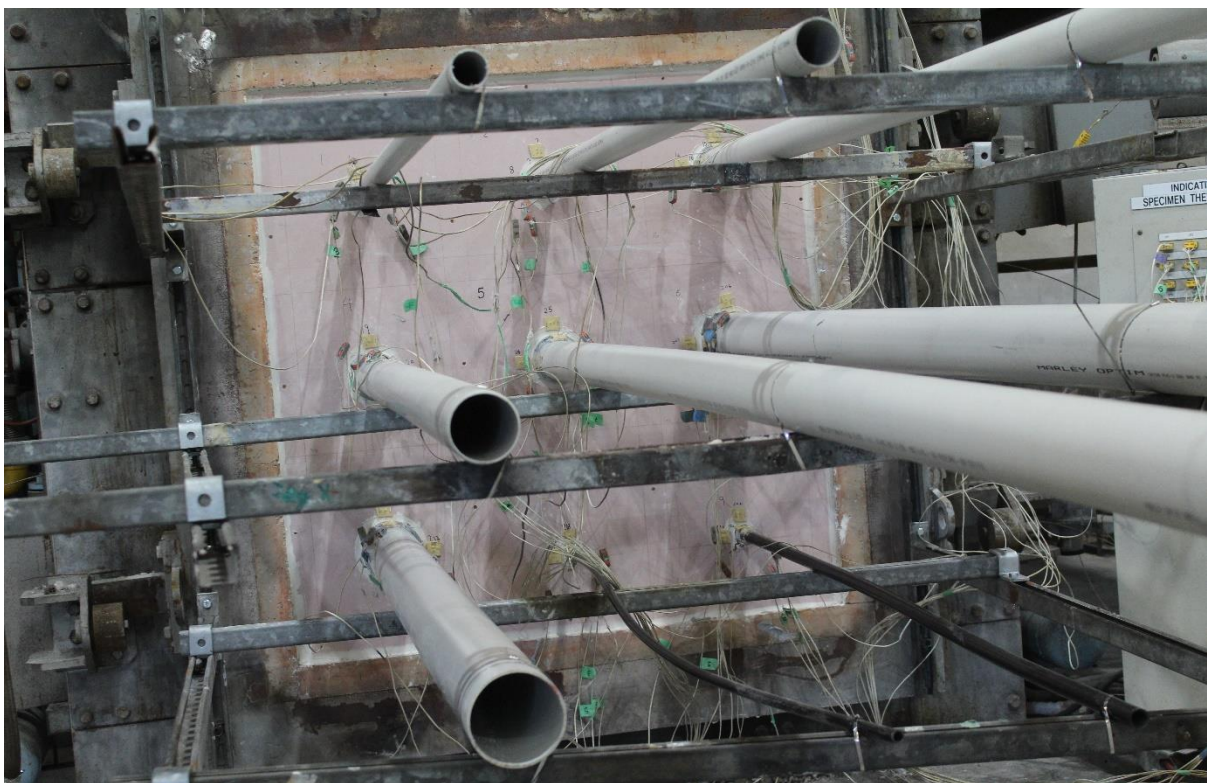
**Figure 13 – Unexposed face prior to test commencement**

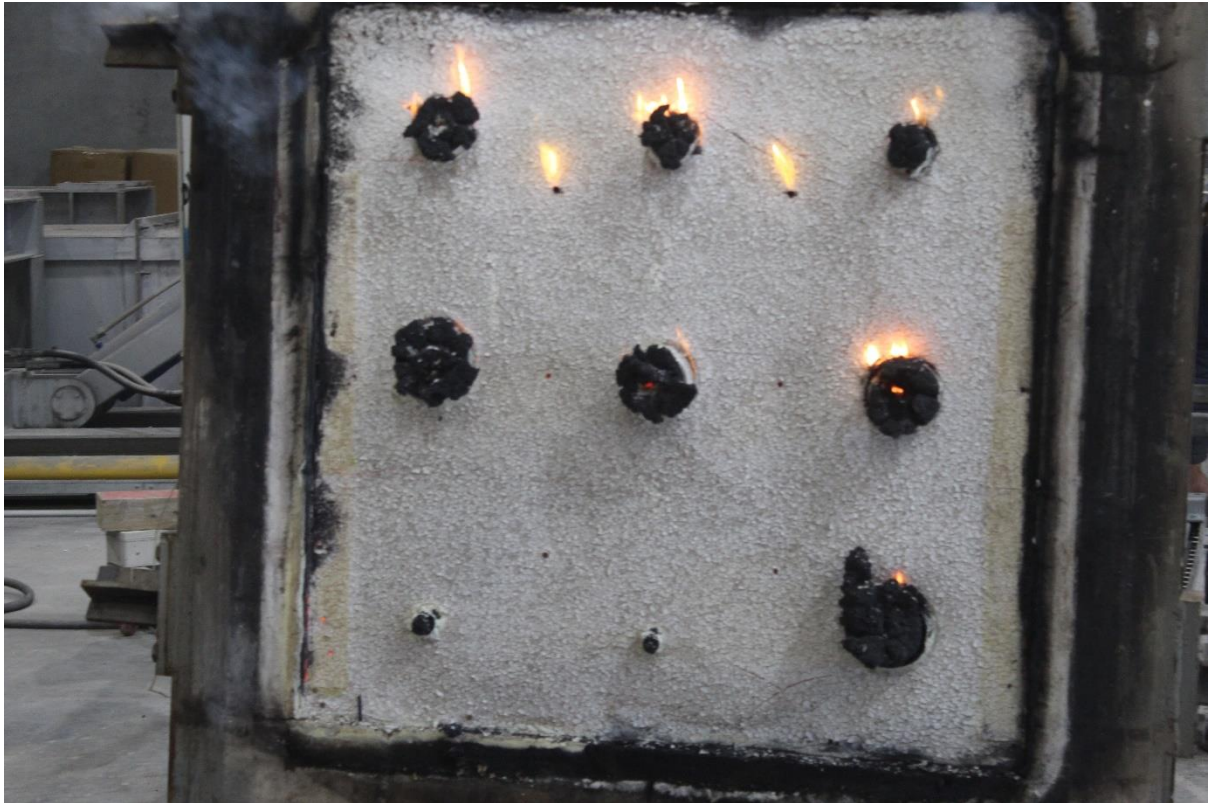
**Figure 21 – Exposed face after the test**
