# Regulatory Information Report

**PF24145**

**Fire resistance test for penetrations through a  
vertical separating element**

Client:	<b>Agnitek Pty Ltd</b>
Test method:	AS1530.4-2014
Report Date:	10/03/2025
Test number:	PF24145

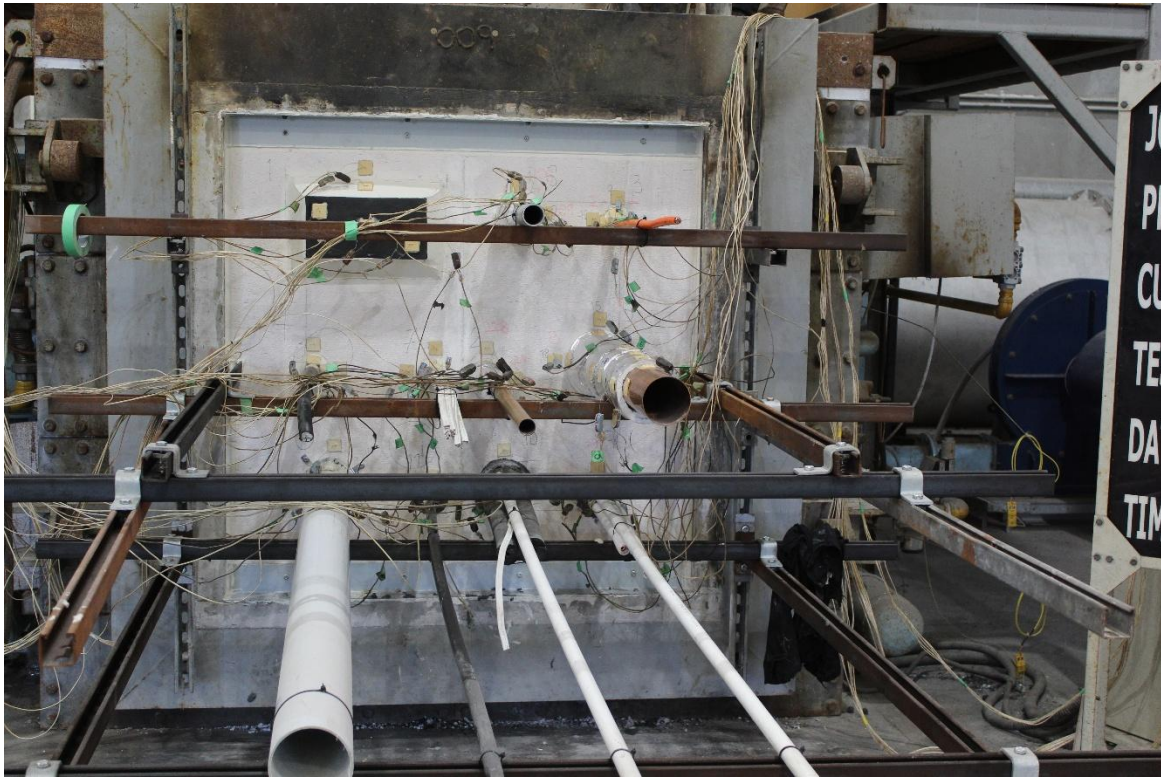
Figure 1 - Unexposed face prior to test commencement

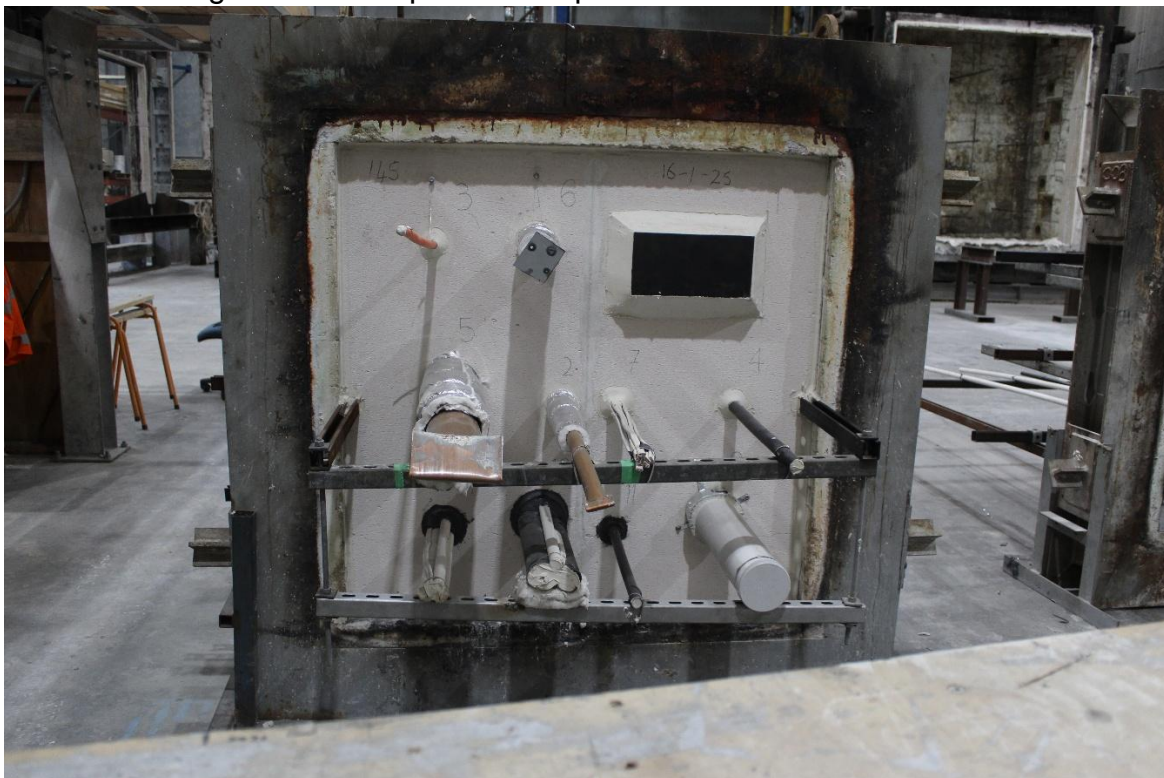
Figure 2 - Exposed face prior to test commencement
