Test report # PF23060

Client: Firestop Centre Ltd

Fire resistance test for the C-purlin and I-beam penetrations through a vertical separating element

Test method: AS 1530.4:2014

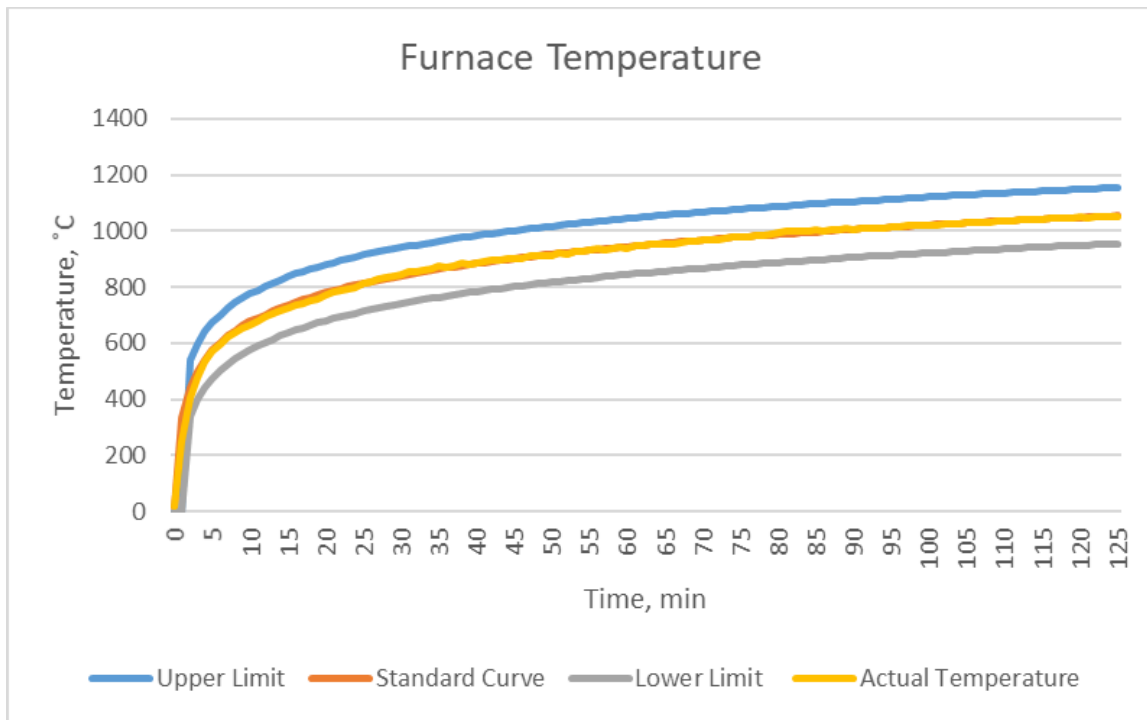
The furnace was controlled to follow the temperature/time relationship specified in AS 1530.4-2014.

Figure 1 – Furnace Temperature during the test

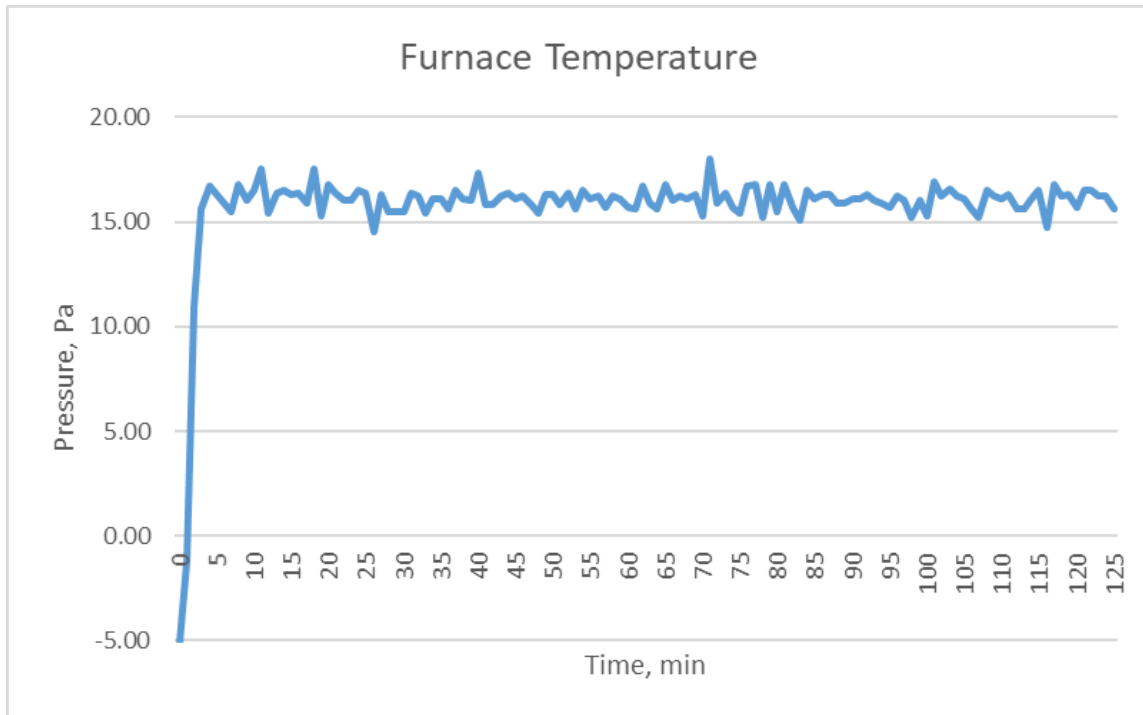
After the first 5 minutes of the test, the furnace pressure was maintained at 16 ± 3 Pa with respect to atmosphere. The probe was located 500mm above the furnace floor.

Figure 2– Furnace Pressure during the test

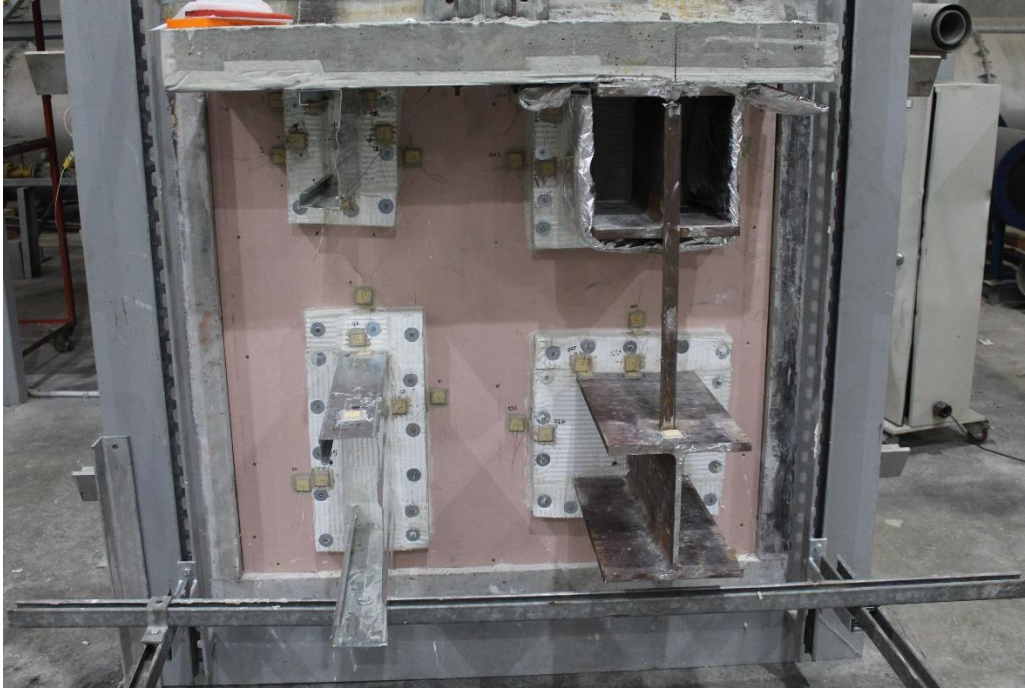
Figure 3 – Unexposed Face of the test

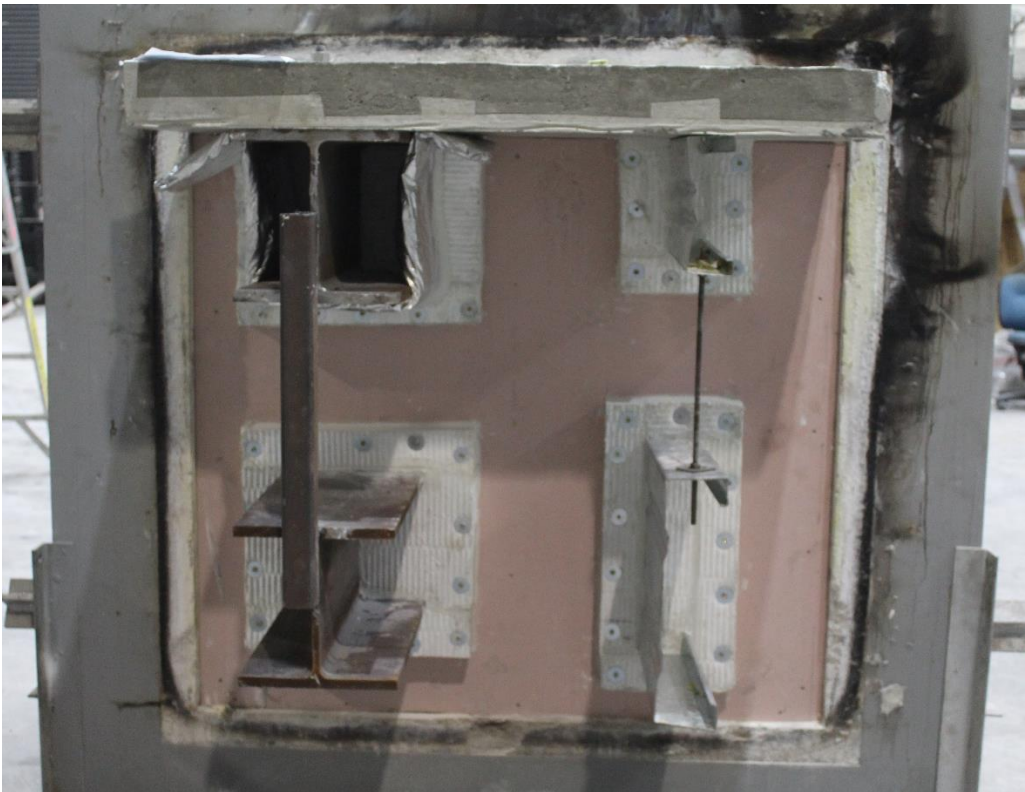
Figure 4 – Exposed Face of the test

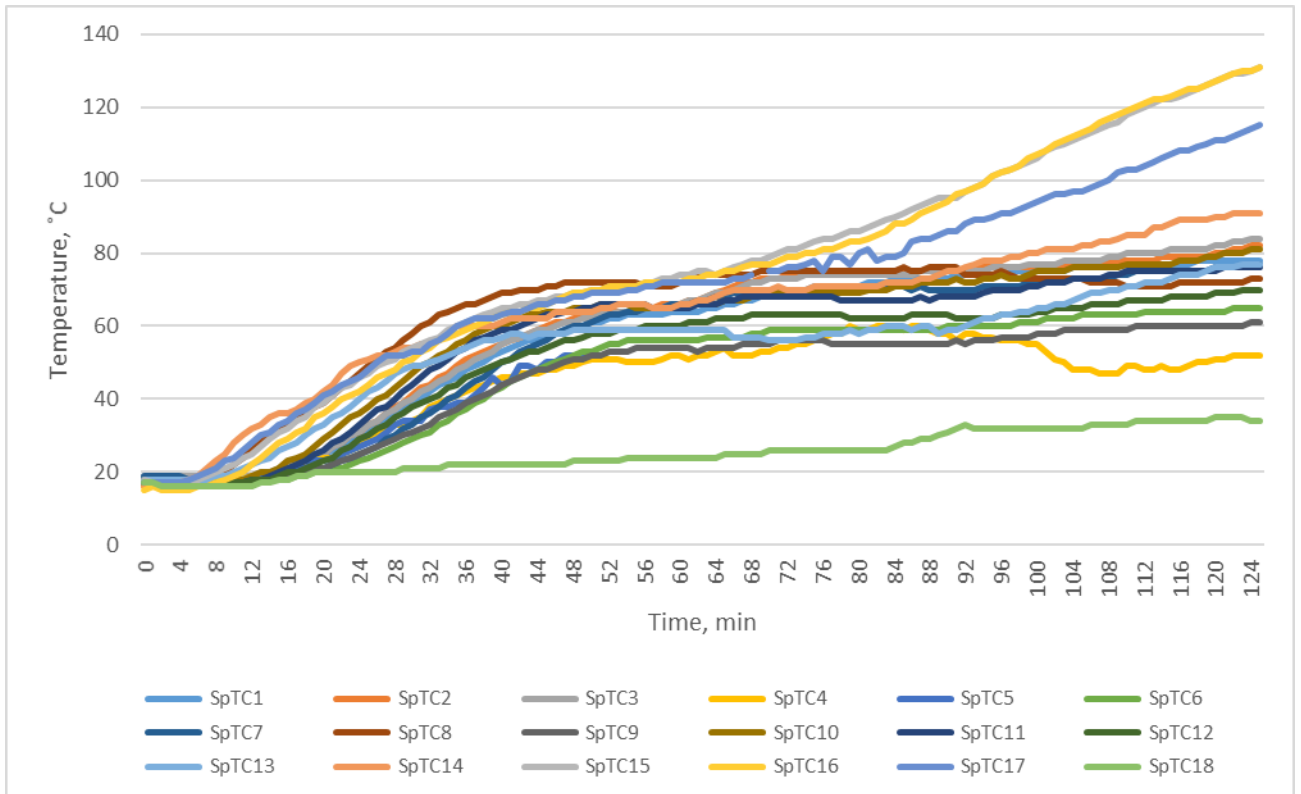
Structural adequacy	Not Applicable
Integrity	No failure at 125 minutes
Insulation	No failure at 125 minutes

Figure 5 – Specimen A thermocouples readings

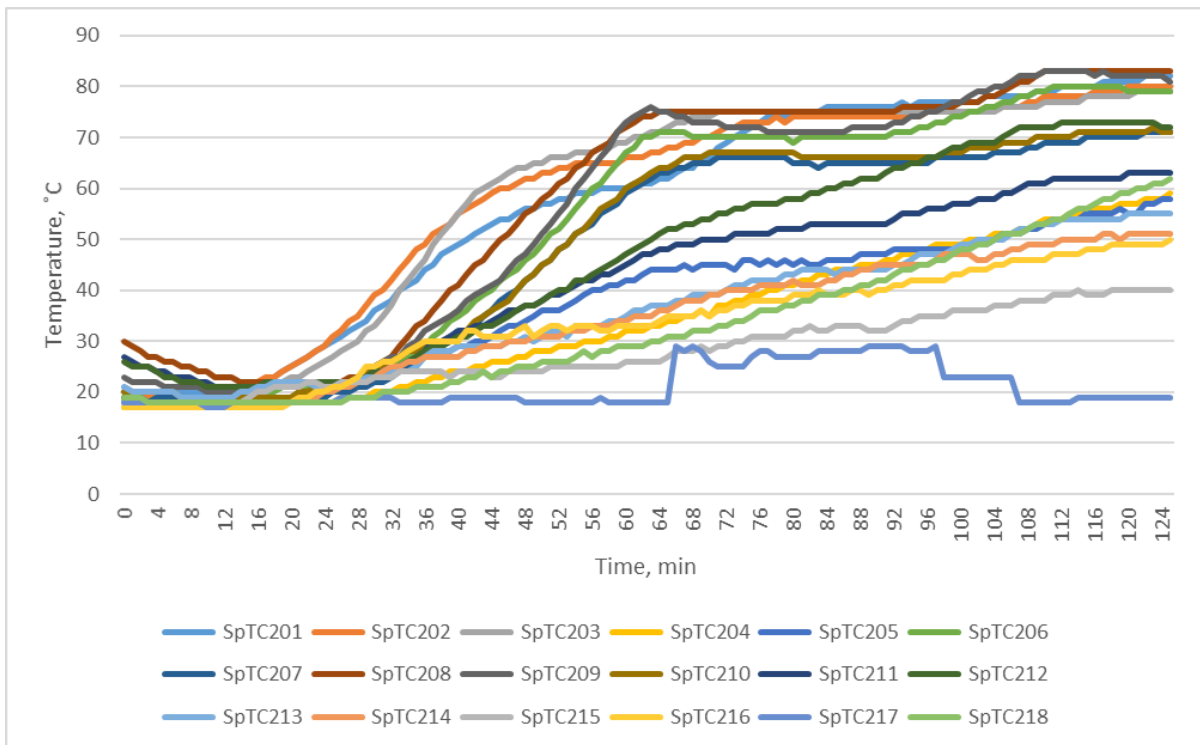
Structural adequacy	Not Applicable
Integrity	No failure at 125 minutes
Insulation	No failure at 125 minutes

Figure 6 – Specimen B thermocouples readings

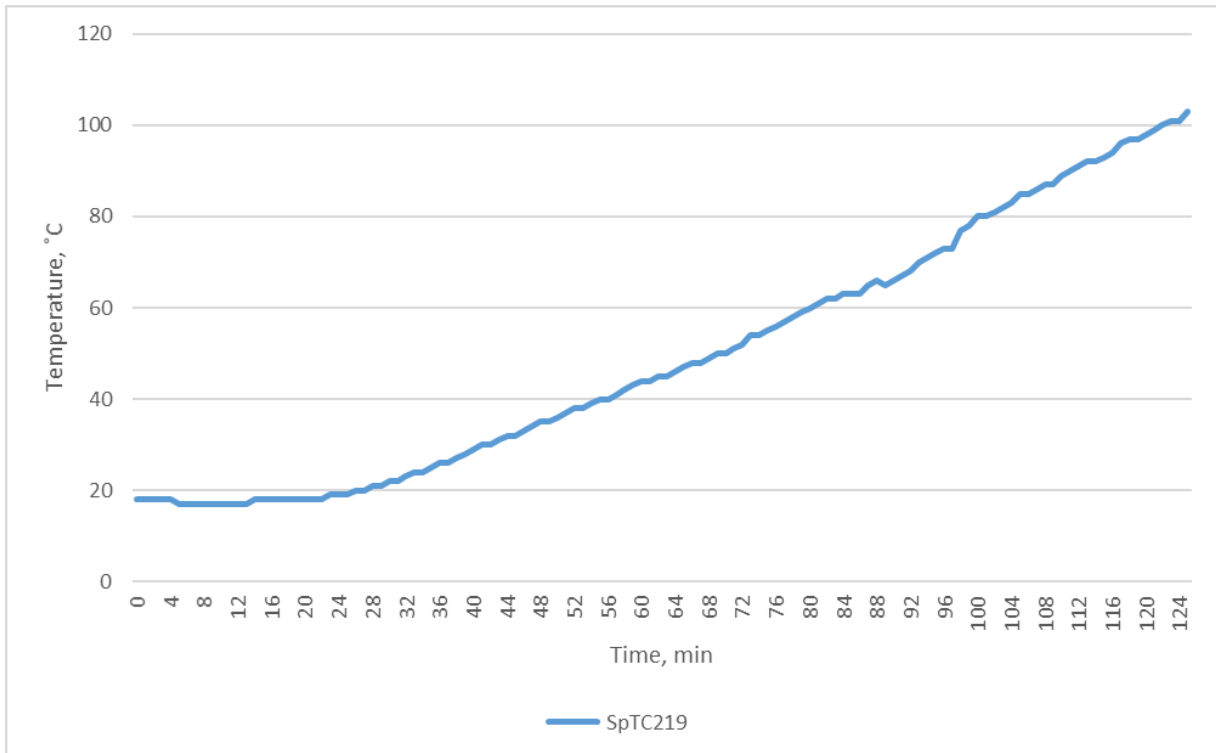
Figure 6.1 – Specimen B, SpTC219 was attached inside the wrapped section on the I beam surface 25mm from the FR Board (center of left bottom flange, from unexposed face view) – upon client request, for information purpose only.

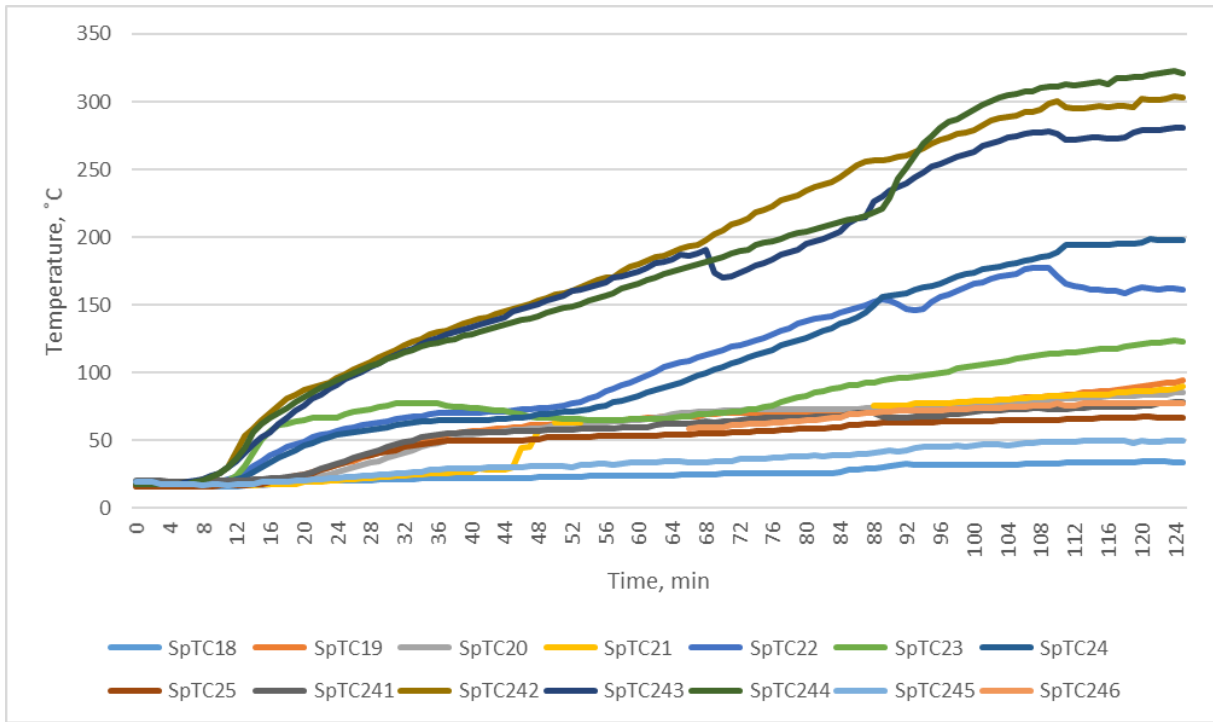
Structural adequacy	Not Applicable
Integrity	No failure at 125 minutes
Insulation	68 minutes

Figure 7 – Specimen C thermocouples readings

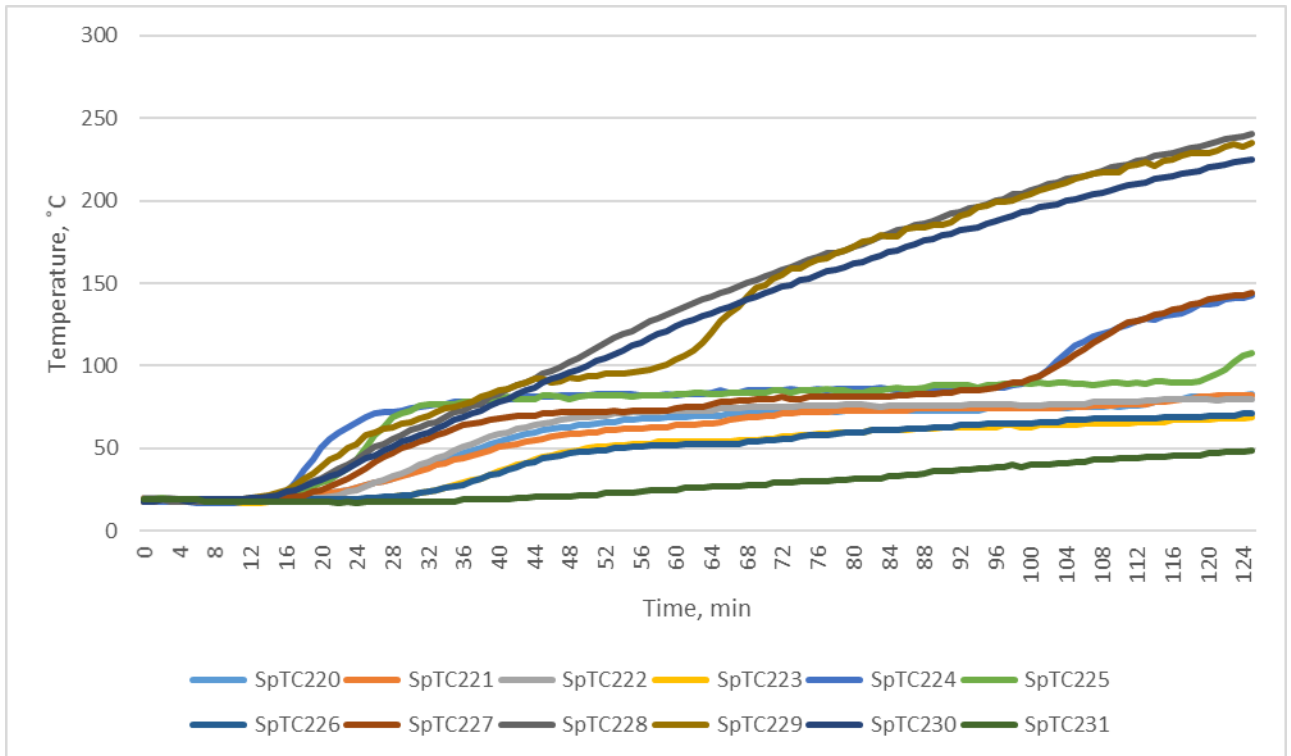
Structural adequacy	Not Applicable
Integrity	No failure at 125 minutes
Insulation	95 minutes

Figure 8 – Specimen D thermocouples readings

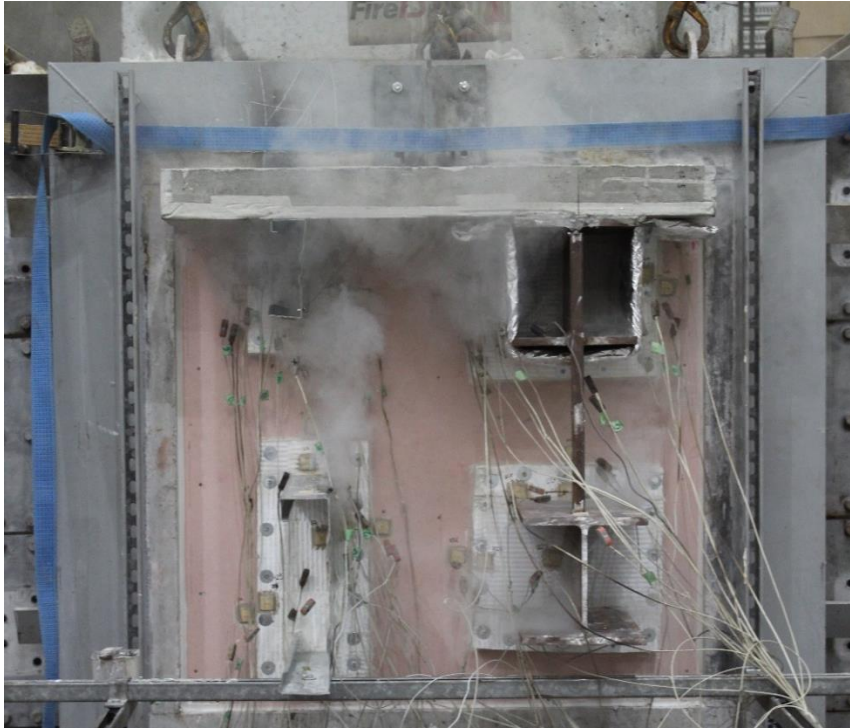
Figure 9 – Unexposed face at 15 minutes

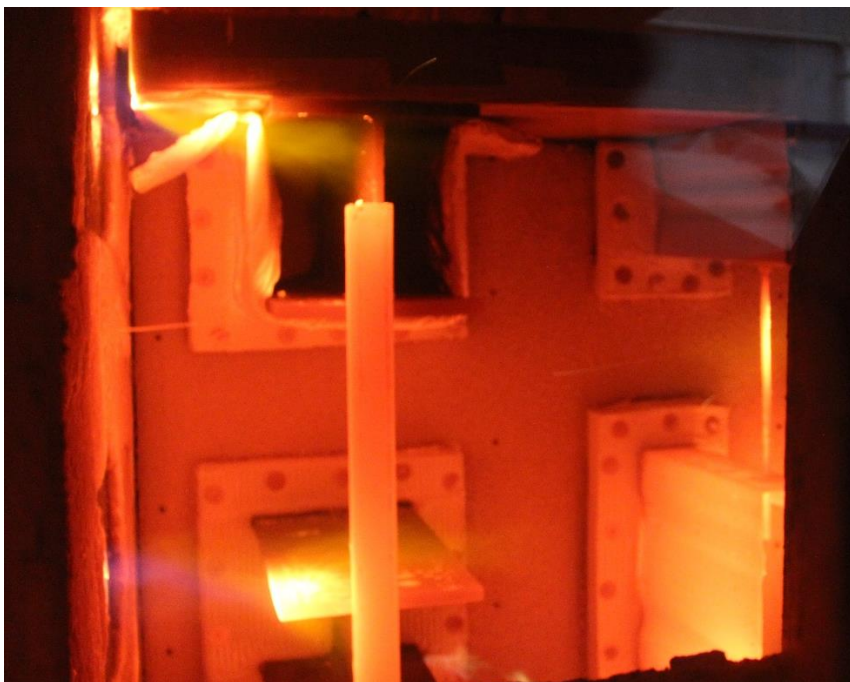
Figure 10 – Exposed face at 15 minutes

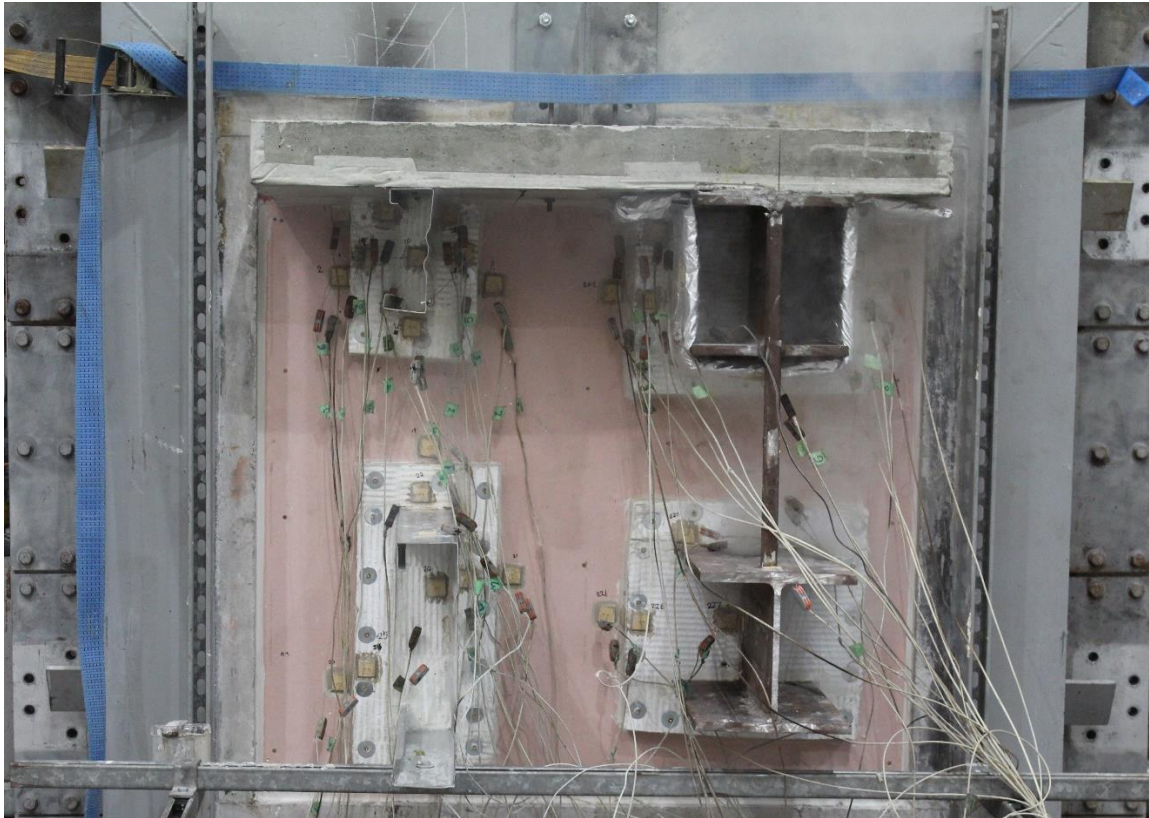
Figure 11 – Unexposed face at 30 minutes

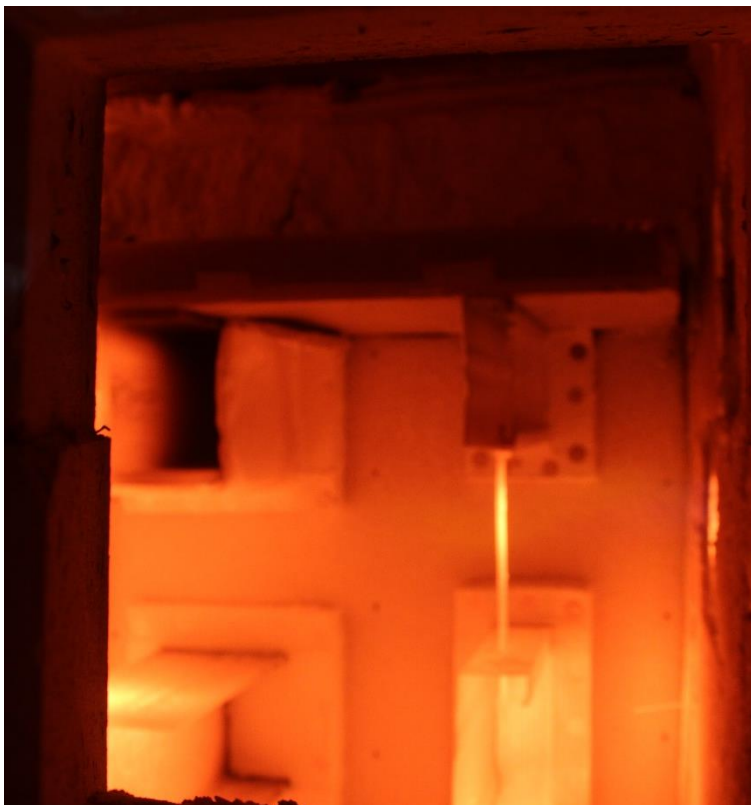
Figure 12 – Exposed face at 30 minutes

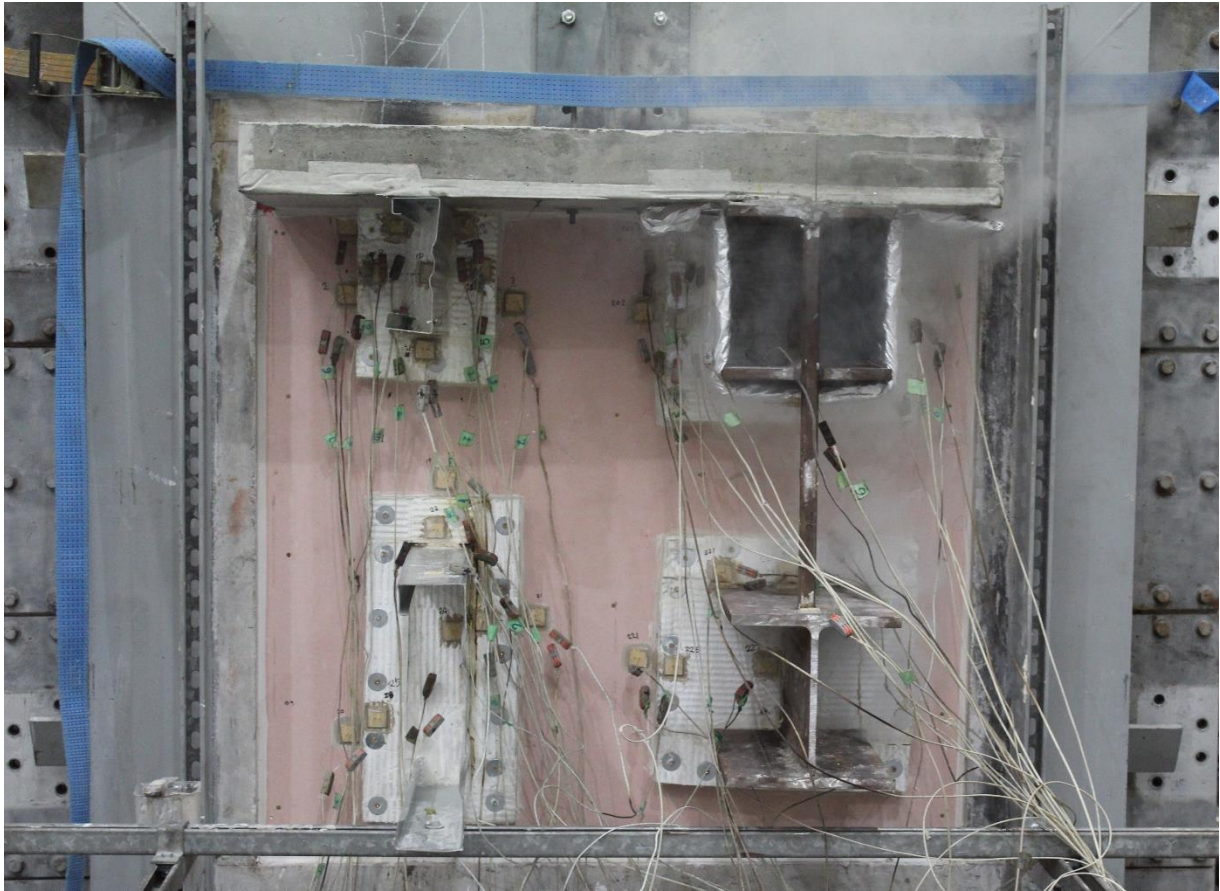
Figure 13 – Unexposed face at 45 minutes

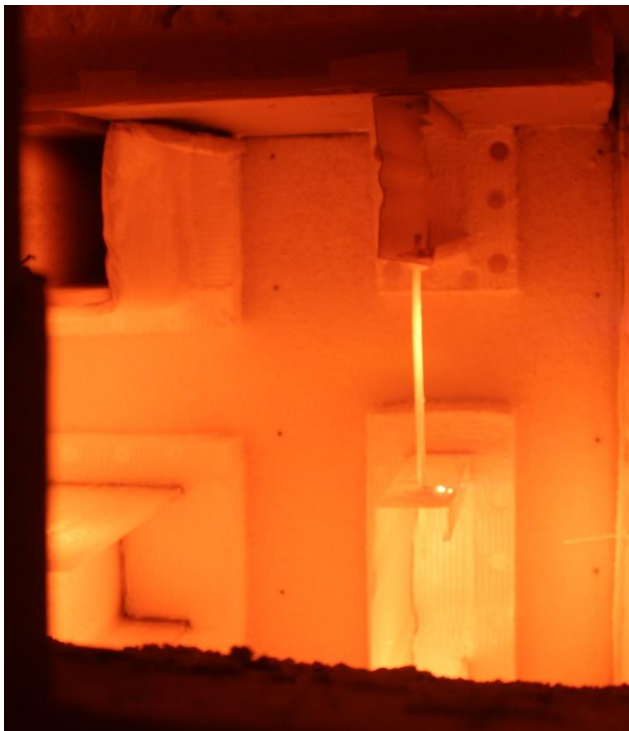
Figure 14 – Exposed face at 45 minutes

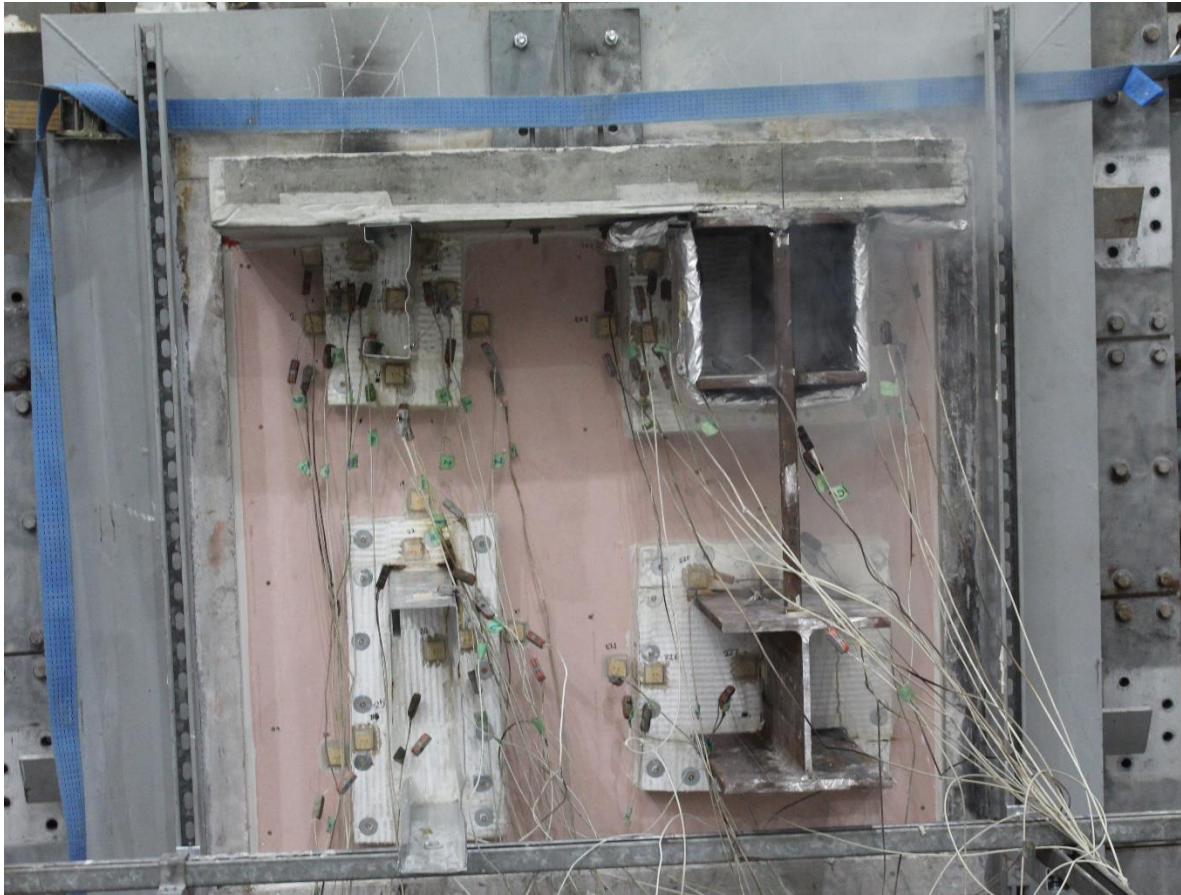
Figure 15 – Unexposed face at 60 minutes

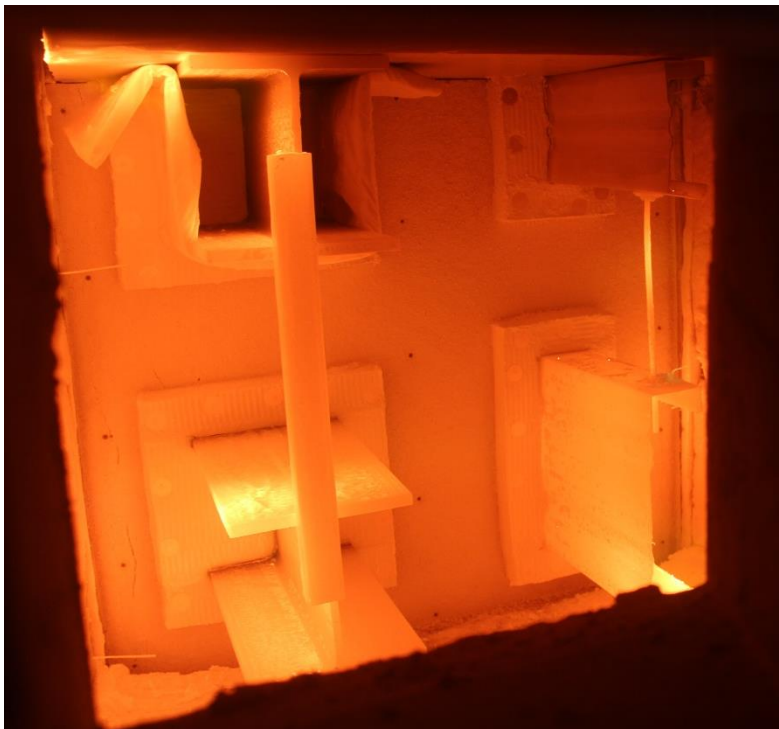
Figure 16 – Exposed face at 60 minutes

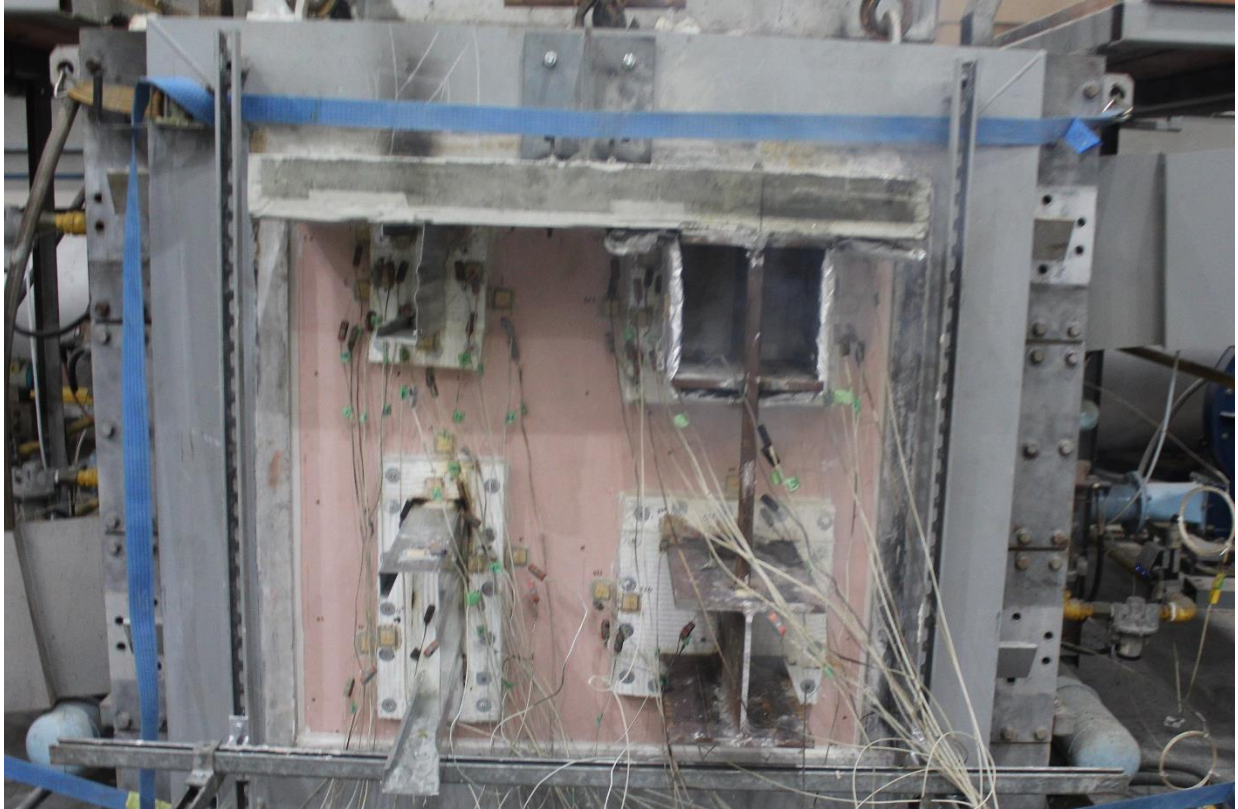
Figure 17 – Unexposed face at 75 minutes

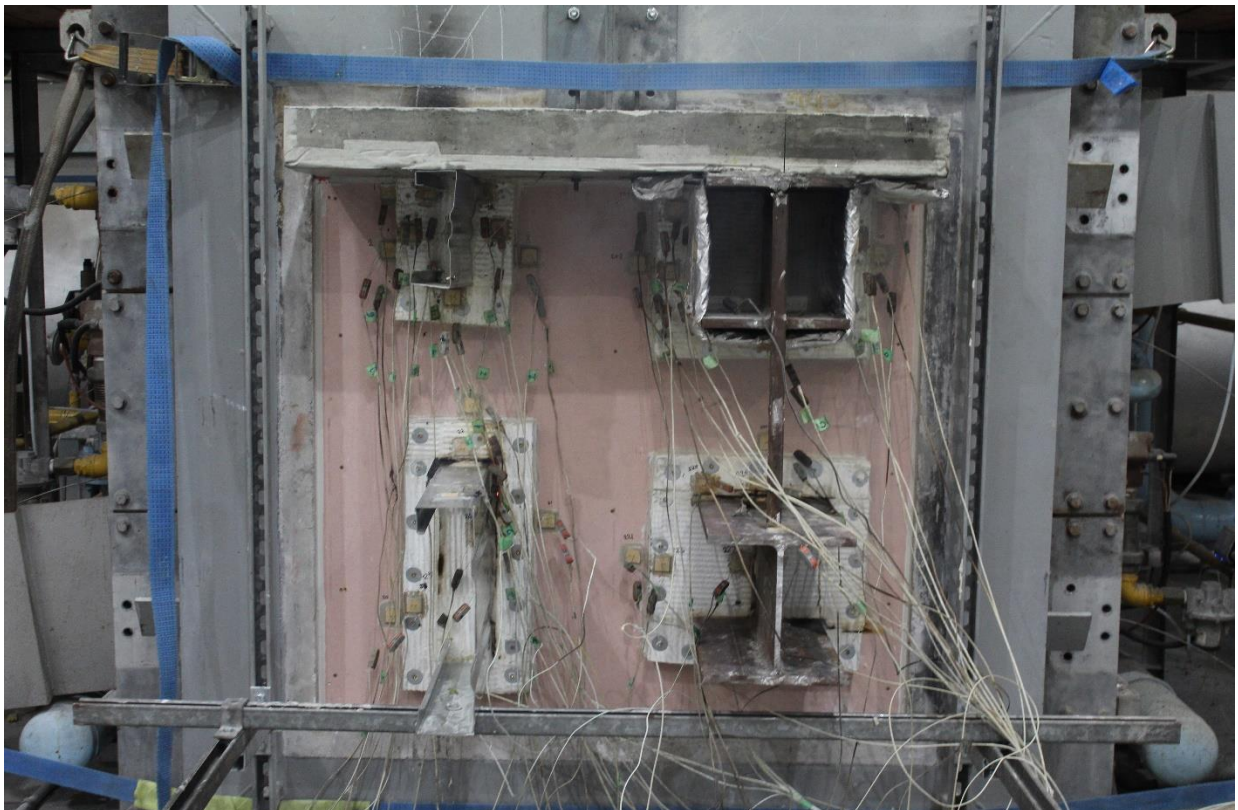
Figure 18 – Unexposed face at 90 minutes

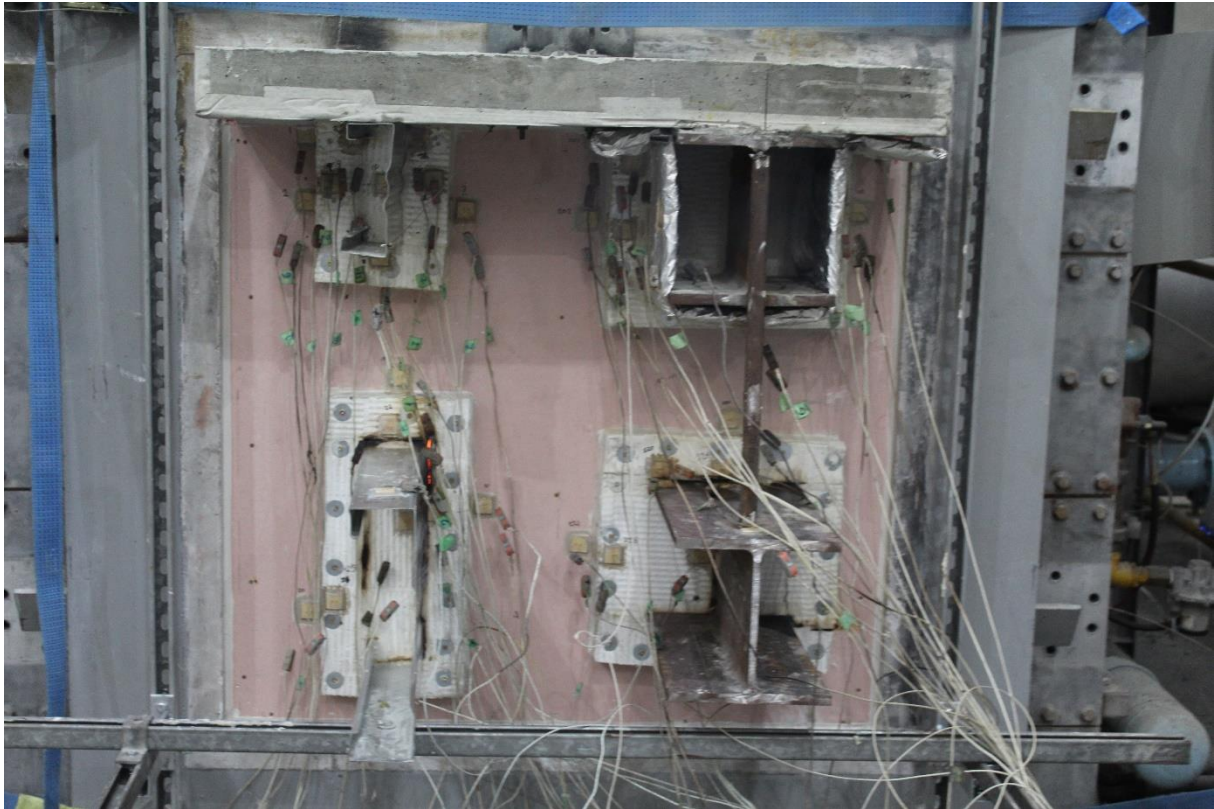
Figure 19 – Unexposed face at 105 minutes

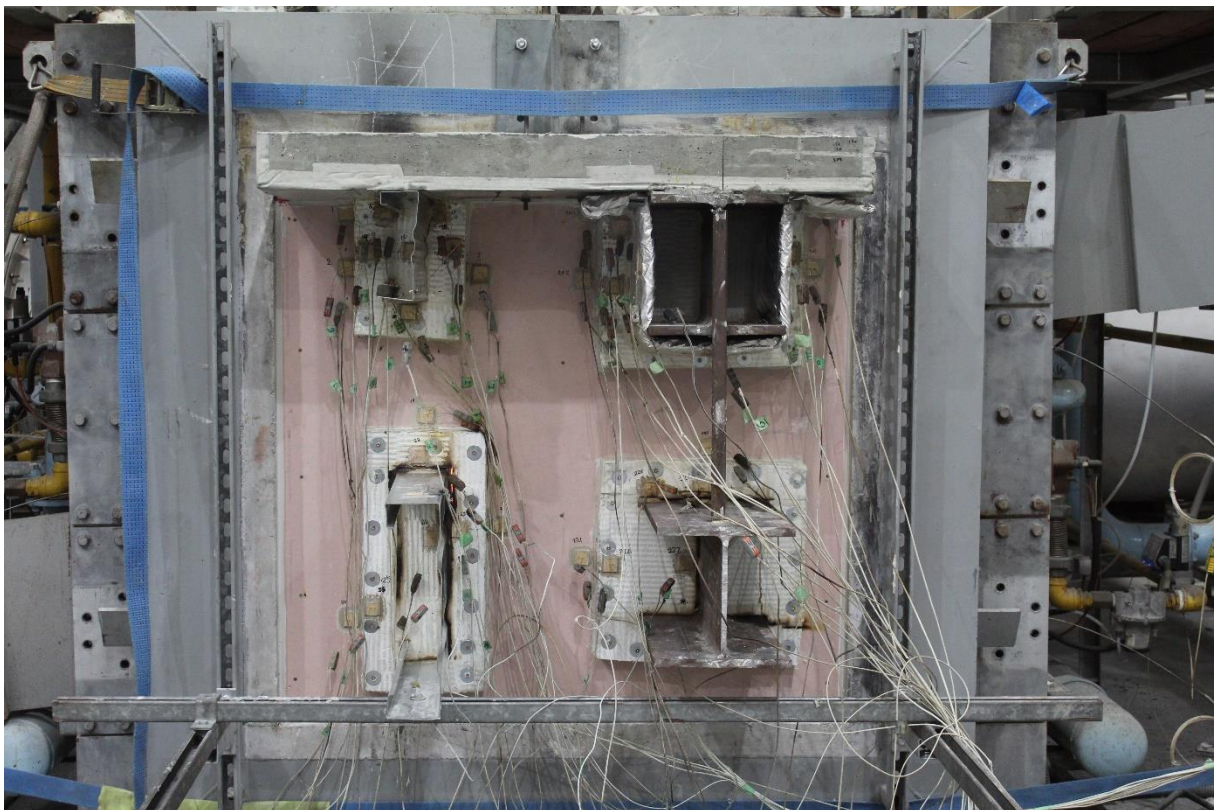
Figure 20 – Unexposed face at 120 minutes

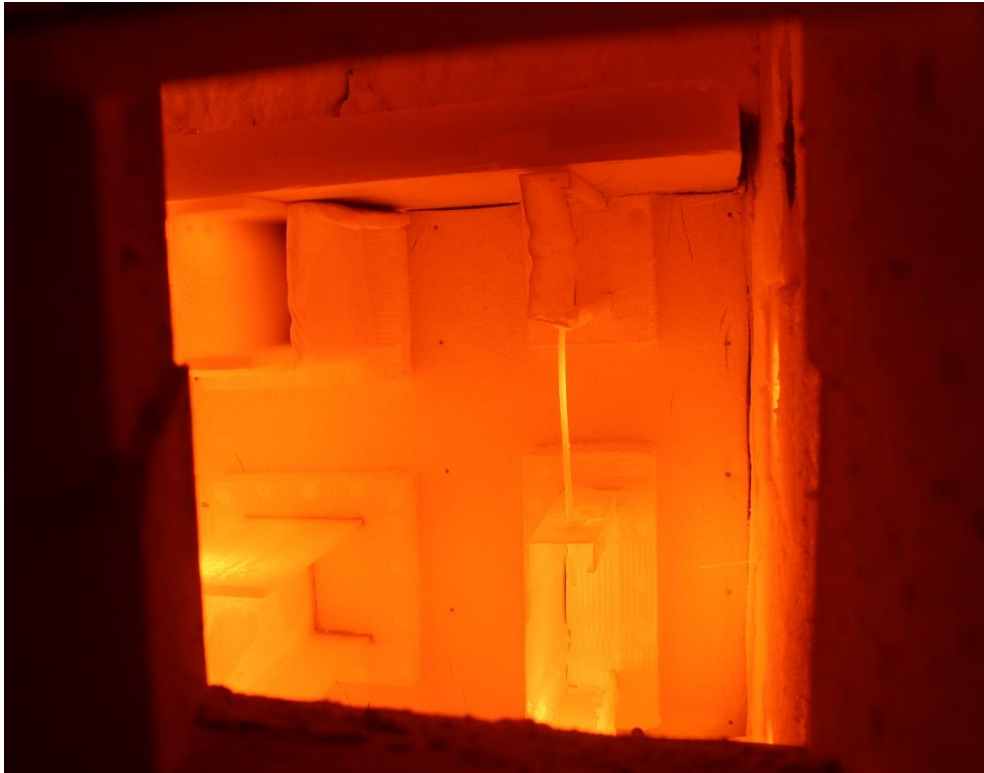
Figure 21 – Exposed face at 120 minutes

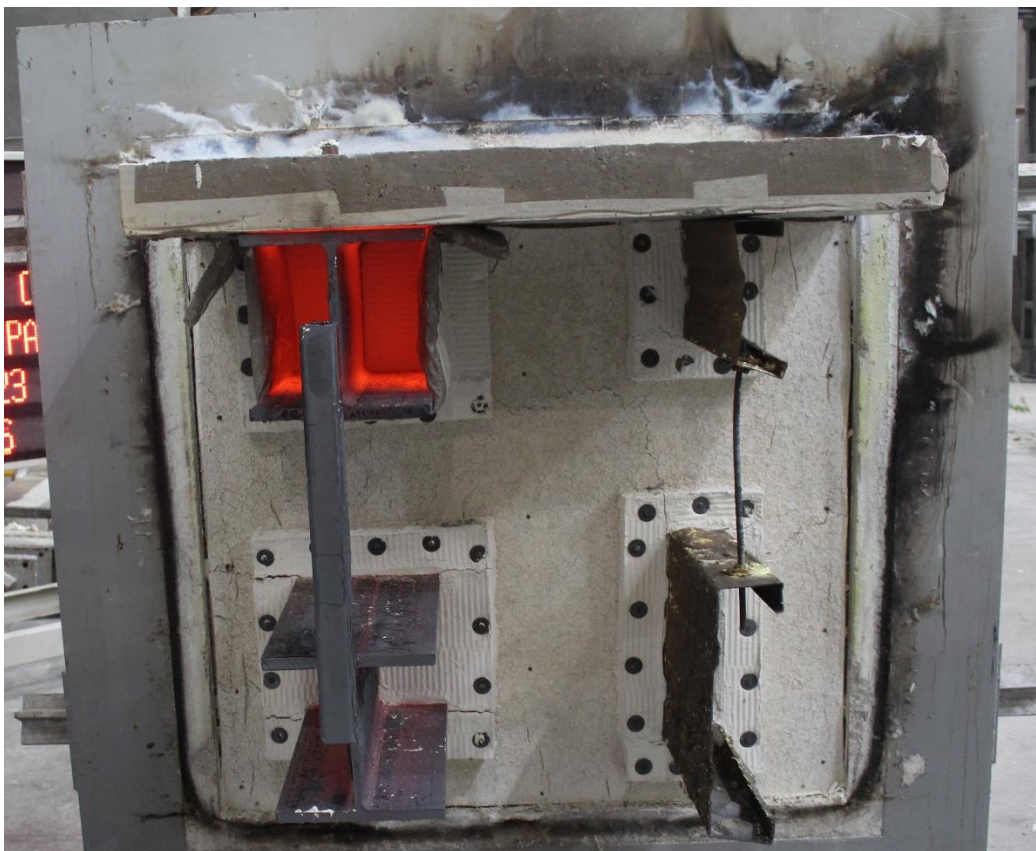
Figure 22 – Exposed face after the test
