Test report # PF22076

Client: RLA Polymers Pty Ltd

Fire resistance tests for wall linear gaps

Test method: AS 1530.4:2014

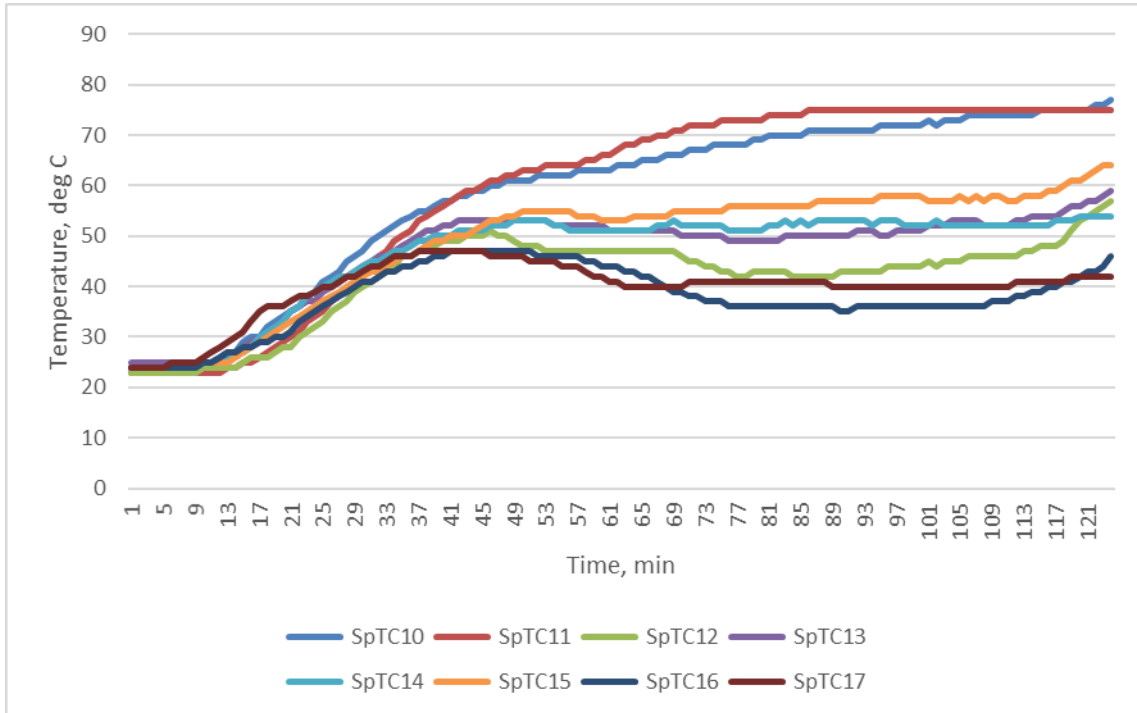
Specimen B Thermocouples Readings

Penetration System		
B	Service	D1 cable configuration with the replacement of cable b)
	Service Details	Cables (2.3, 2.4, 2.5, 2.6), Cable Tray (2.7) Sealant (3.1), Ceramic Fibre Blanket (5.1), Cable Ties (4.4)
	Service Support	Unistrut structure at 500mm
	Aperture Size	331mm x 64mm
	Annular Spacing	Min: 1mm, Max: 63mm
	Local Fire-stopping Protection	
Application	Symmetrical	
Protection Used	Aperture was cut into the separating element. The 60 x D2 Cables (2.3, 2.4, 2.5, 2.6), were bundled into like groups using cable ties and evenly spaced on the cable tray (2.7). The Cable tray was placed through the aperture, extending 500mm from the exposed face. Sealant (3.1) was installed between the cable tray and the separating element, flush with the plasterboard, resulting in a 26mm (nominal) seal. An additional 50mm x 70mm cone of sealant was applied between the cable tray and separating element. The cone extended 50mm from the cable bundle onto the separating element, and 70mm along the cables. Once the sealant had cured, the cable tray was wrapped with ceramic blanket (5.1). Two revolutions were applied around the cable tray, with 150mm (nominal) overlap. The wrap extended 300mm from the separating element, and was secured using two cable ties, spaced 100mm from each end of the wrap.

Structural adequacy	Not applicable
Integrity	No failure at 123 min
Insulation	No failure at 123 min

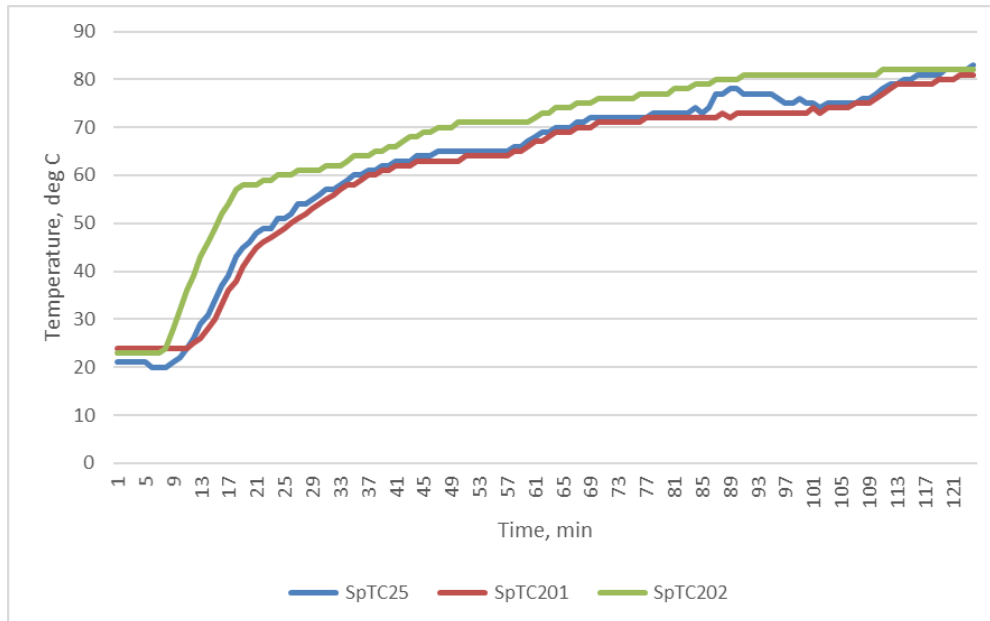
Specimen C Thermocouples Readings

Penetration System			
C	Service	40mm blank seal	
	Service Details	Sealant (3.1)	
	Service Support	N/A	
	Aperture Size	40mm	
	Annular Spacing	N/A	
	Local Fire-stopping Protection		
	Application	Symmetrical	
Protection Used	Aperture was cut into the separating element. Sealant (3.1) was installed in the aperture, flush with the plasterboard, resulting in a 26mm (nominal) seal.

Structural adequacy	Not applicable
Integrity	No failure at 123 min
Insulation	No failure at 123 min
