Test report # PF22077

Client: RLA Polymers Pty Ltd

Fire resistance tests for wall linear gaps

Test method: AS 1530.4:2014

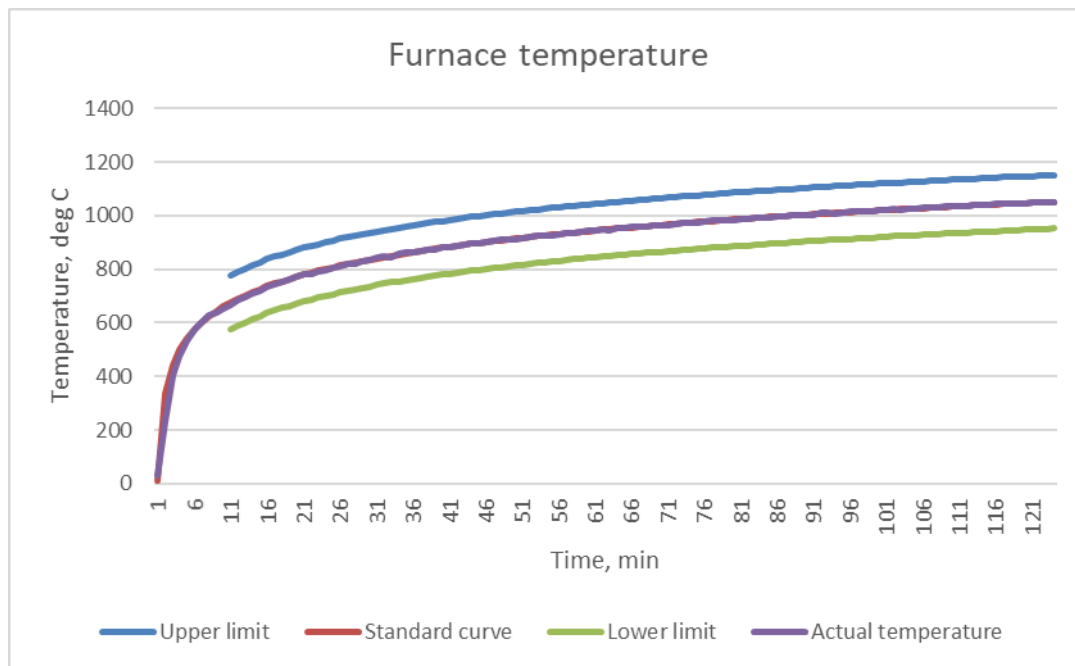
6.1 Furnace Temperature

The furnace was controlled to follow the temperature/time relationship specified in AS 1530.4-2014.

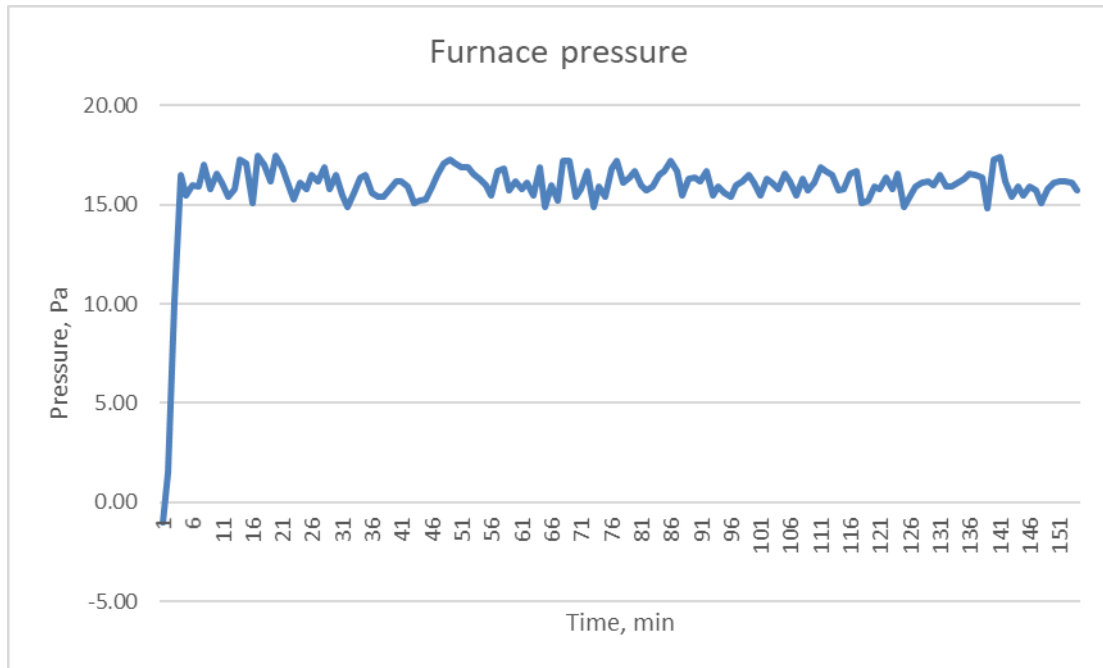
6.3 Pressure Readings

After the first 5 minutes of the test, the furnace pressure was maintained at 16 ± 3 Pa with respect to atmosphere. The probe was located 500mm above the furnace floor.

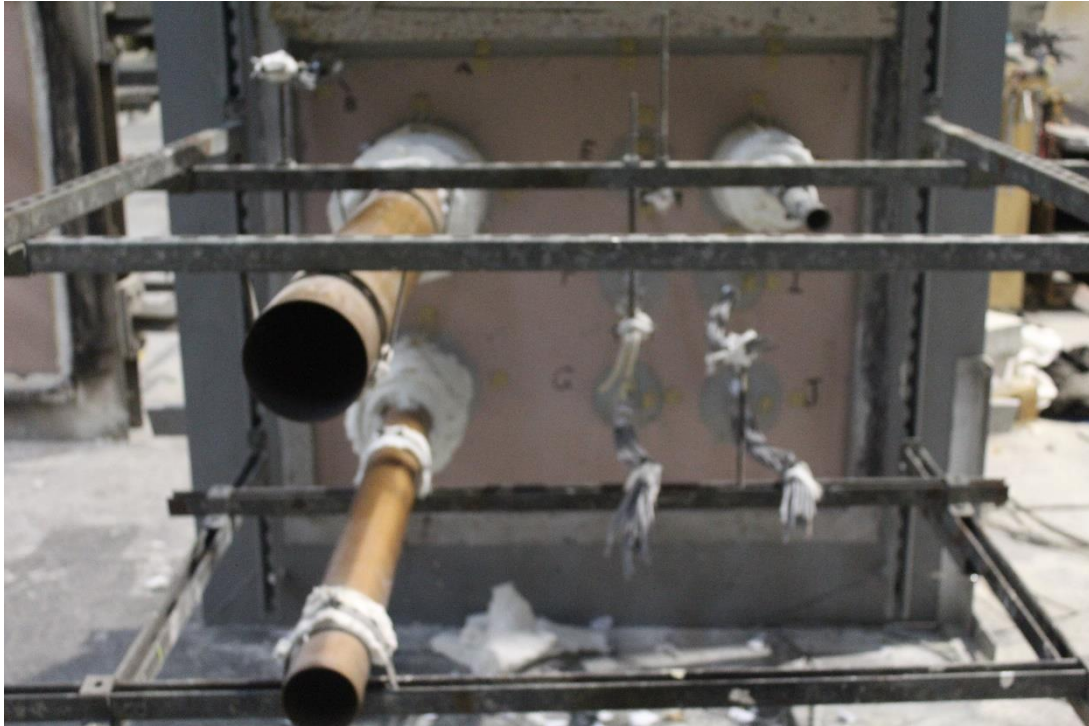
Unexposed faced:

The separating element was constructed by the laboratory following client-approved drawings. A 150mm concrete slab (1.5) was fixed to the top of the refractory frame, with each side of the slab protruding evenly from the unexposed and exposed faces of the frame. The Steel stud frame was constructed using three studs (1.2) and two tracks (1.3). The tracks were fixed to the bottom of the concrete slab and bottom of the refractory frame, with the studs installed between the tracks. The studs were located at 25mm, 582mm and 1140mm from the right side of the refractory frame (unexposed view). The steel frame components were all fixed using screws (4.3). Two layers of plasterboard were fixed to each face of the separating elements. The plasterboard was cut to a height of 1010mm, resulting in a horizontal deflection gap measuring 40mm. The first layers were fixed using screws (4.1) at 600mm centres.

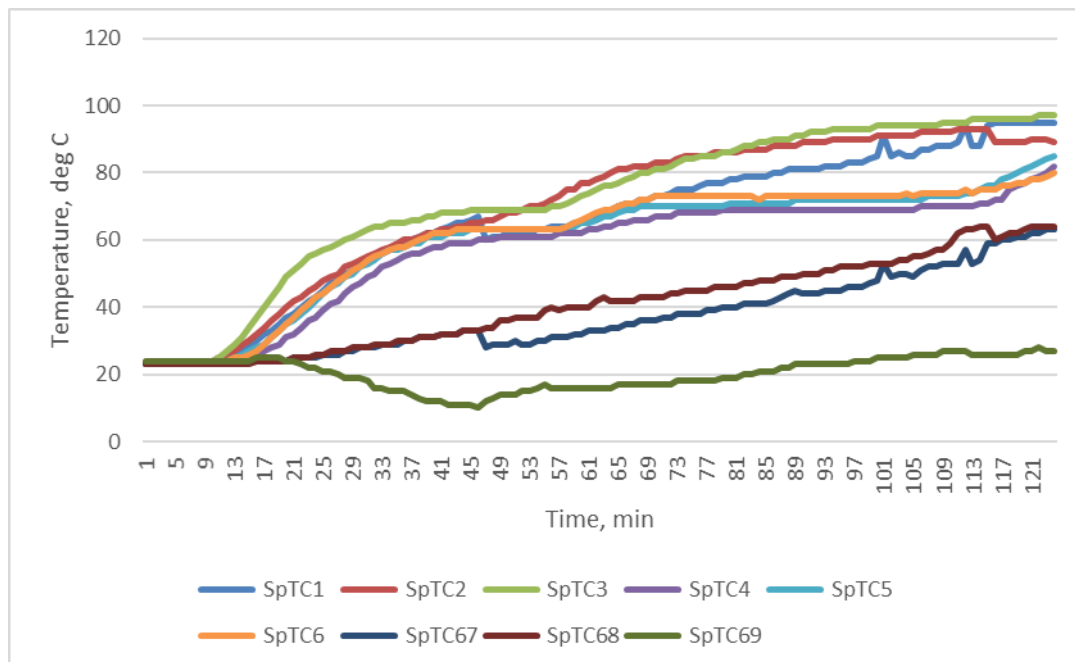
Specimen A Thermocouples Readings

Penetration System		
A	Service	40mm Horizontal Linear Gap seal
	Joint Details	Sealant (3.1)
	Aperture Size	20mm x 1000mm
	Local Fire-stopping Protection	
	Application	Symmetrical
	Protection Used	The top of the plasterboard was measured to be 40mm below the concrete slab, exposing the deflection head track. Sealant (3.1) was applied on top of the deflection head track, flush with the plasterboard, resulting in a 26mm (nominal) seal.

Structural adequacy	Not applicable
Integrity	No failure at 123 min
Insulation	No failure at 123 min

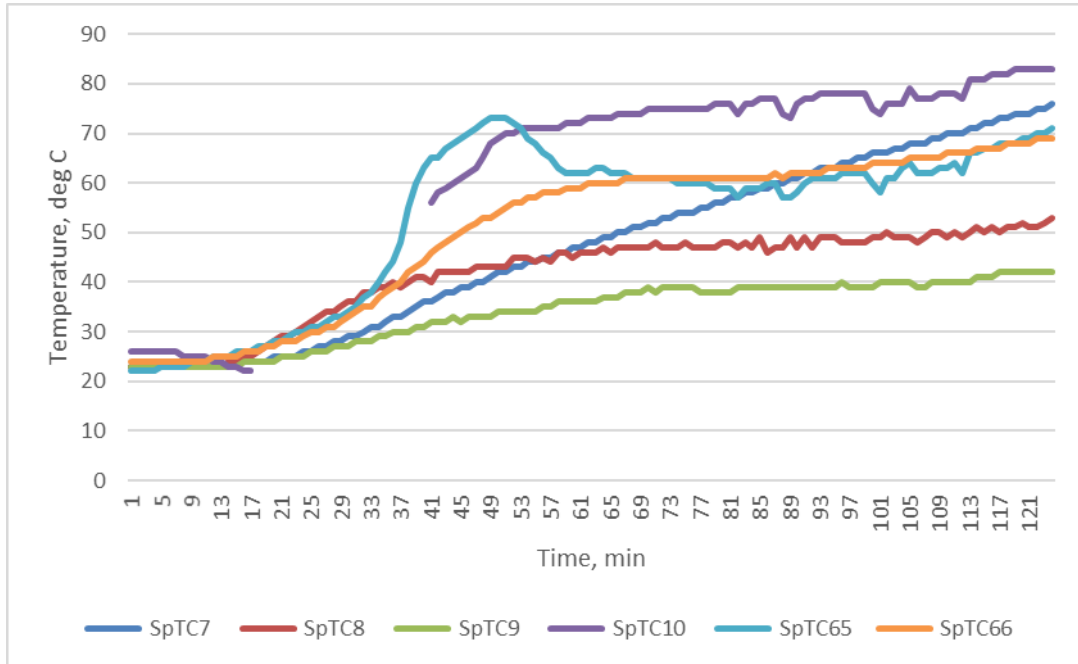
Specimen B Thermocouples Readings

Penetration System		
B	Service	20mm Cable Bundle
	Service Details	8 x Cable (2.1), Sealant (3.1)
	Service Support	Unistrut structure at 400mm
	Aperture Size	30mm
	Annular Spacing	Min: 2mm, Max: 4mm
	Local Fire-stopping Protection	
Application	Symmetrical	
Protection Used	Aperture was cut into the deflection head track, between the concrete slab and the plasterboard. 8 x cables (2.1) were bundled together (25mm nominal bundle OD), then passed through the aperture, extending 500mm from the exposed face. Sealant was applied on top of the deflection head track, flush with the plasterboard, resulting in a 26mm (nominal) seal. An additional 50mm x 70mm cone of sealant was applied between the cable bundle and separating element. The cone extended 50mm from the cable bundle onto the separating element, and 70mm along the cable bundle.

Structural adequacy	Not applicable
Integrity	No failure at 123 min
Insulation	No failure at 123 min

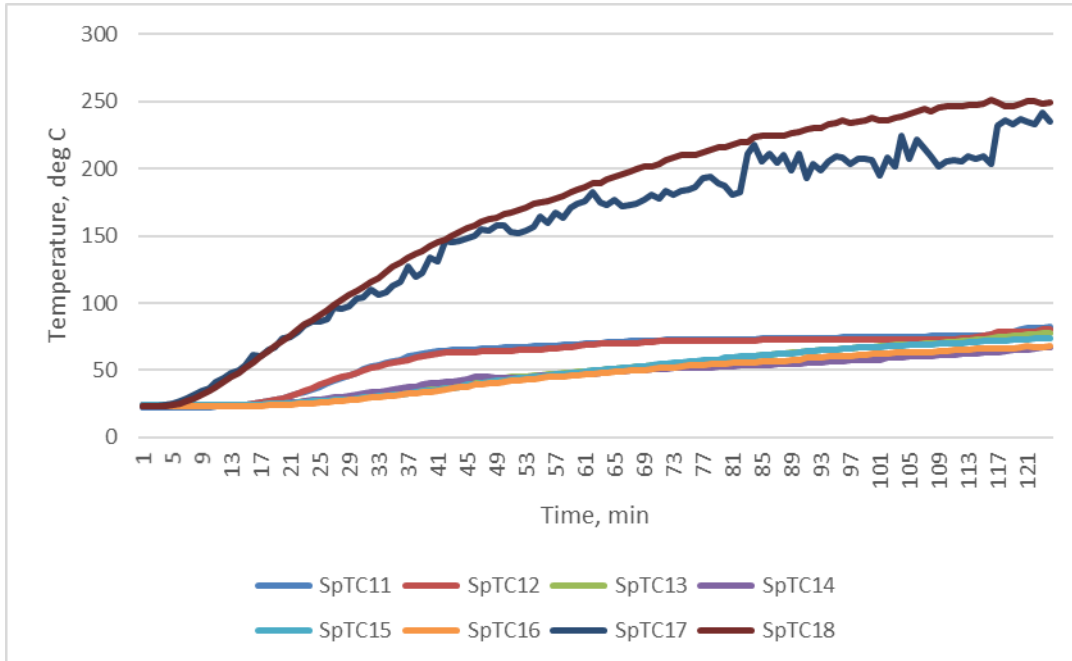
Specimen C Thermocouples Readings

Penetration System		
C	Service	DN150 Copper pipe
	Service Details	Pipe (2.2), Sealant (3.1), Ceramic Fibre Blanket (5.1), Cable Ties (4.4)
	Service Support	Unistrut structure at 400mm
	Aperture Size	153mm
	Annular Spacing	Min: 0mm, Max: 1mm
	Local Fire-stopping Protection	
	Application	Symmetrical
	Protection Used	Aperture was cut into the separating element. The pipe (2.8) was placed through the aperture, extending 500mm from the exposed face. A 50mm x 70mm cone of sealant was applied between the pipe and separating element. The cone extended 50mm from the pipe onto the separating element, and 70mm along the pipe. Once the sealant had cured, the cable tray was wrapped with ceramic blanket (5.1). Two revolutions were applied around the pipe, with 150mm (nominal) overlap. The wrap extended 300mm from the separating element, and was secured using two cable ties, spaced 100mm from each end of the wrap.

Structural adequacy	Not applicable
Integrity	No failure at 123 min
Insulation	70 min

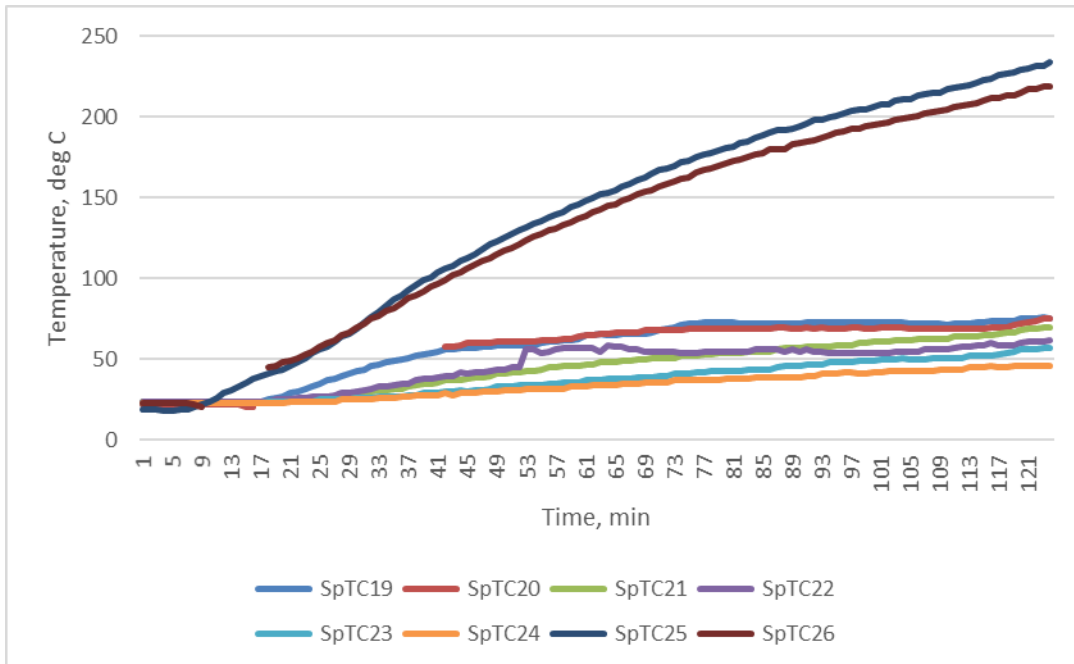
Specimen D Thermocouples Readings

Penetration System		
D	Service	DN100 Copper pipe
	Service Details	Pipe (2.3), Sealant (3.1), Ceramic Fibre Blanket (5.1), Cable Ties (4.4)
	Service Support	Unistrut structure at 400mm
	Aperture Size	102mm
	Annular Spacing	Min: 0mm, Max: 1mm
	Local Fire-stopping Protection	
Application	Symmetrical	
Protection Used	Aperture was cut into the separating element. The pipe (2.8) was placed through the aperture, extending 500mm from the exposed face. A 50mm x 70mm cone of sealant was applied between the pipe and separating element. The cone extended 50mm from the pipe onto the separating element, and 70mm along the pipe. Once the sealant had cured, the cable tray was wrapped with ceramic blanket (5.1). Two revolutions were applied around the pipe, with 150mm (nominal) overlap. The wrap extended 300mm from the separating element, and was secured using two cable ties, spaced 100mm from each end of the wrap.

Structural adequacy	Not applicable
Integrity	No failure at 123 min
Insulation	96 min

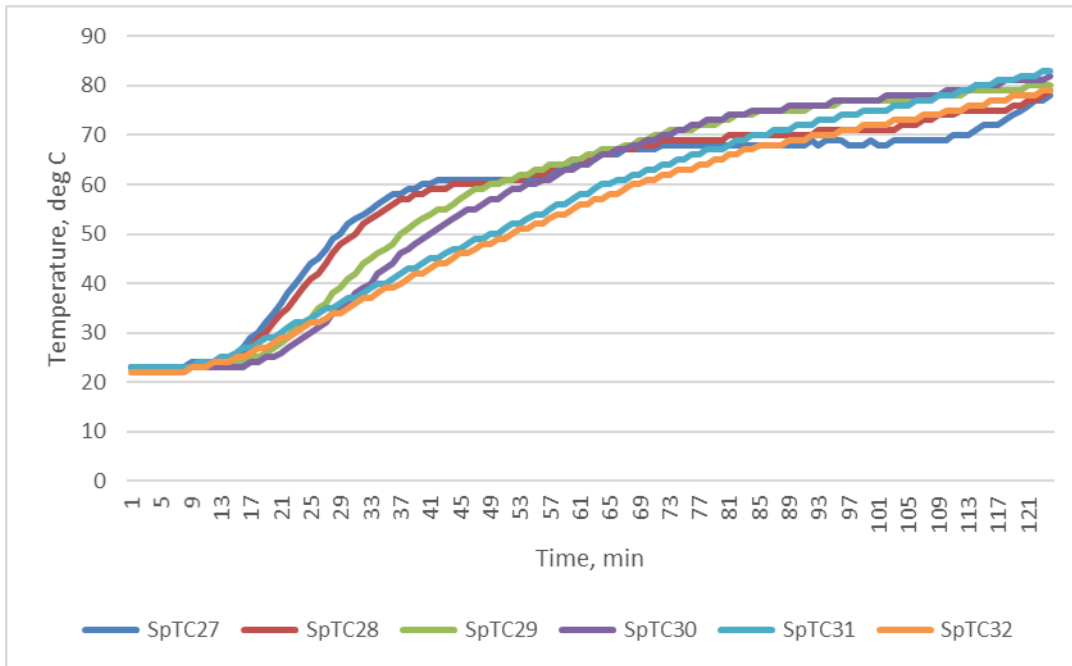
Specimen E Thermocouples Readings

Penetration System		
E	Service	Single Cable
	Service Details	1 x Cable (2.4), Sealant (3.1)
	Service Support	Unistrut structure at 400mm
	Aperture Size	25mm
	Annular Spacing	Min: 10mm, Max: 16mm
	Local Fire-stopping Protection	
	Application	Symmetrical
Protection Used	Aperture was cut into the separating element. 1 x cable (2.4) was passed through the aperture, extending 500mm from the exposed face. Sealant was installed in the annular gap, flush with the plasterboard, resulting in a 26mm (nominal) seal. An additional 50mm x 70mm cone of sealant was applied between the cable and separating element. The cone extended 50mm from the cable onto the separating element, and 70mm along the cable.

Structural adequacy	Not applicable
Integrity	No failure at 123 min
Insulation	No failure at 123 min

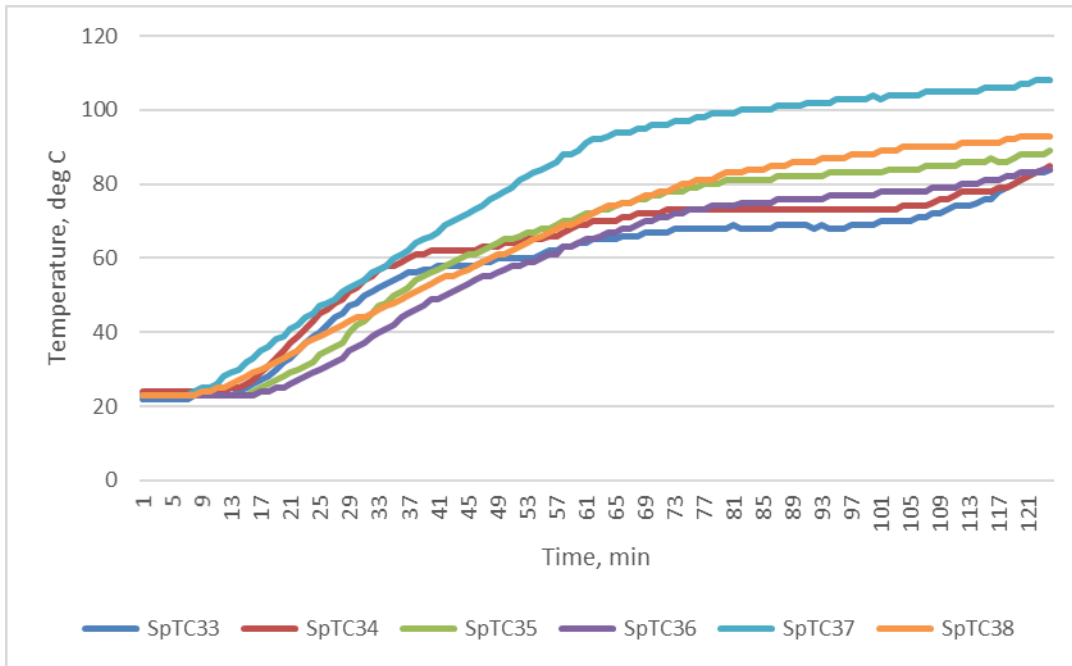
Specimen F Thermocouples Readings

Penetration System		
F	Service	5mm Cable Bundle
	Service Details	2 x Cable (2.4), Sealant (3.1)
	Service Support	Unistrut structure at 400mm
	Aperture Size	25mm
	Annular Spacing	Min: 8mm, Max: 10mm
	Local Fire-stopping Protection	
	Application	Symmetrical
	Protection Used	Aperture was cut into the separating element. 2 x cables (2.1) were bundled together (14mm nominal bundle OD), then passed through the aperture, extending 500mm from the exposed face. Sealant was installed in the annular gap, flush with the plasterboard, resulting in a 26mm (nominal) seal. An additional 50mm x 70mm cone of sealant was applied between the cable bundle and separating element. The cone extended 50mm from the cable bundle onto the separating element, and 70mm along the cable bundle.

Structural adequacy	Not applicable
Integrity	No failure at 123 min
Insulation	No failure at 123 min

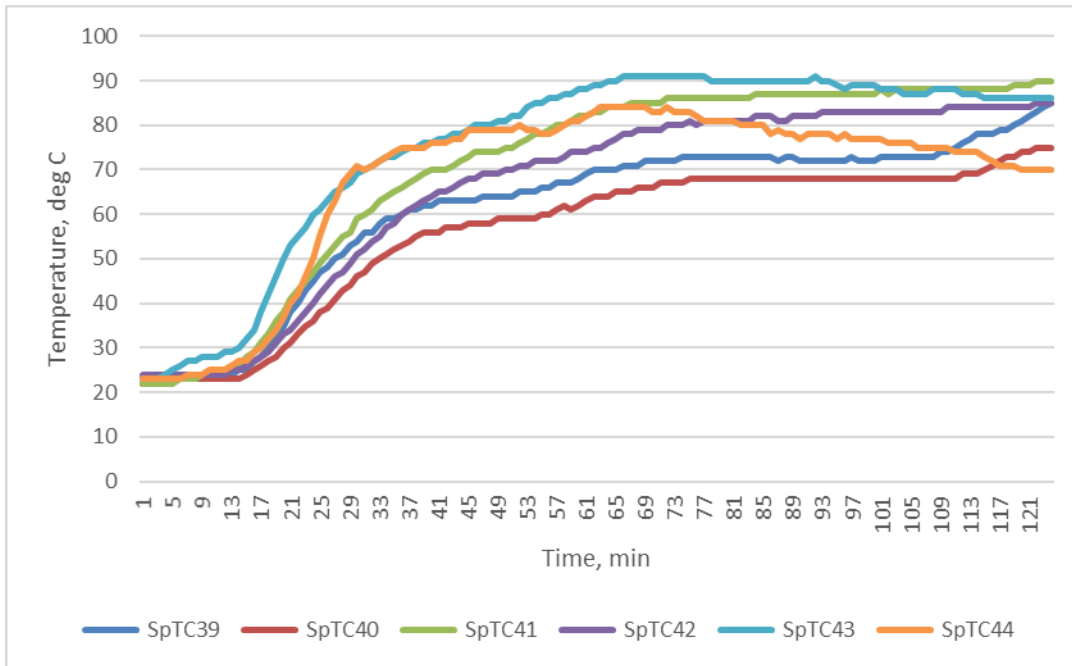
Specimen G Thermocouples Readings

Penetration System		
G	Service	35mm Cable Bundle
	Service Details	16 x Cable (2.1), Sealant (3.1)
	Service Support	Unistrut structure at 400mm
	Aperture Size	50mm
	Annular Spacing	Min: 5mm, Max: 8mm
	Local Fire-stopping Protection	
Application	Symmetrical	
Protection Used	Aperture was cut into the separating element. 16 x cables (2.1) were bundled together (40mm nominal bundle OD), then passed through the aperture, extending 500mm from the exposed face. Sealant was installed in the annular gap, flush with the plasterboard, resulting in a 26mm (nominal) seal. An additional 50mm x 70mm cone of sealant was applied between the cable bundle and separating element. The cone extended 50mm from the cable bundle onto the separating element, and 70mm along the cable bundle.

Structural adequacy	Not applicable
Integrity	No failure at 123 min
Insulation	No failure at 123 min

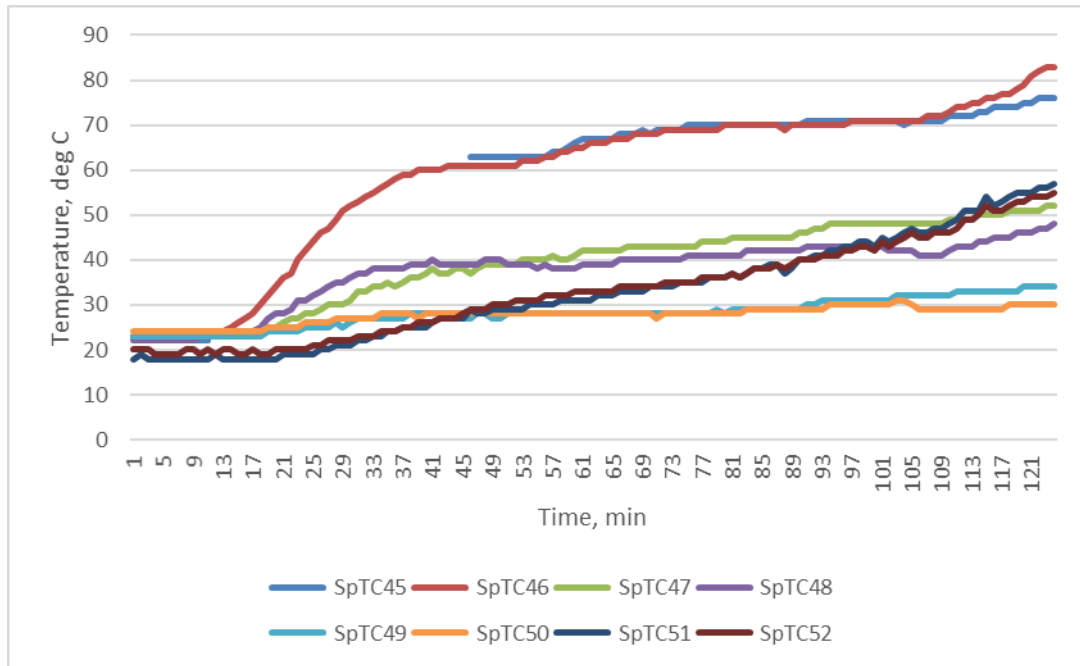
Specimen H Thermocouples Readings

Penetration System		
H	Service	32 NB Steel pipe
	Service Details	Pipe (2.3), Sealant (3.1), Ceramic Fibre Blanket (5.1), Cable Ties (4.4)
	Service Support	Unistrut structure at 400mm
	Aperture Size	58mm
	Annular Spacing	Min: 7mm, Max: 9mm
	Local Fire-stopping Protection	
Application	Symmetrical	
Protection Used	Aperture was cut into the separating element. The pipe (2.8) was placed through the aperture, extending 500mm from the exposed face. A 50mm x 70mm cone of sealant was applied between the pipe and separating element. The cone extended 50mm from the pipe onto the separating element, and 70mm along the pipe. Once the sealant had cured, the cable tray was wrapped with ceramic blanket (5.1). Two revolutions were applied around the pipe, with 150mm (nominal) overlap. The wrap extended 300mm from the separating element, and was secured using two cable ties, spaced 100mm from each end of the wrap.

Structural adequacy	Not applicable
Integrity	No failure at 123 min
Insulation	No failure at 123 min

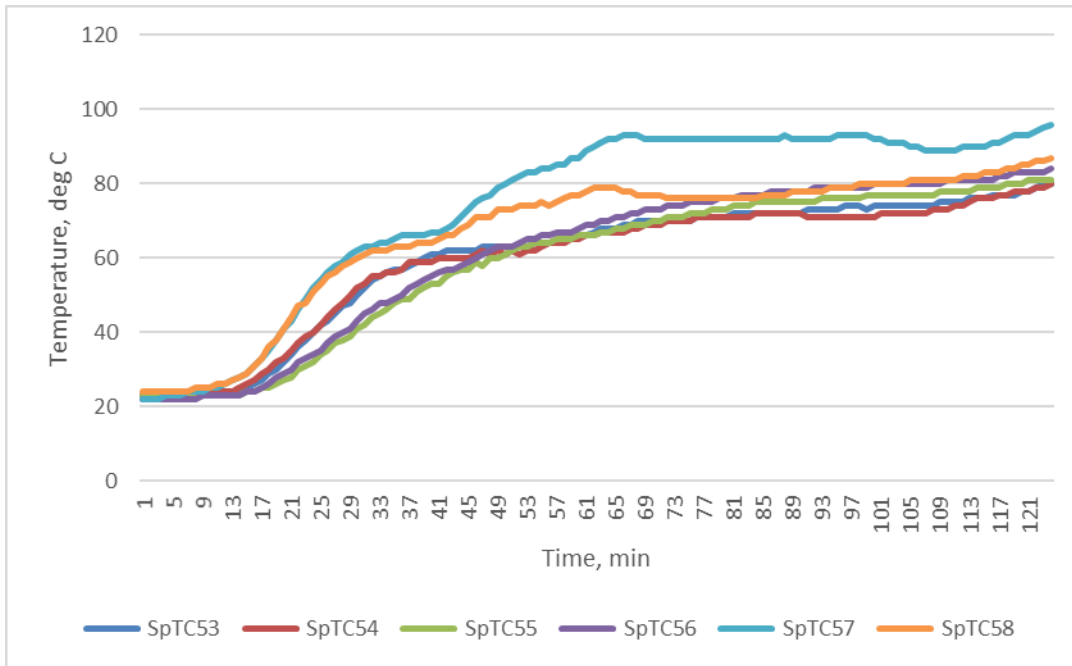
Specimen I Thermocouples Readings

Penetration System		
I	Service	20mm Cable Bundle
	Service Details	8 x Cable (2.1), Sealant (3.1)
	Service Support	Unistrut structure at 400mm
	Aperture Size	30mm
	Annular Spacing	Min: 0mm, Max: 4mm
	Local Fire-stopping Protection	
	Application	Symmetrical
	Protection Used	Aperture was cut into the separating element. 8 x cables (2.1) were bundled together (25mm nominal bundle OD), then passed through the aperture, extending 500mm from the exposed face. Sealant was installed in the annular gap, flush with the plasterboard, resulting in a 26mm (nominal) seal. An additional 50mm x 70mm cone of sealant was applied between the cable bundle and separating element. The cone extended 50mm from the cable bundle onto the separating element, and 70mm along the cable bundle.

Structural adequacy	Not applicable
Integrity	No failure at 123 min
Insulation	No failure at 123 min

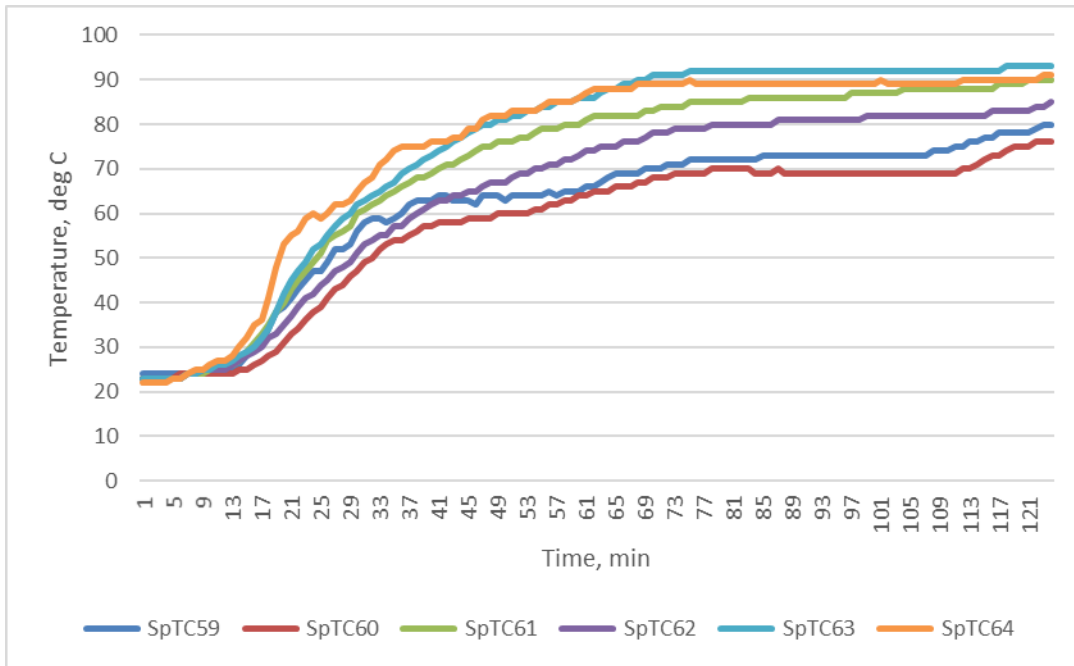
Specimen J Thermocouples Readings

Penetration System		
J	Service	35mm Cable Bundle
	Service Details	16 x Cable (2.4), Sealant (3.1)
	Service Support	Unistrut structure at 400mm
	Aperture Size	30mm x 70mm
	Annular Spacing	Min: 5mm, Max: 10mm
	Local Fire-stopping Protection	
Application	Symmetrical	
Protection Used	Aperture was cut into the separating element. 16 x cables (2.1) were bundled together (20mm x 50mm nominal bundle OD), then passed through the aperture, extending 500mm from the exposed face. Sealant was installed in the annular gap, flush with the plasterboard, resulting in a 26mm (nominal) seal. An additional 50mm x 70mm cone of sealant was applied between the cable bundle and separating element. The cone extended 50mm from the cable bundle onto the separating element, and 70mm along the cable bundle.

Structural adequacy	Not applicable
Integrity	No failure at 123 min
Insulation	No failure at 123 min

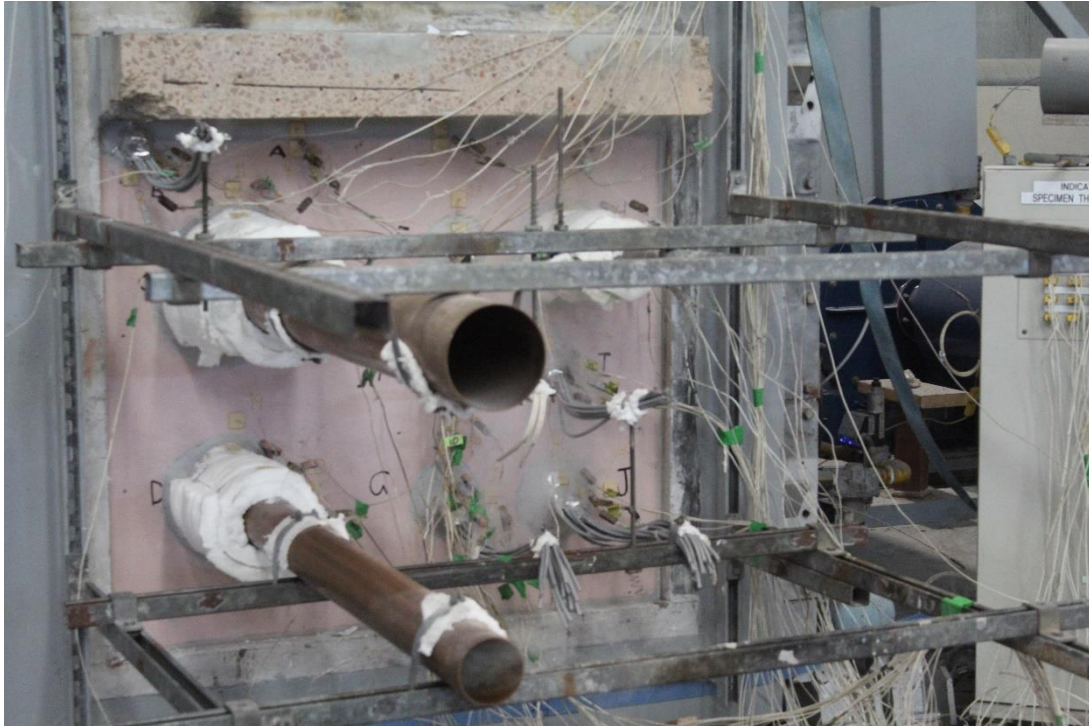
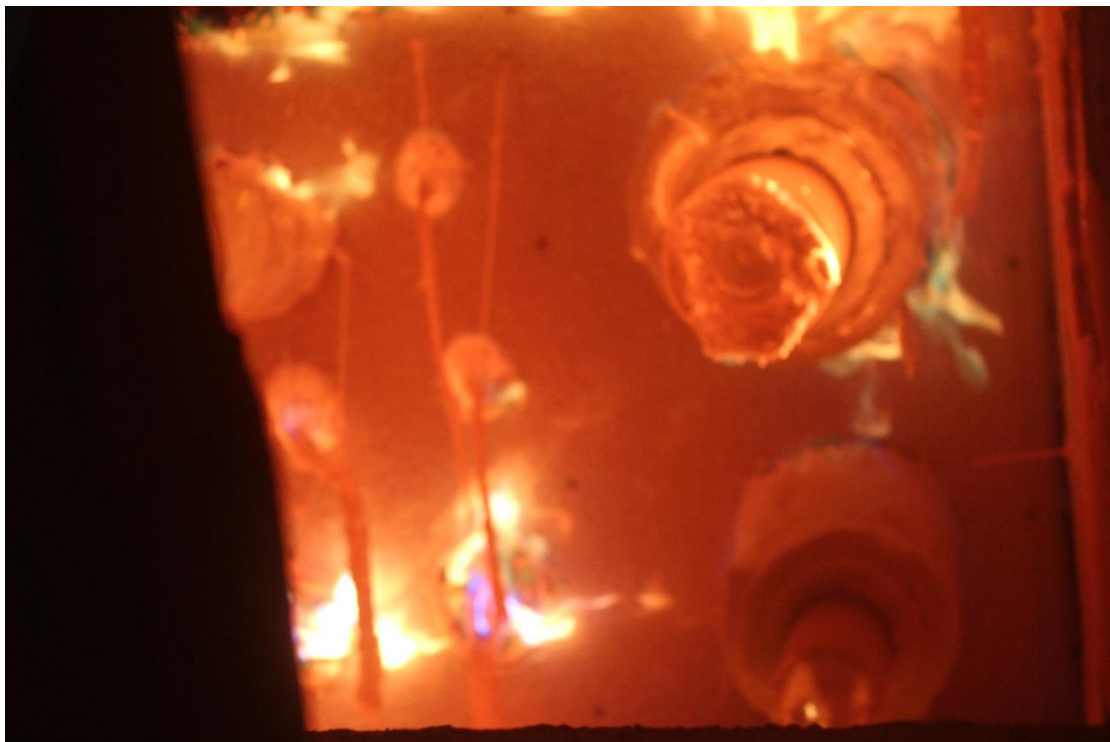
11.1 During and after the test 30 minutes:

Time Minutes	Test Face	SP#	Observations
2	U	G, I, J	Smoke from between cables
8	U	A	Smoke from between cables
9	U	C, D	Smoke from end of pipe
10	E	B, E, F, G, I, J	Visible charring/discolouring of sealant cone
10	E	B, E, F, G, I, J	Cables have combusted and are deforming
20	U	ALL	No notable changes
30	E	A	Combustion of sealant, visible discolouring
45	U	ALL	No notable changes
60	U	ALL	No notable changes
75	U	ALL	No notable changes
90	U	ALL	No notable changes
95	U	A	Visible expansion of sealant cone, crack in sealant
120	U	H	Crack between sealant and wrap junction
120	U	C	Discolouring of copper pipe 200mm from wrap
123			TEST DISCONTINUED
