## **Test report # PF23003**

**Client: Firestop Centre Ltd**

**Fire resistance test for linear gaps in  
horizontal concrete separating element**

**Test method: AS 1530.4:2014**

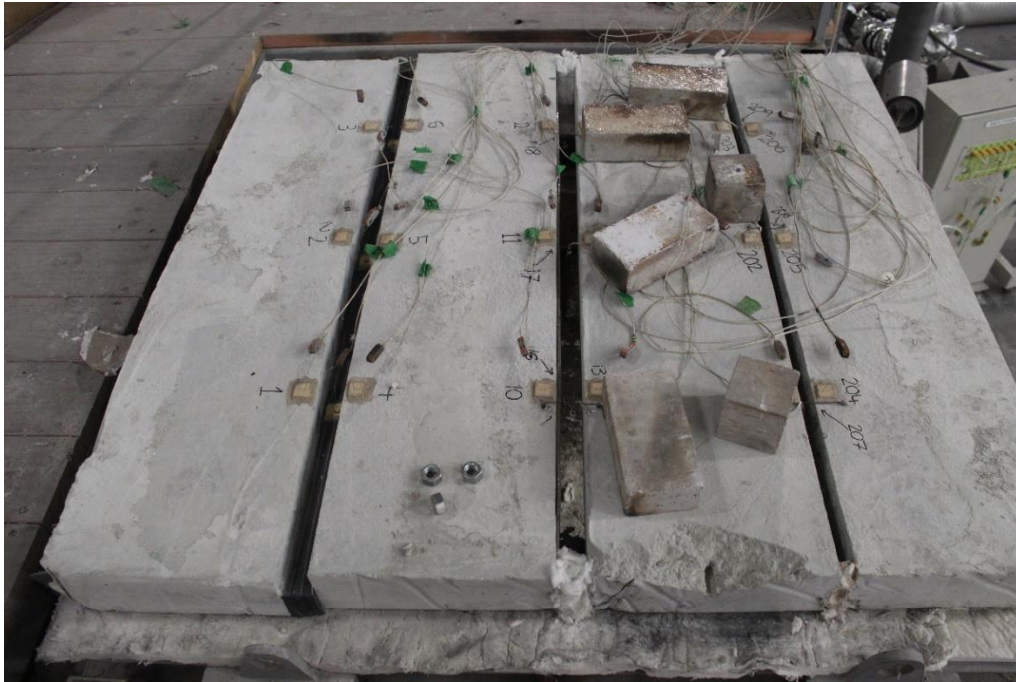
Unexposed face:

Time Minutes	Test Face	SPECIMEN	Observations
1	U	A	Visible smoke between specimen joint
5	U	A	Large increase in amount of smoke
9	U	A	Cotton pad test for 30 seconds above specimen A - PASS
12	U	A	Visible activation of intumescent
58	U	A	Cotton pad test for 30 seconds above specimen A - PASS
76	U	A	Small visible red spot in seal
80	U	A	Cotton pad test for 30 seconds above red spot - FAIL
85			TEST DISCONTINUED

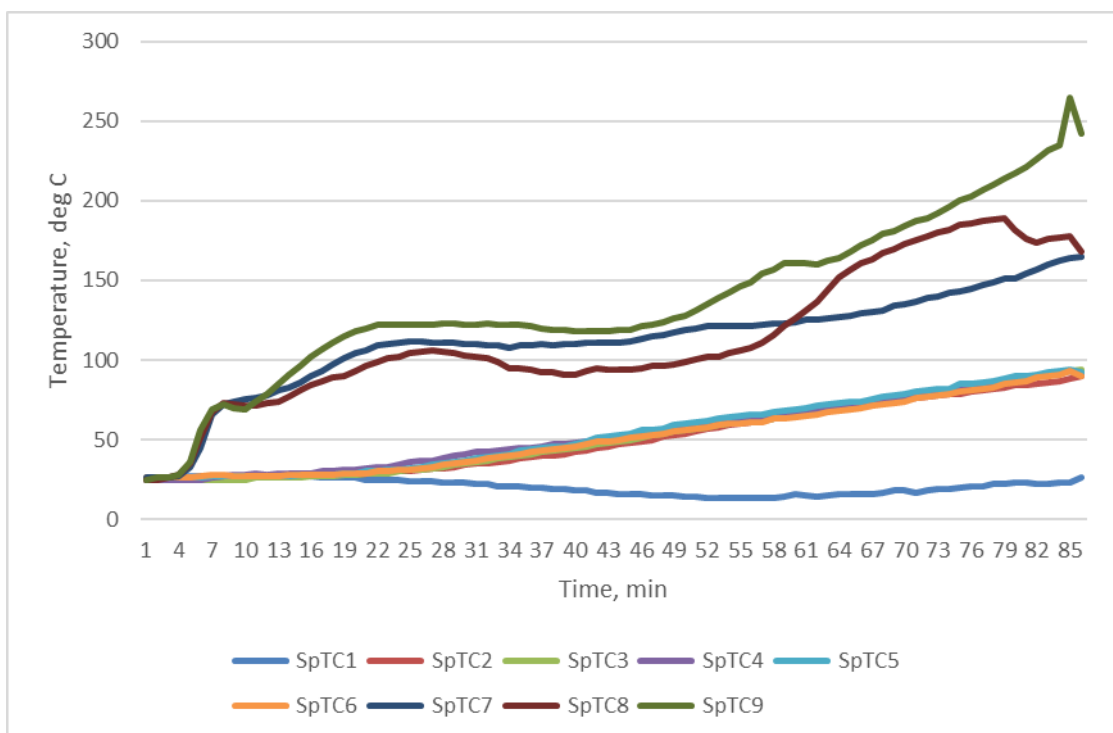
### Specimen A Thermocouples Readings

Structural adequacy	Not applicable
Integrity	80 min
Insulation	76 min
