# Regulatory Information Report

**RIRF24124**

## Fire resistance test for penetrations through a vertical separating element

Test method: AS1530.4-2014

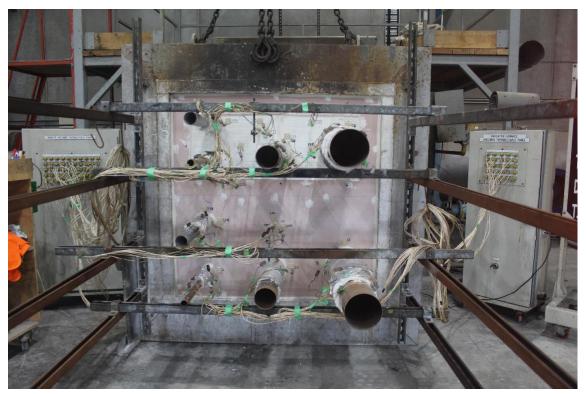
Figure 16 – Unexposed face prior to test commencement
