# Regulatory Information Report

**RIRF24122**

# Fire resistance test for penetrations through the horizontal separating element

Test method: AS1530.4-2014

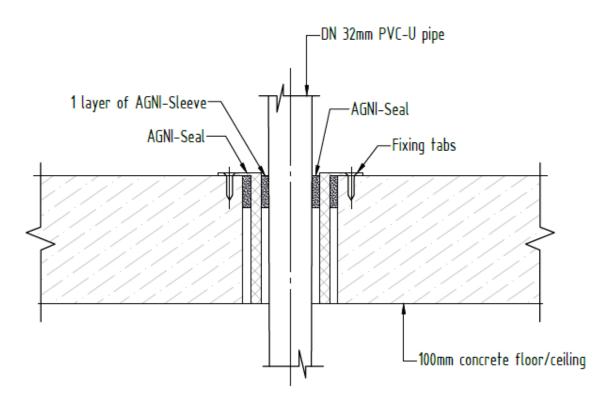
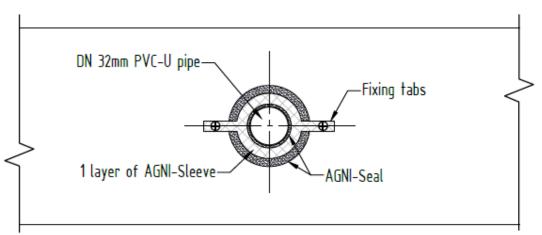
# 6.2 Specimen 1

Service penetration details	
Service	DN32 PVC-U DWV PIPE
Aperture Diameter	45mm
Annular Spacing	Min: 3.5mm Max: 4.9mm

Local Fire-stopping system		
Application	Asymmetrical – installed from the unexposed side	
System description	<ol> <li>1. 150mm wide AGNI-Sleeve was cut to fit one revolution of the aperture.</li> <li>2. The AGNI-Sleeve was then cut down to include two 50mm high x 25mm wide tabs.</li> <li>3. The cut AGNI-Sleeve was inserted into the aperture through the unexposed surface, tabs remained past the face of the unexposed surface.</li> <li>4. The tabs were bent over onto the surface of the separating element and secured using concrete anchors.</li> <li>5. AGNI-Seal was applied 10mm (nominal) deep between the separating element and the pipe, finishing flush with the face of the separating element.</li> </ol>

Test results	
Structural adequacy	Not applicable
Integrity	No failure at 122 minutes
Insulation	No failure at 122 minutes

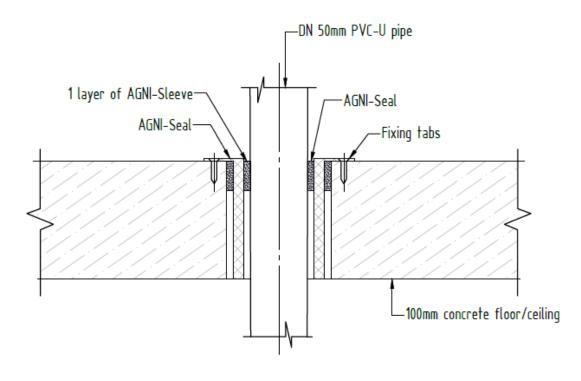
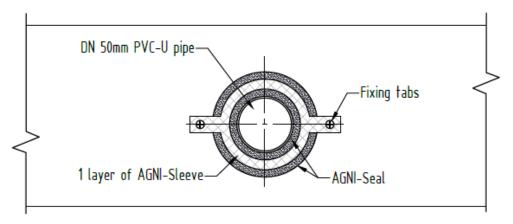
# 6.3 Specimen 2

Service penetration details	
Service	DN50 PVC-U DWV PIPE
Aperture Diameter	66mm
Annular Spacing	Min: 4.0mm Max: 5.7mm

Local Fire-stopping system		
Application	Asymmetrical – installed from the unexposed side	
System description	<ol> <li>1. 150mm wide AGNI-Sleeve was cut to fit one revolution of the aperture.</li> <li>2. The AGNI-Sleeve was then cut down to include two 50mm high x 25mm wide tabs.</li> <li>3. The cut AGNI-Sleeve was inserted into the aperture through the unexposed surface, tabs remained past the face of the unexposed surface.</li> <li>4. The tabs were bent over onto the surface of the separating element and secured using concrete anchors.</li> <li>5. AGNI-Seal was applied 10mm (nominal) deep between the separating element and the pipe, finishing flush with the face of the separating element.</li> </ol>

Test results	
Structural adequacy	Not applicable
Integrity	No failure at 122 minutes
Insulation	No failure at 122 minutes

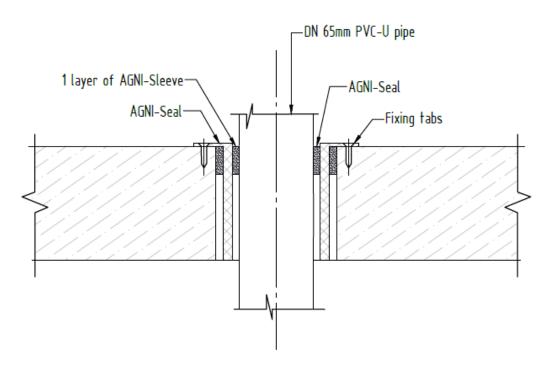
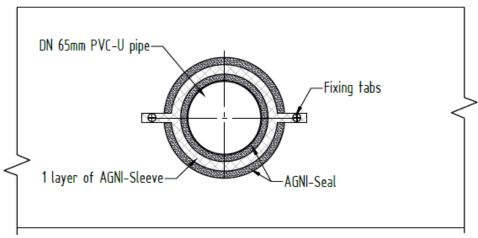
# 6.4 Specimen 3

Service penetration details		
Service	DN65 PVC-U DWV PIPE	
Service Support	Unexposed Side - Multistrut at 600mm and 1650mm	
Aperture Diameter	77.5mm	
Annular Spacing	Min: 3.5mm Max: 5.0mm

Local Fire-stopping system		
Application	Asymmetrical – installed from the unexposed side	
System description	<ol> <li>1. 150mm wide AGNI-Sleeve was cut to fit one revolution of the aperture.</li> <li>2. The AGNI-Sleeve was then cut down to include two 50mm high x 25mm wide tabs.</li> <li>3. The cut AGNI-Sleeve was inserted into the aperture through the unexposed surface, tabs remained past the face of the unexposed surface.</li> <li>4. The tabs were bent over onto the surface of the separating element and secured using concrete anchors.</li> <li>5. AGNI-Seal was applied 10mm (nominal) deep between the separating element and the pipe, finishing flush with the face of the separating element.</li> </ol>

Test results	
Structural adequacy	Not applicable
Integrity	No failure at 122 minutes
Insulation	No failure at 122 minutes

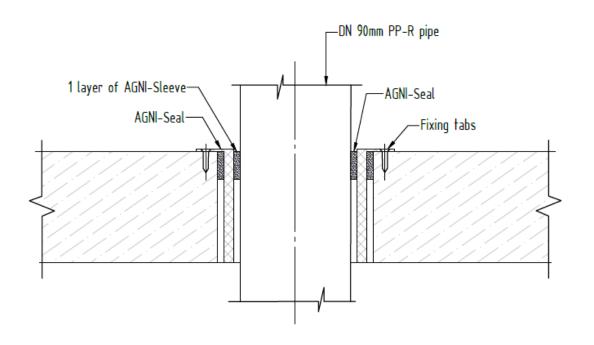
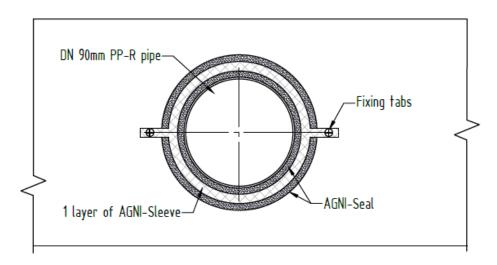
# 6.5 Specimen 4

Service penetration details		
Service	SDR11 S 90mm PPR PIPE	
Aperture Diameter	100.9mm	
Annular Spacing	Min: 4.5mm Max: 6.2mm

Local Fire-stopping system		
Application	Asymmetrical – installed from the unexposed side	
System description	<ol> <li>1. 150mm wide AGNI-Sleeve was cut to fit one revolution of the aperture.</li> <li>2. The AGNI-Sleeve was then cut down to include two 50mm high x 25mm wide tabs.</li> <li>3. The cut AGNI-Sleeve was inserted into the aperture through the unexposed surface, tabs remained past the face of the unexposed surface.</li> <li>4. The tabs were bent over onto the surface of the separating element and secured using concrete anchors.</li> <li>5. AGNI-Seal was applied 10mm (nominal) deep between the separating element and the pipe, finishing flush with the face of the separating element.</li> </ol>

Test results	
Structural adequacy	Not applicable
Integrity	No failure at 122 minutes
Insulation	No failure at 122 minutes

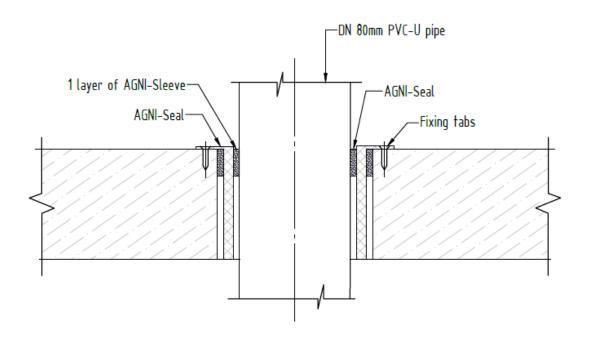
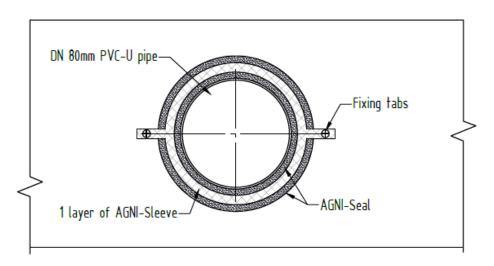
# 6.6 Specimen 6

Service penetration details	
Service	DN80 PVC-U DWV PIPE
Aperture Diameter	100.9mm
Annular Spacing	Min: 6.0mm Max: 12.7mm

Local Fire-stopping system		
Application	Asymmetrical – installed from the unexposed side	
System description	<ol> <li>1. 150mm wide AGNI-Sleeve was cut to fit one revolution of the aperture.</li> <li>2. The AGNI-Sleeve was then cut down to include two 50mm high x 25mm wide tabs.</li> <li>3. The cut AGNI-Sleeve was inserted into the aperture through the unexposed surface, tabs remained past the face of the unexposed surface.</li> <li>4. The tabs were bent over onto the surface of the separating element and secured using concrete anchors.</li> <li>5. AGNI-Seal was applied 10mm (nominal) deep between the separating element and the pipe, finishing flush with the face of the separating element.</li> </ol>

Test results		
Structural adequacy	Not applicable	
Integrity	No failure at 123 minutes	
Insulation	No failure at 123 minutes

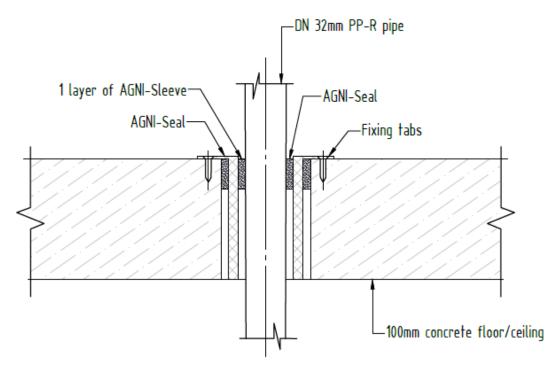
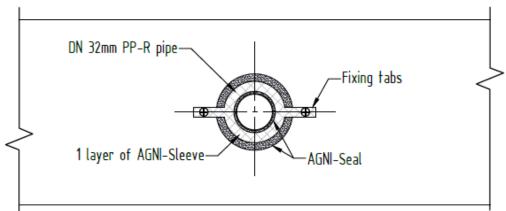
# 6.7 Specimen 7

Service penetration details		
Service	SDR11 S 32mm PPR PIPE	
Aperture Diameter	45.8mm	
Annular Spacing	Min: 5.5mm Max: 8.3mm

Local Fire-stopping system		
Application	Asymmetrical – installed from the unexposed side	
System description	<ol> <li>1. 150mm wide AGNI-Sleeve was cut to fit one revolution of the aperture.</li> <li>2. The AGNI-Sleeve was then cut down to include two 50mm high x 25mm wide tabs.</li> <li>3. The cut AGNI-Sleeve was inserted into the aperture through the unexposed surface, tabs remained past the face of the unexposed surface.</li> <li>4. The tabs were bent over onto the surface of the separating element and secured using concrete anchors.</li> <li>5. AGNI-Seal was applied 10mm (nominal) deep between the separating element and the pipe, finishing flush with the face of the separating element.</li> </ol>

Test results		
Structural adequacy	Not applicable	
Integrity	No failure at 122 minutes	
Insulation	No failure at 122 minutes

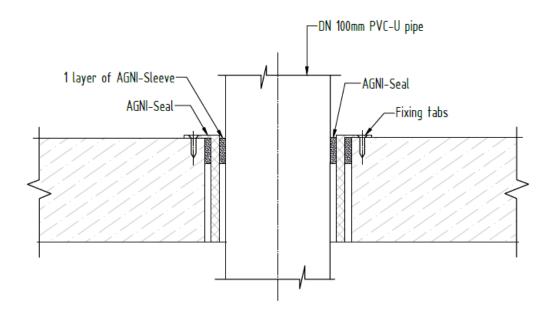
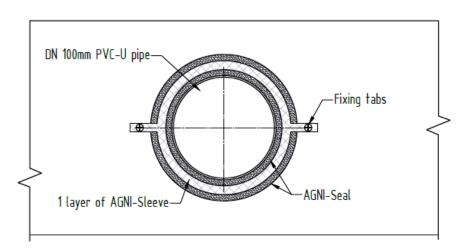
# 6.8 Specimen 8

Service penetration details	
Service	DN100 PVC-U DWV PIPE
Aperture Diameter	129.8mm
Annular Spacing	Min: 8.0mm Max: 11.3mm

Local Fire-stopping system		
Application	Asymmetrical – installed from the unexposed side	
System description	<ol> <li>1. 150mm wide AGNI-Sleeve was cut to fit one revolution of the aperture.</li> <li>2. The AGNI-Sleeve was then cut down to include two 50mm high x 25mm wide tabs.</li> <li>3. The cut AGNI-Sleeve was inserted into the aperture through the unexposed surface, tabs remained past the face of the unexposed surface.</li> <li>4. The tabs were bent over onto the surface of the separating element and secured using concrete anchors.</li> <li>5. AGNI-Seal was applied 10mm (nominal) deep between the separating element and the pipe, finishing flush with the face of the separating element.</li> </ol>

Test results		
Structural adequacy	Not applicable	
Integrity	No failure at 122 minutes	
Insulation	121 minutes

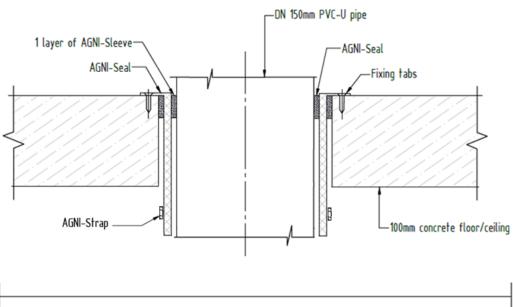
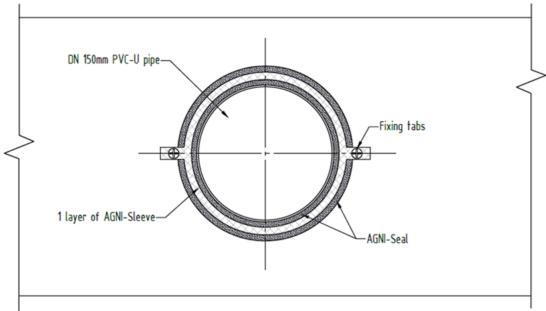
# 6.9 Specimen 9

Service penetration details	
Service	DN150 PVC-U DWV PIPE
Aperture Diameter	170.8mm
Annular Spacing	Min: 4.5mm Max: 6.1mm

Local Fire-stopping system	
Application	Asymmetrical – installed from the unexposed side
System description	<ol> <li>250mm wide AGNI-Sleeve was cut to fit one revolution of the aperture (100mm past the face of the exposed side).</li> </ol>

- 2. The AGNI-Sleeve was then cut down to include two 50mm high x 25mm wide tabs.
- The cut AGNI-Sleeve secured with stainless stee cable tie 50mm from the side opposed to the fixing tabs and was inserted into the aperture through the unexposed surface, tabs remained past the face of the unexposed surface.
- 4. The tabs were bent over onto the surface of the separating element and secured using concrete anchors.
- 5. AGNI-Seal was applied 10mm (nominal) deep between the separating element and the pipe, finishing flush with the face of the separating element.

Other				
5.2	Item / Product Name	AGNI-Strap – stainless steel tie		
	Dimensions	Width (W): 5mm		
	Installation	Used for the specimen 9

Time min	Test face	SP#	OBSERVATIONS/REMARKS
94	U	9	Holes appearing in the pipe, flame seen through holes. Naked flame + 10sec - FAIL
122			TEST DISCONTINUED
