Regulatory Information Report

**Fire resistance test for penetrations through a
horizontal separating element**

Test method: AS1530.4-2014

Test number: PF24123

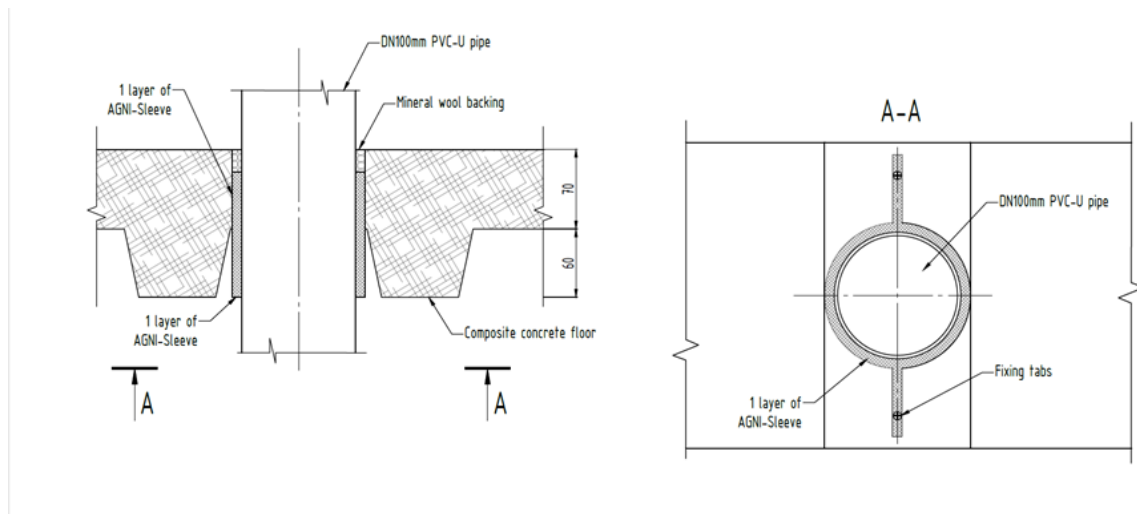
5.2 Specimen 1

Service penetration details	
Service	DN100 PVC-U DWV PIPE
Aperture Diameter	127.2mm
Annular Spacing	Min: 8.4mm Max: 8.8mm

Local Fire-stopping system	
Application	Asymmetrical – installed from the exposed side only
System description	<ol style="list-style-type: none"> 20mm (nominal) thick AGNI-Board was pushed up into the annular gap around the pipe. 110mm wide AGNI-Sleeve is cut to fit one revolution of the aperture (nominal 50mm within the slab). Two 10mm (wide) x 40mm (high) tabs are cut from the top of the AGNI-Sleeve. The AGNI-Sleeve tabs are bent over as the AGNI-Sleeve is pushed into the annular gap. The AGNI-Sleeve was fixed with masonry screws.

Structural adequacy	Not applicable
Integrity	No failure at 68 minutes
Insulation	No failure at 68 minutes

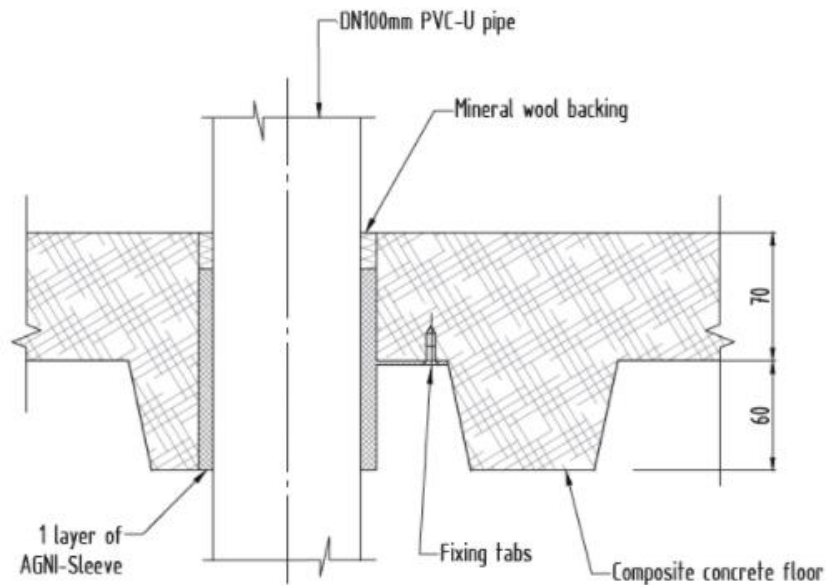
5.3 Specimen 2

Service	DN100 PVC-U DWV PIPE
Aperture Diameter	127.8mm
Annular Spacing	Min: 5.6mm Max: 11.2mm

Local Fire-stopping system	
Application	Asymmetrical – installed from the exposed side only
System description	<ol style="list-style-type: none"> 1. 20mm (nominal) thick AGNI-Board were pushed up into the annular gap around the pipe. 2. 110mm wide AGNI-Sleeve is cut to fit one revolution of the aperture (nominal 50mm within the slab). 3. Two 10mm (wide) x 40mm (high) tabs are cut from the top of the AGNI-Sleeve. 4. The AGNI-Sleeve tabs are bent over as the AGNI-Sleeve is pushed into the annular gap. 5. The AGNI-Sleeve was fixed with masonry screws.

Structural adequacy	Not applicable
Integrity	No failure at 68 minutes
Insulation	No failure at 68 minutes

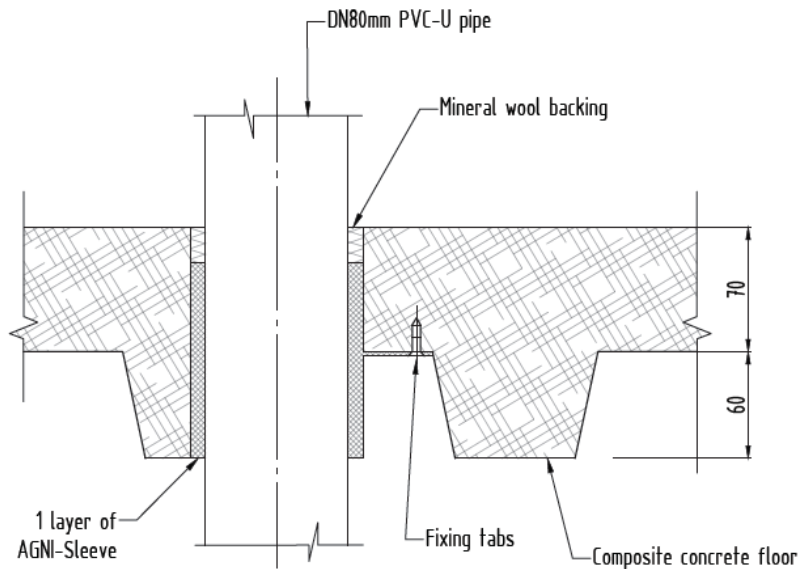
5.4 Specimen 3

Service penetration details	
Service	DN80 PVC-U DWV PIPE
Aperture Diameter	102.6mm
Annular Spacing	Min: 8.9mm Max: 11.7mm

Local Fire-stopping system	
Application	Asymmetrical – installed from the exposed side only
System description	<ol style="list-style-type: none"> 20mm (nominal) thick AGNI-Board were pushed up into the annular gap around the pipe. 110mm wide AGNI-Sleeve is cut to fit one revolution of the aperture (nominal 50mm within the slab). Two 10mm (wide) x 40mm (high) tabs are cut from the top of the AGNI-Sleeve. The AGNI-Sleeve tabs are bent over as the AGNI-Sleeve is pushed into the annular gap. The AGNI-Sleeve was fixed with masonry screws.

Structural adequacy	Not applicable
Integrity	No failure at 68 minutes
Insulation	No failure at 68 minutes

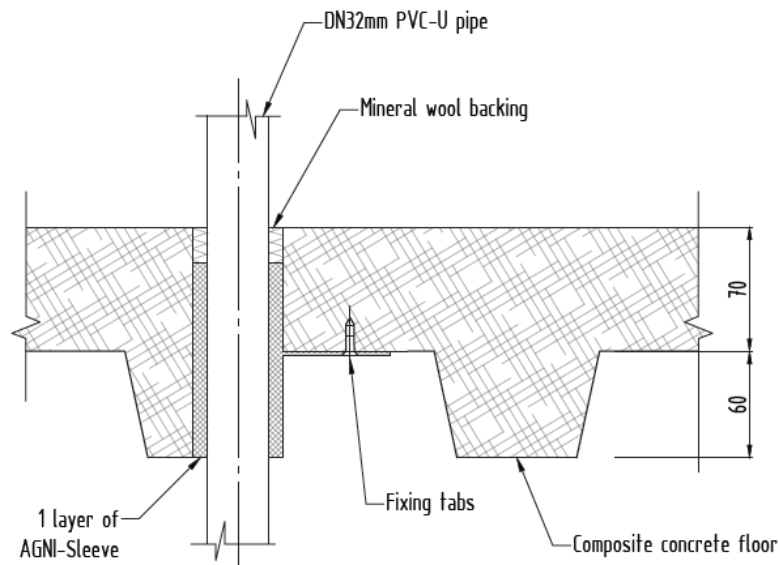
5.5 Specimen 4

Service penetration details	
Service	DN32 PVC-U DWV PIPE
Aperture Diameter	57.7mm
Annular Spacing	Min: 8.3mm Max: 12.7mm

Local Fire-stopping system	
Application	Asymmetrical – installed from the exposed side only
System description	<ol style="list-style-type: none"> 1. 20mm (nominal) thick AGNI-Board were pushed up into the annular gap around the pipe. 2. 110mm wide AGNI-Sleeve is cut to fit one revolution of the aperture (nominal 50mm within the slab). 3. Two 10mm (wide) x 40mm (high) tabs are cut from the top of the AGNI-Sleeve. 4. The AGNI-Sleeve tabs are bent over as the AGNI-Sleeve is pushed into the annular gap. 5. The AGNI-Sleeve was fixed with masonry screws.

Structural adequacy	Not applicable
Integrity	No failure at 68 minutes
Insulation	No failure at 68 minutes

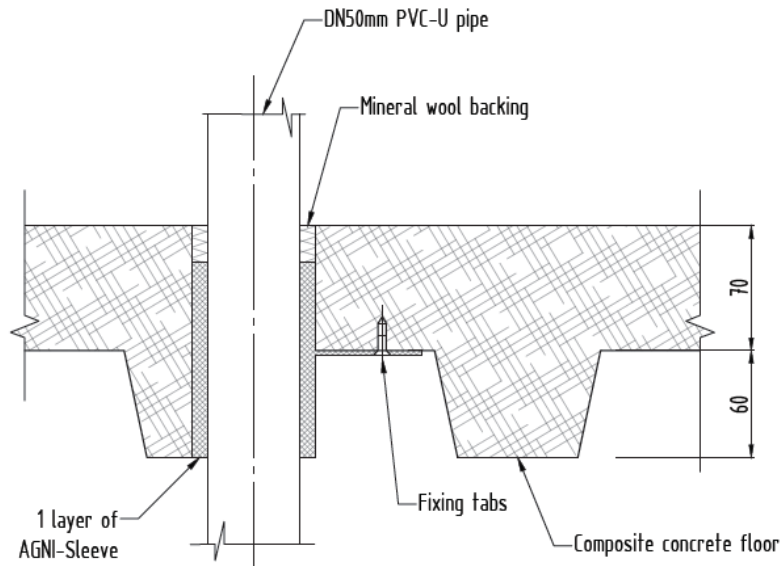
5.6 Specimen 5

Service penetration details	
Service	DN50 PVC-U PIPE
Aperture Diameter	66.9mm
Annular Spacing	Min: 4.6mm Max: 6.3mm

Local Fire-stopping system	
Application	Asymmetrical – installed from the exposed side only
System description	<ol style="list-style-type: none"> 1. 20mm (nominal) thick AGNI-Board were pushed up into the annular gap around the pipe. 2. 110mm wide AGNI-Sleeve is cut to fit one revolution of the aperture (nominal 50mm within the slab). 3. Two 10mm (wide) x 40mm (high) tabs are cut from the top of the AGNI-Sleeve. 4. The AGNI-Sleeve tabs are bent over as the AGNI-Sleeve is pushed into the annular gap. 5. The AGNI-Sleeve was fixed with masonry screws.

Structural adequacy	Not applicable
Integrity	No failure at 68 minutes
Insulation	No failure at 68 minutes

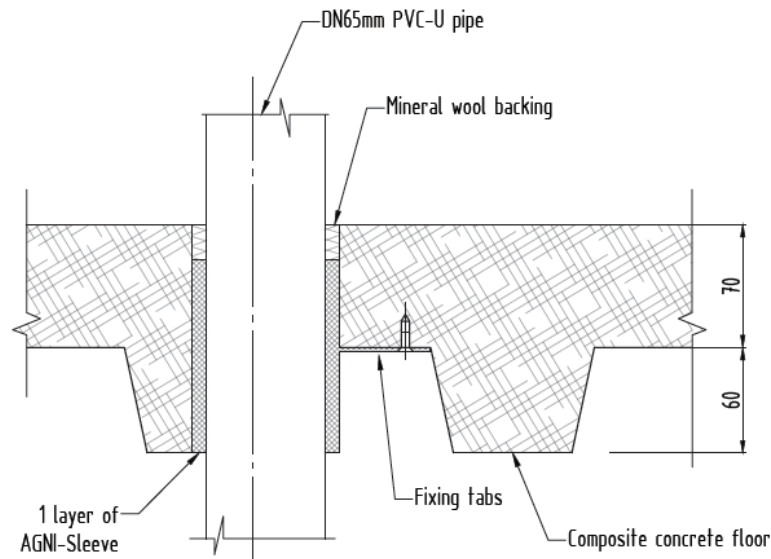
5.7 Specimen 6

Service penetration details	
Service	DN65 PVC-U PIPE
Aperture Diameter	87mm
Annular Spacing	Min: 7.5mm Max: 10.5mm

Local Fire-stopping system	
Application	Asymmetrical – installed from the exposed side only
System description	<ol style="list-style-type: none"> 1. 20mm (nominal) thick AGNI-Board were pushed up into the annular gap around the pipe. 2. 110mm wide AGNI-Sleeve is cut to fit one revolution of the aperture (nominal 50mm within the slab). 3. Two 10mm (wide) x 40mm (high) tabs are cut from the top of the AGNI-Sleeve. 4. The AGNI-Sleeve tabs are bent over as the AGNI-Sleeve is pushed into the annular gap. 5. The AGNI-Sleeve was fixed with masonry screws.

Structural adequacy	Not applicable
Integrity	No failure at 68 minutes
Insulation	No failure at 68 minutes

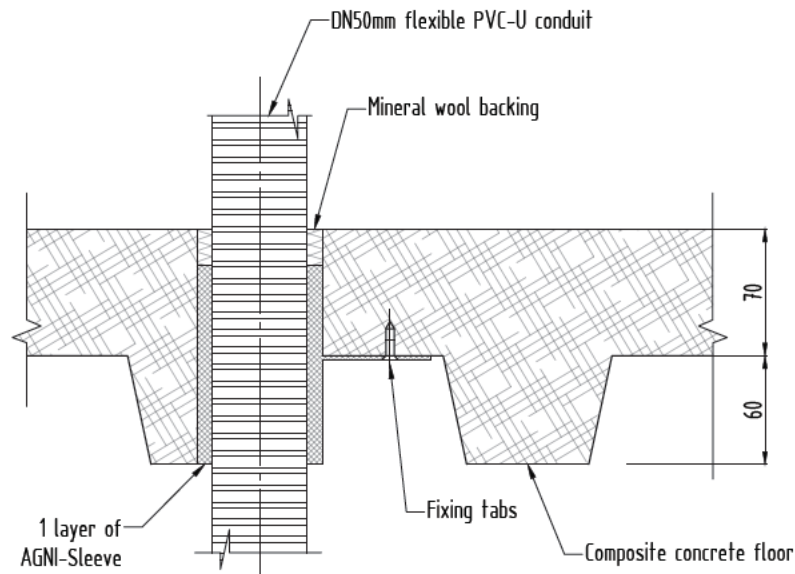
5.8 Specimen 7

Service penetration details	
Service	50mm FLEXIBLE CONDUIT (empty)
Aperture Diameter	67.7mm
Annular Spacing	Min: 6.5mm Max: 11.2mm

Local Fire-stopping system	
Application	Asymmetrical – installed from the exposed side only
System description	<ol style="list-style-type: none"> 20mm (nominal) thick AGNI-Board were pushed up into the annular gap around the pipe. 110mm wide AGNI-Sleeve is cut to fit one revolution of the aperture (nominal 50mm within the slab). Two 10mm (wide) x 40mm (high) tabs are cut from the top of the AGNI-Sleeve. The AGNI-Sleeve tabs are bent over as the AGNI-Sleeve is pushed into the annular gap. The AGNI-Sleeve was fixed with masonry screws.

Structural adequacy	Not applicable
Integrity	No failure at 68 minutes
Insulation	No failure at 68 minutes

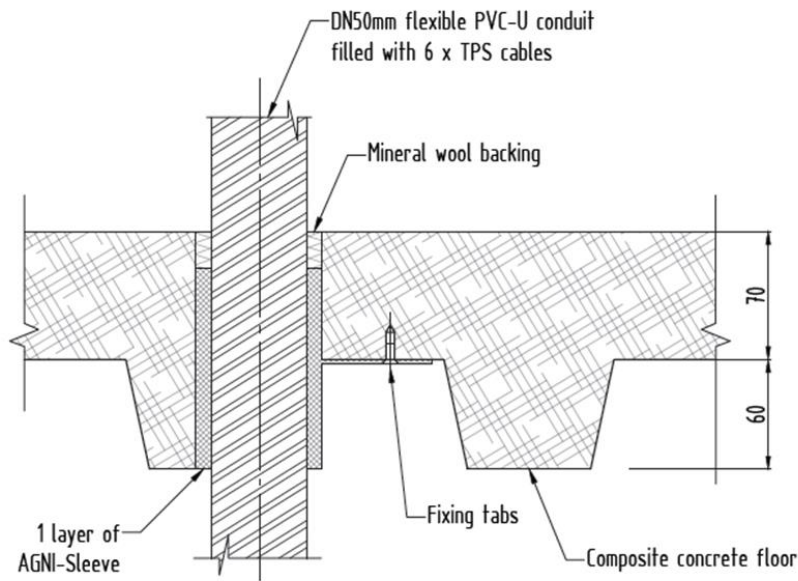
5.9 Specimen 8

Service penetration details	
Service	50mm FLEXIBLE CONDUIT (filled 6 x TPS Cables)
Aperture Diameter	67.5mm
Annular Spacing	Min: 8.6mm Max: 8.9mm

Local Fire-stopping system	
Application	Asymmetrical – installed from the exposed side only
System description	<ol style="list-style-type: none"> 1. 20mm (nominal) thick AGNI-Board were pushed up into the annular gap around the pipe. 2. 110mm wide AGNI-Sleeve is cut to fit one revolution of the aperture (nominal 50mm within the slab). 3. Two 10mm (wide) x 40mm (high) tabs are cut from the top of the AGNI-Sleeve. 4. The AGNI-Sleeve tabs are bent over as the AGNI-Sleeve is pushed into the annular gap. 5. The AGNI-Sleeve was fixed with masonry screws.

Structural adequacy	Not applicable
Integrity	No failure at 68 minutes
Insulation	No failure at 68 minutes

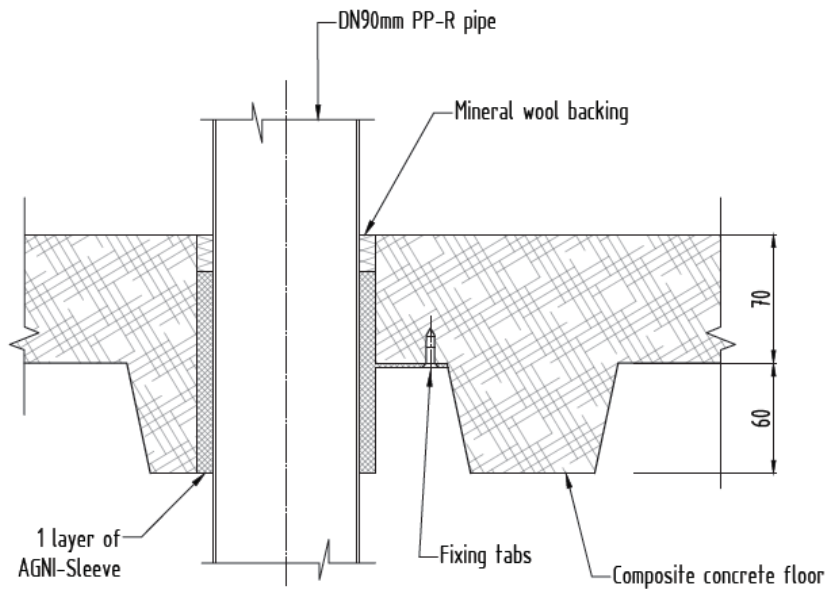
5.10 Specimen 9

Service penetration details	
Service	90mm PPR PIPE
Aperture Diameter	128.7mm
Annular Spacing	Min: 17.3mm Max: 21.4mm

Local Fire-stopping system	
Application	Asymmetrical – installed from the exposed side only
System description	<ol style="list-style-type: none"> 1. 20mm (nominal) thick AGNI-Board were pushed up into the annular gap around the pipe. 2. 110mm wide AGNI-Sleeve is cut to fit one revolution of the aperture (nominal 50mm within the slab). 3. Two 10mm (wide) x 40mm (high) tabs are cut from the top of the AGNI-Sleeve. 4. The AGNI-Sleeve tabs are bent over as the AGNI-Sleeve is pushed into the annular gap. 5. The AGNI-Sleeve was fixed with masonry screws.

Structural adequacy	Not applicable
Integrity	No failure at 68 minutes
Insulation	No failure at 68 minutes

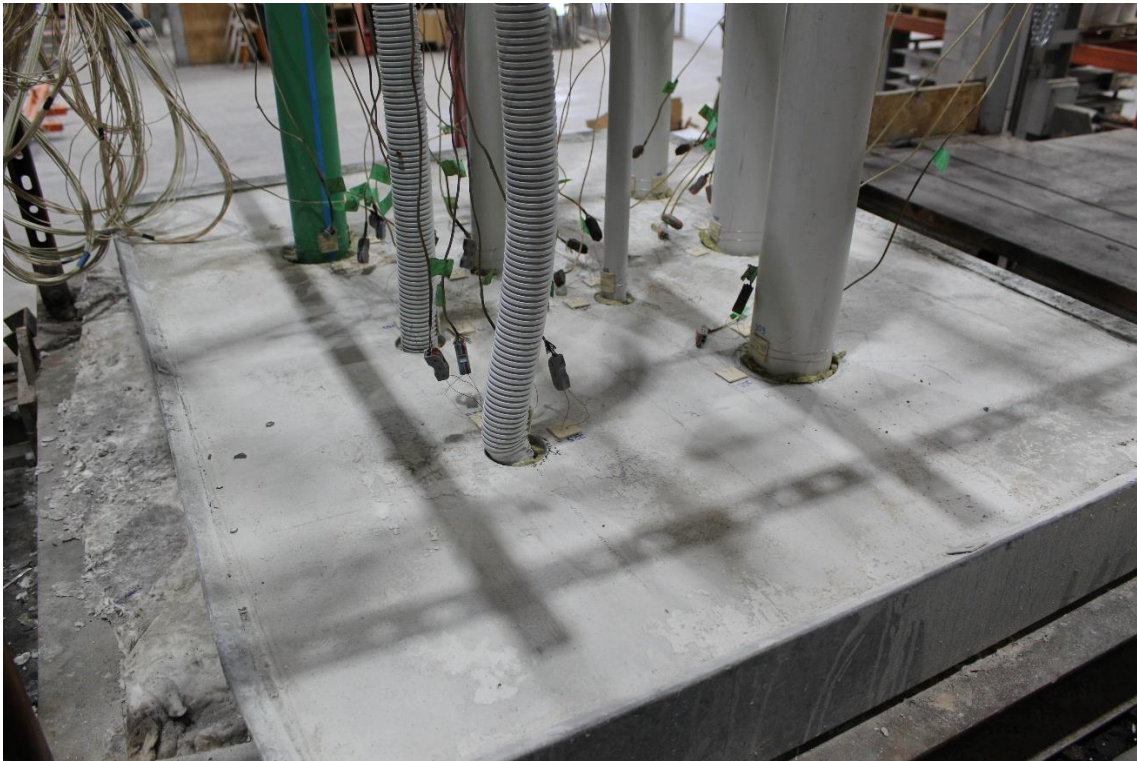
Figure 1 – Unexposed face prior to test commencement

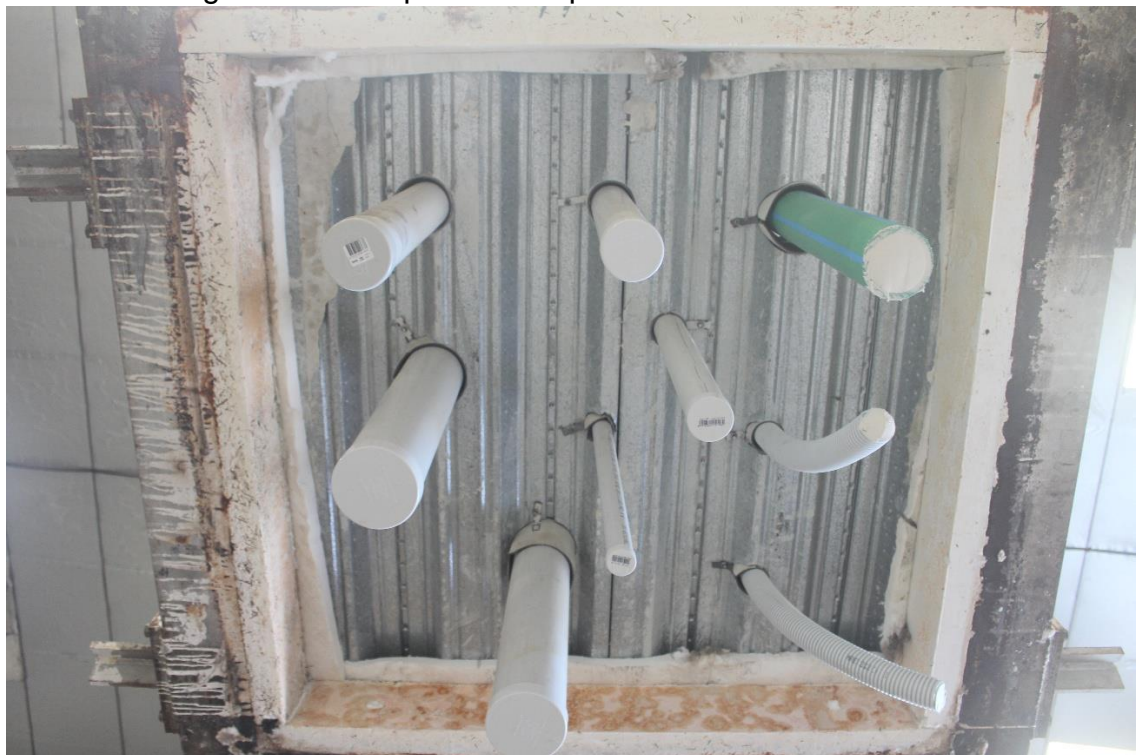
Figure 2 – Exposed face prior to test commencement
