Regulatory Information Report

RIRF23097

**Fire resistance test for penetrations through a
horizontal separating element**

Test method: AS1530.4-2014

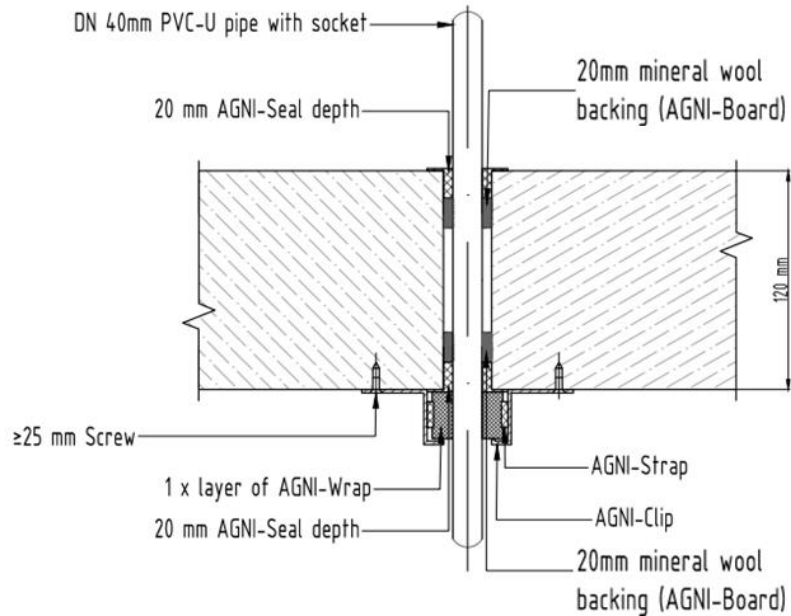
Figure 4 – Specimen 1 (side view)

Service penetration details	
Service	DN 40 PVC Pipe
Aperture Diameter	57mm
Annular Spacing	Min: 6mm, Max: 8mm

Local Fire-stopping system	
Application	Asymmetrical
System description	AGNI-Board was installed in annular space, 20mm from both faces of separating element. 20mm (nominal) deep sealant was installed in the annular space from both faces. On exposed face, 1 revolution of intumescent strip with 11mm overlap was wrapped around the pipe. The intumescent was secured using a cable tie then fixed to the separating element with 2 screw and clip fixings.

Structural adequacy	Not applicable
Integrity	No failure at 243 minutes
Insulation	225 minutes

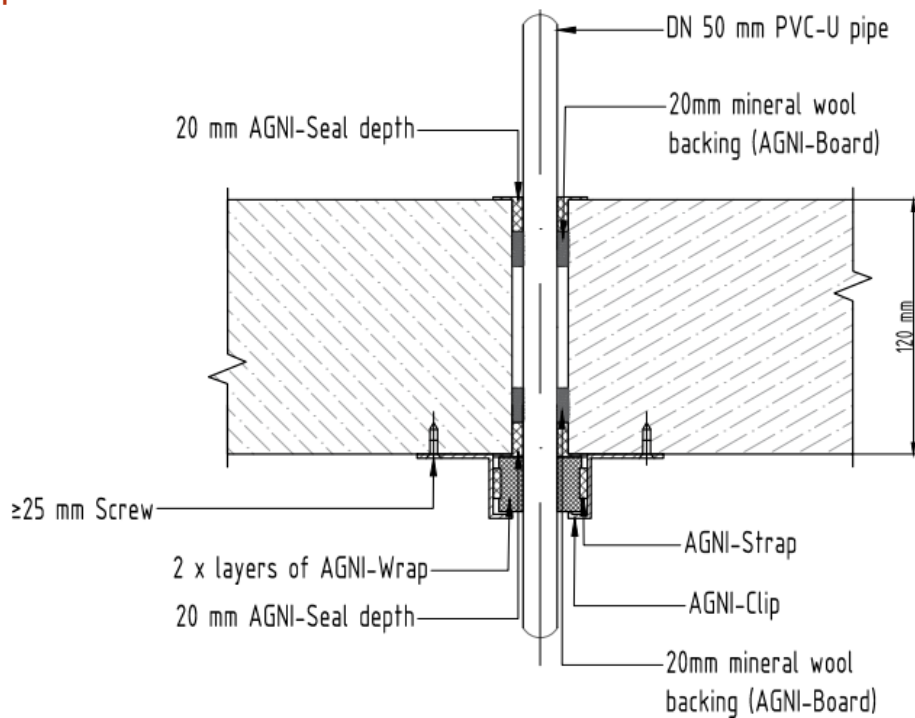
Figure 7 – Specimen 2 (side view)

Service penetration details	
Service	DN 50 PVC Pipe
Aperture Diameter	72mm
Annular Spacing	Min: 2mm, Max: 14mm

Local Fire-stopping system	
Application	Asymmetrical
System description	AGNI-Board was installed in annular space, 20mm from both faces of separating element. 20mm (nominal) deep sealant was installed in the annular space from both faces. On exposed face, 2 revolutions of intumescent strip with 15mm overlap were wrapped around the pipe. The intumescent was secured using a cable tie then fixed to the separating element with 3 screw and clip fixings.

Structural adequacy	Not applicable
Integrity	No failure at 243 minutes
Insulation	222 minutes

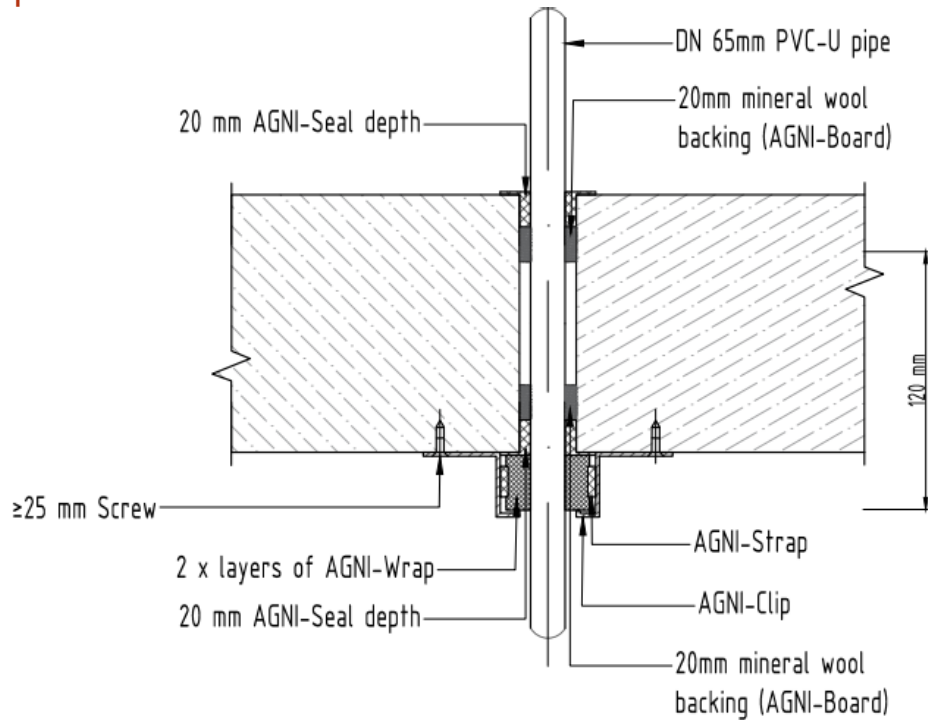
Figure 10 – Specimen 3 (side view)

Service penetration details	
Service	DN 65 PVC Pipe
Aperture Diameter	87mm
Annular Spacing	Min:3.5mm, Max: 14mm

Local Fire-stopping system	
Application	Asymmetrical
System description	AGNI-Board was installed in annular space, 20mm from both faces of separating element. 20mm (nominal) deep sealant was installed in the annular space from both faces. On exposed face, 2 revolutions of intumescent strip with 10mm overlap were wrapped around the pipe. The intumescent was secured using a cable tie then fixed to the separating element with 3 screw and clip fixings.

Structural adequacy	Not applicable
Integrity	No failure at 243 minutes
Insulation	124 minutes

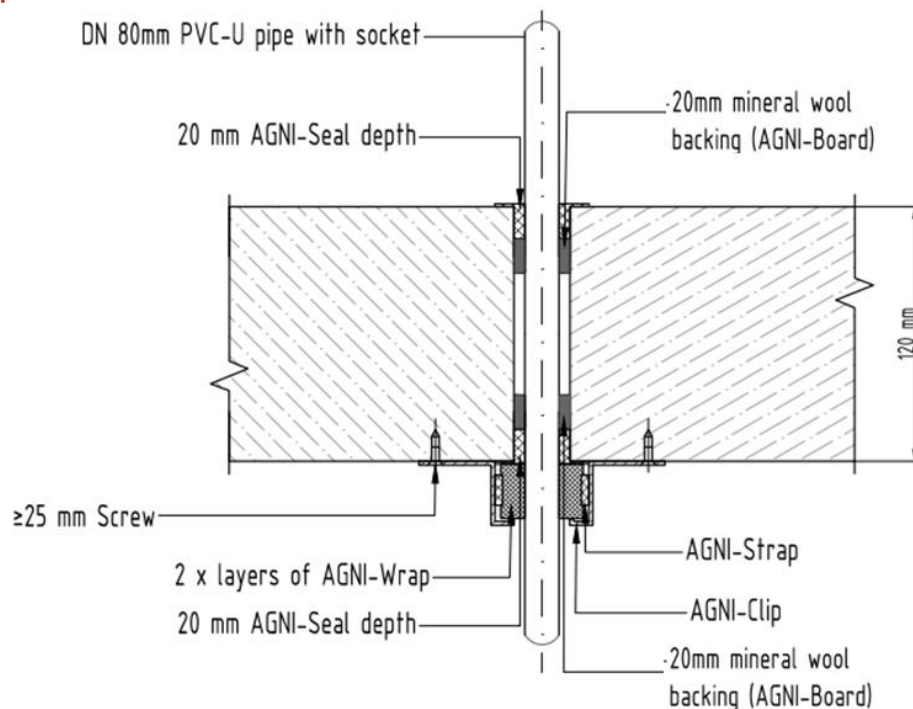
Figure 13 – Specimen 4 (side view)

Service penetration details	
Service	DN 80 PVC Pipe
Aperture Diameter	92mm
Annular Spacing	Min: 4mm, Max: 6mm

Local Fire-stopping system	
Application	Asymmetrical
System description	AGNI-Board was installed in annular space, 20mm from both faces of separating element. 20mm (nominal) deep sealant was installed in the annular space from both faces. On exposed face, 2 revolutions of intumescent strip with 8mm overlap were wrapped around the pipe. The intumescent was secured using a cable tie then fixed to the separating element with 3 screw and clip fixings.

Structural adequacy	Not applicable
Integrity	163 minutes
Insulation	163 minutes

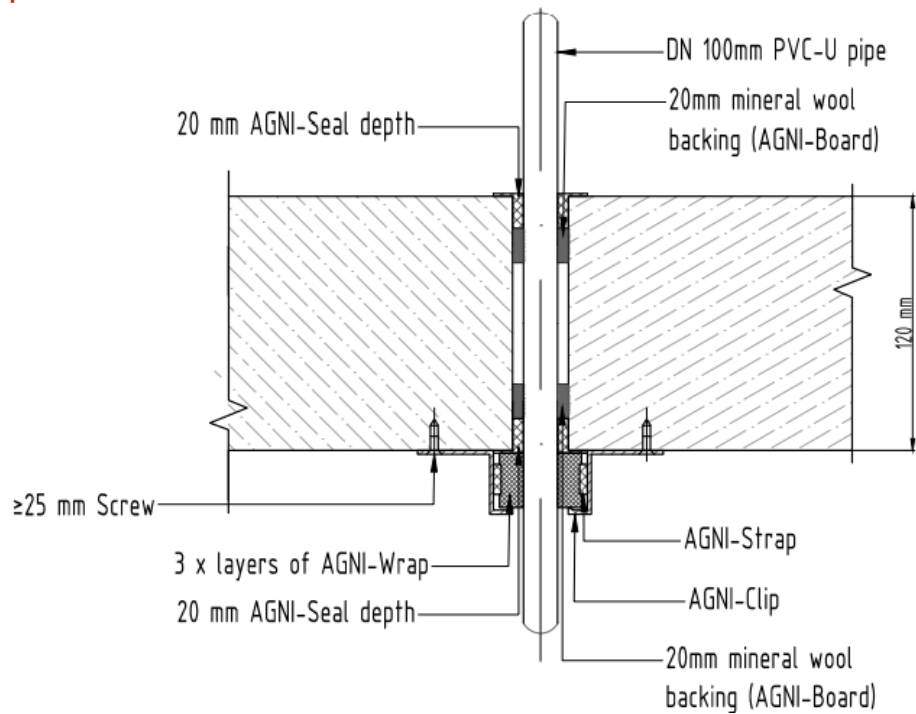
Figure 16 – Specimen 5 (side view)

Service penetration details	
Service	DN 100 PVC Pipe
Aperture Diameter	123mm
Annular Spacing	Min: 2.5mm, Max: 10.5mm

Local Fire-stopping system	
Application	Asymmetrical
System description	AGNI-Board was installed in annular space, 20mm from both faces of separating element. 20mm (nominal) deep sealant was installed in the annular space from both faces. On exposed face, 3 revolutions of intumescent strip with 7mm overlap were wrapped around the pipe. The intumescent was secured using a cable tie then fixed to the separating element with 5 screw and clip fixings.

Structural adequacy	Not applicable
Integrity	118 minutes
Insulation	49 minutes

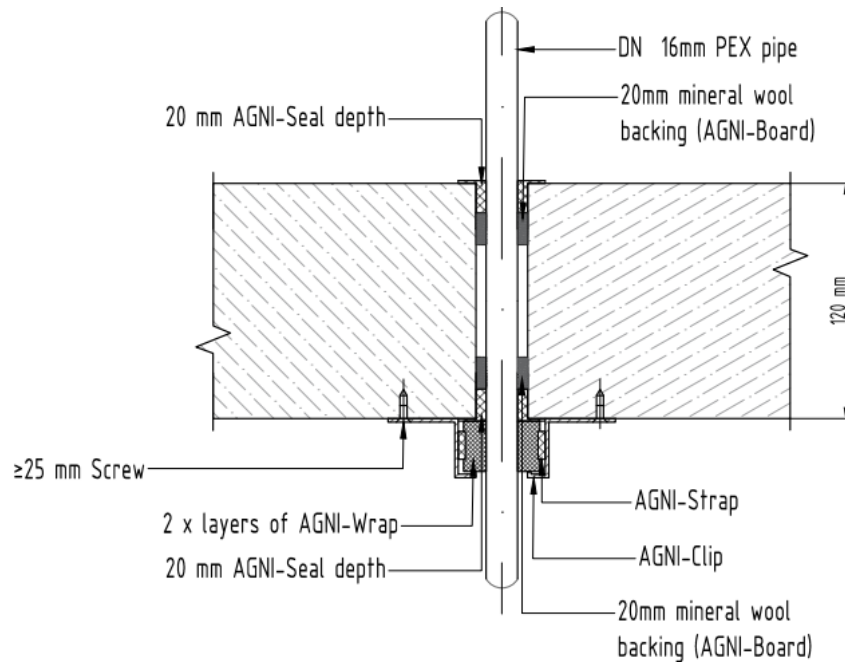
Figure 19 – Specimen 6 (side view)

Service penetration details	
Service	DN 16 PEX Pipe
Aperture Diameter	42mm
Annular Spacing	Min: 12mm, Max: 14mm

Local Fire-stopping system	
Application	Asymmetrical
System description	AGNI-Board was installed in annular space, 20mm from both faces of separating element. 20mm (nominal) deep sealant was installed in the annular space from both faces. On exposed face, 2 revolutions of intumescent strip with 12mm overlap were wrapped around the pipe. The intumescent was secured using a cable tie then fixed to the separating element with 2 screw and clip fixings.

Structural adequacy	Not applicable
Integrity	156 minutes
Insulation	115 minutes

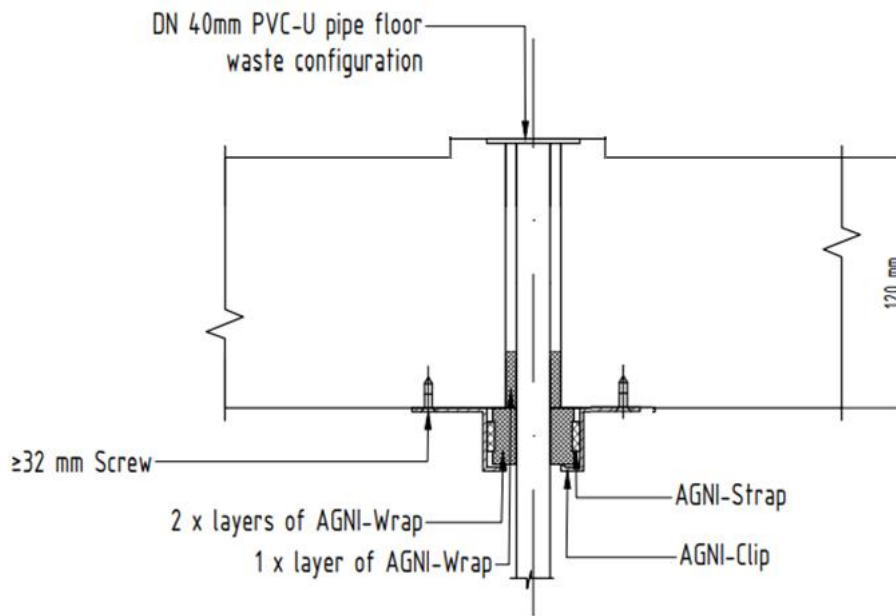
Figure 22 – Specimen 7 (side view)

Service penetration details	
Service	DN 40 Floor waste and socket
Aperture Diameter	62mm
Annular Spacing	Exposed Face, Min: 9mm, Max: 10mm
	Unexposed Face: 0mm

Local Fire-stopping system	
Application	Asymmetrical – Installed on exposed face of separating element
System description	1 revolution of intumescent with 30mm overlap were wrapped around the pipe, recessed 10-15mm from separating element surface. 2 revolutions of intumescent strip with 30mm overlap were wrapped around the pipe. The intumescent was secured using a cable tie then fixed to the separating element with 2 screw and clip fixings.

Structural adequacy	Not applicable
Integrity	No failure at 243 minutes
Insulation	No failure at 243 minutes

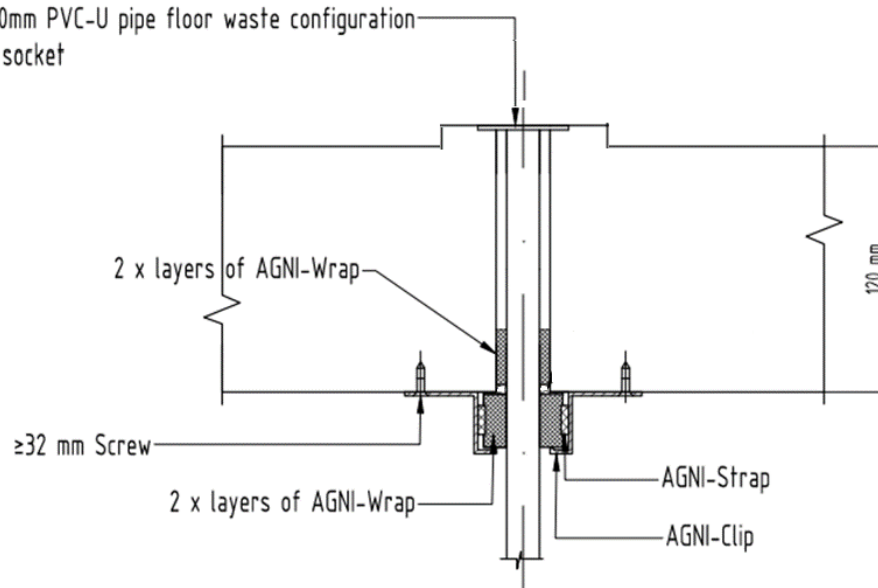
Figure 25 – Specimen 8 (side view)

DN 80mm PVC-U pipe floor waste configuration with socket

Service penetration details	
Service	DN 80 Floor waste and socket
Aperture Diameter	102.5mm
Annular Spacing	Exposed Face, Min: 9.5mm, Max: 11mm
	Unexposed Face: 0mm

Local Fire-stopping system	
Application	Asymmetrical – Installed on exposed face of separating element
System description	1 revolution of intumescent with 18mm overlap were wrapped around the pipe, recessed in annular space and flush with separating element surface. 2 revolutions of intumescent strip with 30mm overlap were wrapped around the pipe. The intumescent was secured using a cable tie then fixed to the separating element with 3 screw and clip fixings.

Structural adequacy	Not applicable
Integrity	144 minutes
Insulation	123 minutes

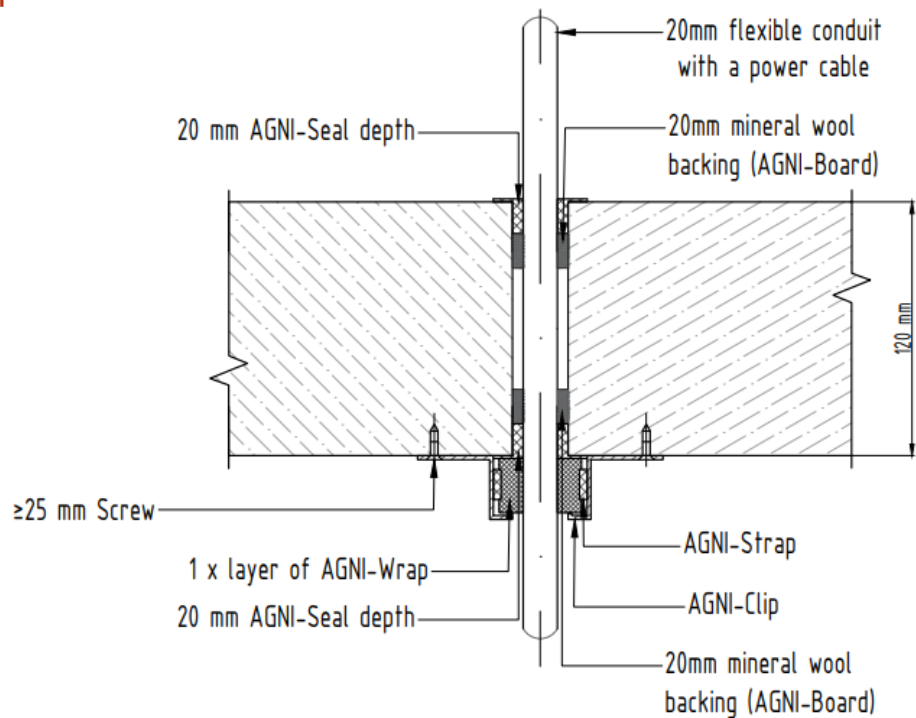
Figure 28 – Specimen 9 (side view)

Service penetration details	
Service	20mm Flexible conduit packed with 1 TPS Cable
Aperture Diameter	42mm
Annular Spacing	Min: 8mm, Max: 14mm

Local Fire-stopping system	
Application	Asymmetrical
System description	AGNI-Board was installed in annular space, 20mm from both faces of separating element. 20mm (nominal) deep sealant was installed in the annular space from both faces. On exposed face, 1 revolution of intumescent strip with 18mm overlap was wrapped around the pipe. The intumescent was secured using a cable tie then fixed to the separating element with 2 screw and clip fixings.

Structural adequacy	Not applicable
Integrity	No failure at 243 minutes
Insulation	207 minutes

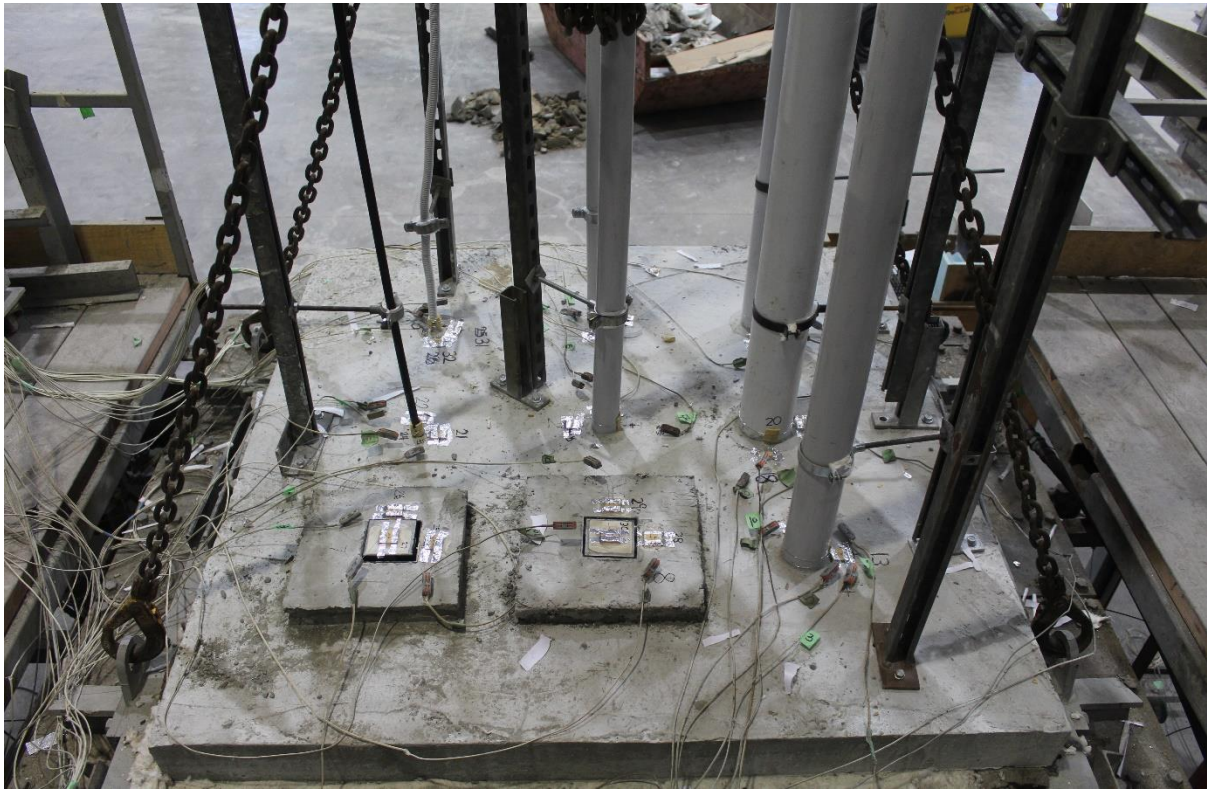
Figure 29 – Unexposed face prior to test commencement

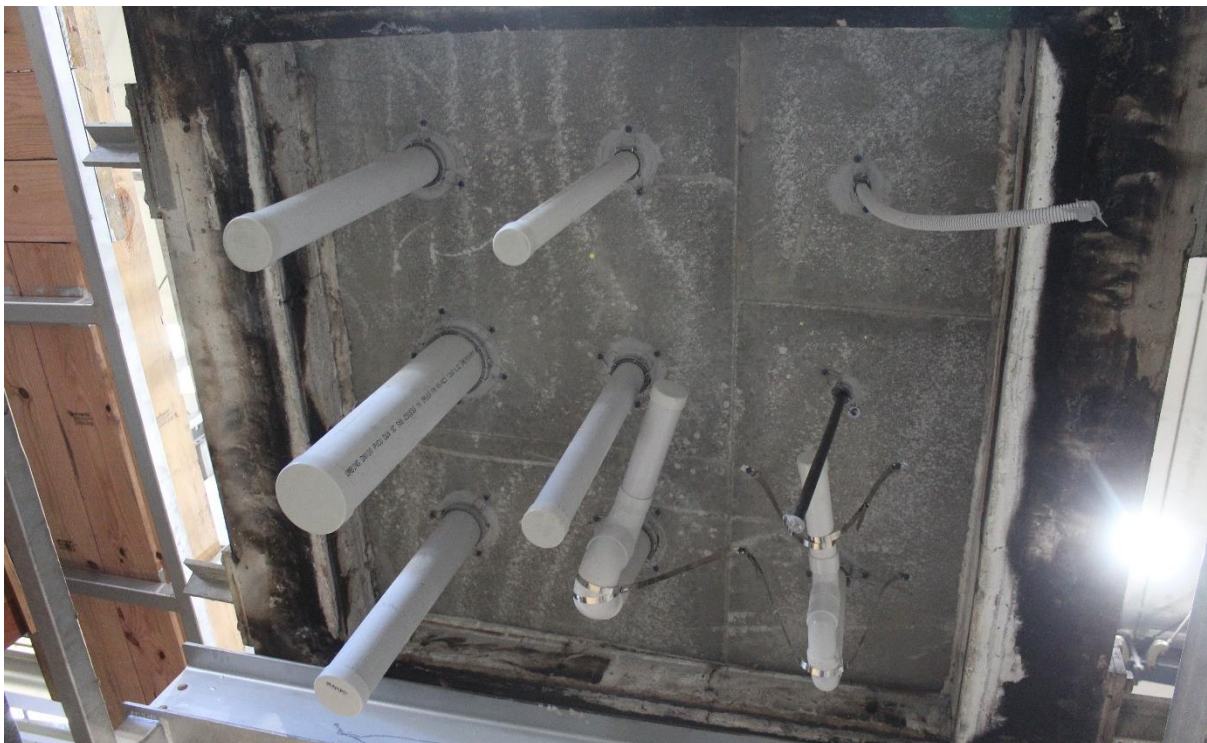
Figure 30 – Exposed face prior to test commencement
