Regulatory Information Report

RIRF24080

Fire resistance test for penetrations through the horizontal separating element

Client: Agnitek Pty Ltd

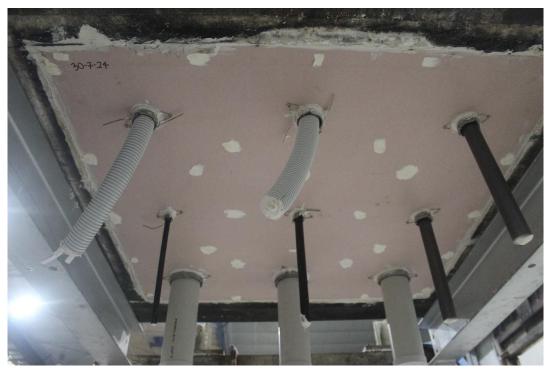
Figure 1 – Exposed face prior to test commencement
