# Regulatory Information Report

**RIRF24100**

## Fire resistance test for penetrations through a vertical separating element

Test number: PF24100

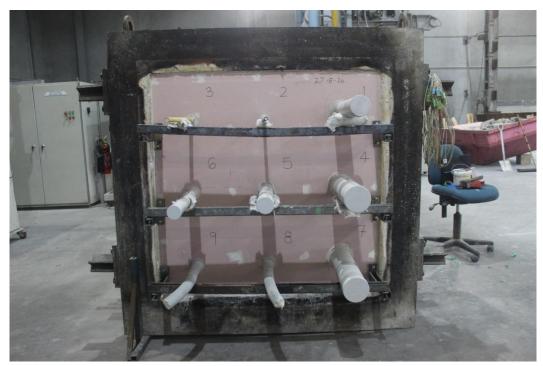
Figure 1 – Exposed face prior to test commencement
