## Test report # PF22002

**Client: Tech Coatings NZ Limited**

**Fire resistance tests for wall penetrations**

**Test method: AS 1530.4:2014**

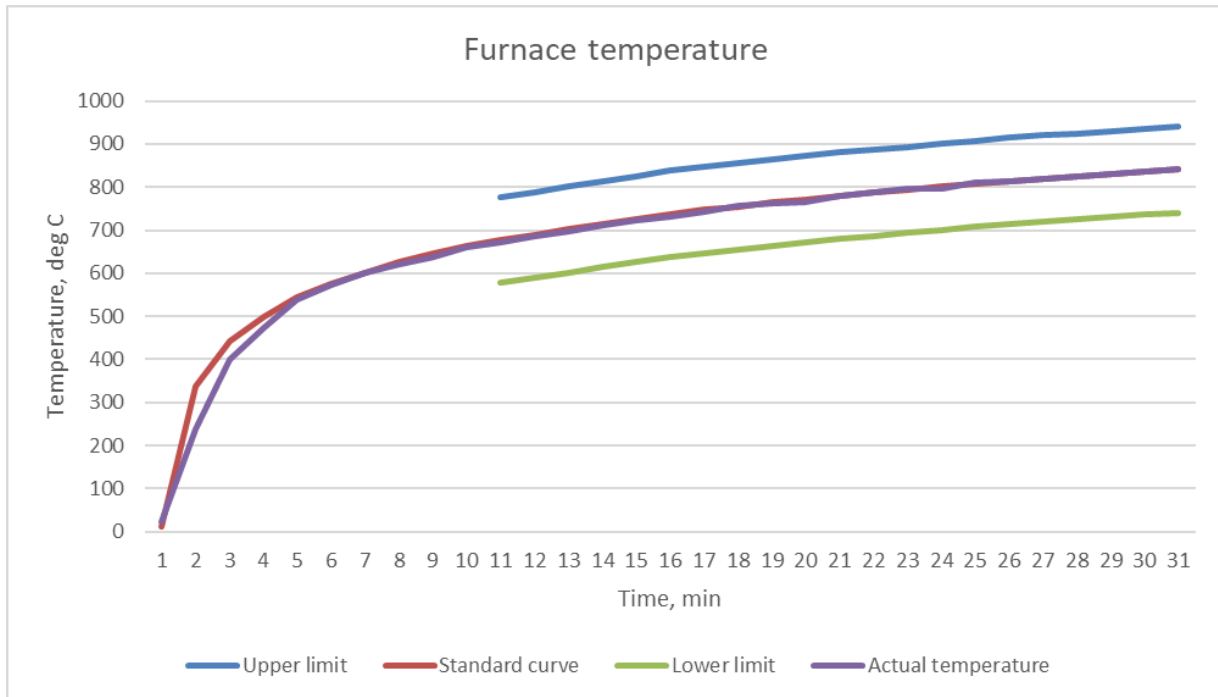
### 6.1 Furnace Temperature

The furnace was controlled to follow the temperature/time relationship specified in AS 1530.4-2014 as closely as possible.

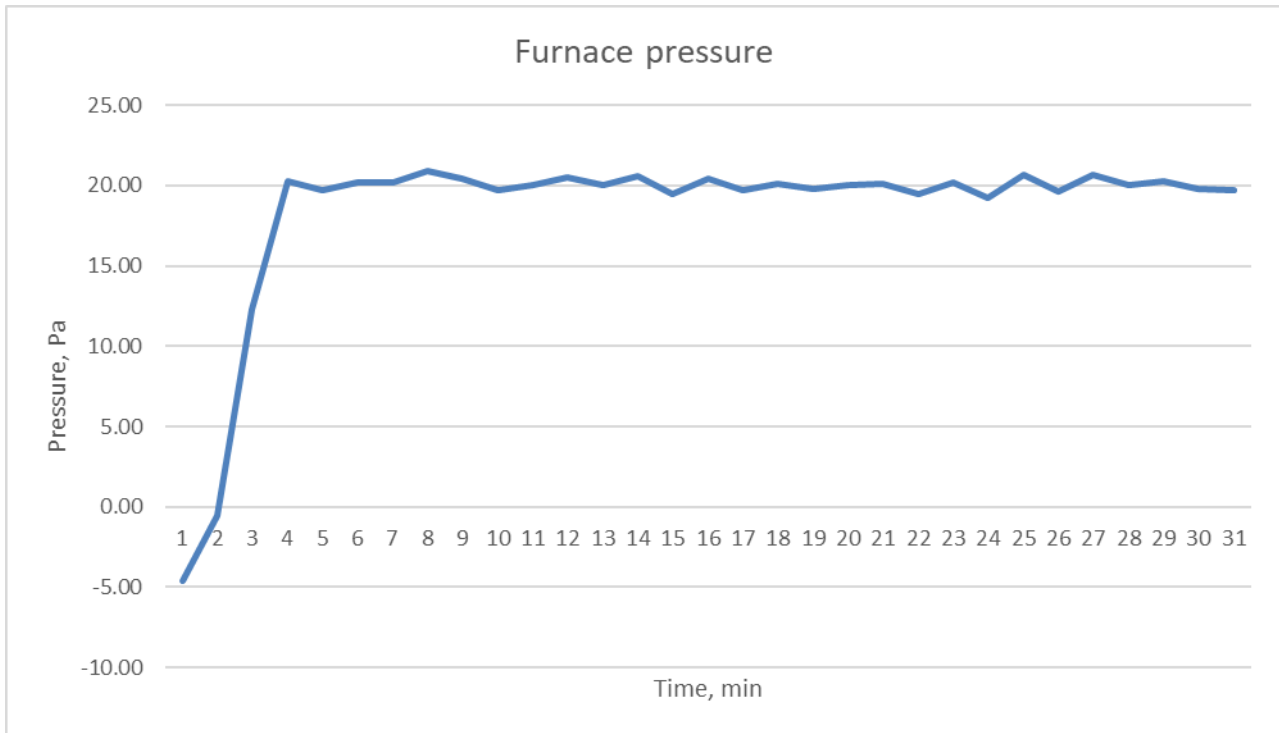
## 6.3 Pressure Readings

After the first 5 minutes of the test, the furnace pressure was maintained at  $20 \pm 3$  Pa with respect to atmosphere. The probe was located at the top of the specimen.

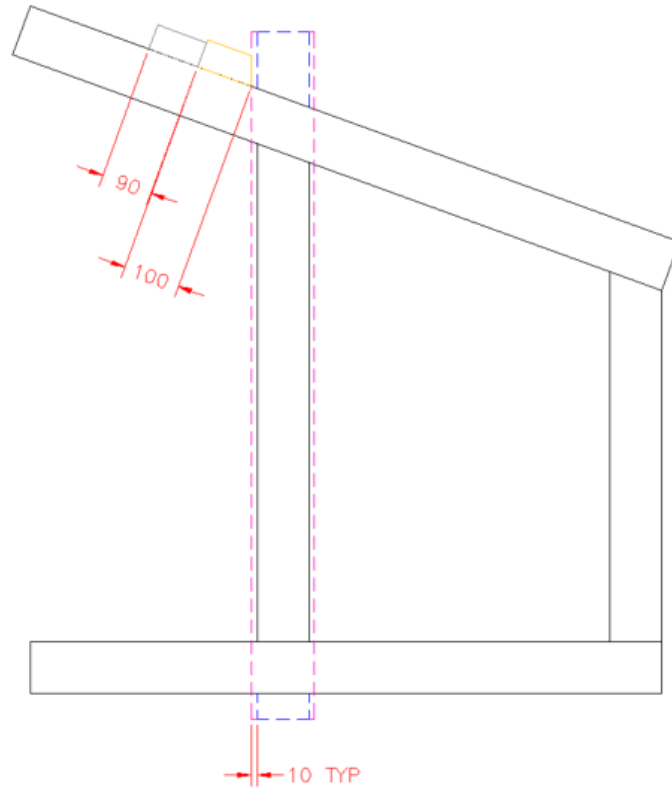
## 10.1 Specimen A

A	Service	Timber penetration
	Service Details	Timber (1.2), Fire Board (5.1), Intumescent Paint (3.1)
	Aperture Size	Width / Height (W/H): 45mm x 1110mm
	<b>Local Fire-stopping Protection</b>	
	Application	Asymmetrical
	Protection Used	<p>A generic truss was constructed using timber (1.2) to be installed in the separating element. The dimensions of these truss sections can be seen below. The truss section was installed within the separating element gaps, fixed using framing nails. The centre stud of the truss protruded 20mm from the exposed face of the timber studs of the separating element. A section of timber was used to create a purlin on the top of the truss structure, located 100mm from the exposed face of the separating element. A section of fire board (5.1) was cut to fit between the purlin section and the separating element. Once plasterboard had been installed on both faces, intumescent paint was applied to the exposed truss stud, fire board, purlin, upper chord and lower chord. The plasterboard was also coated 100mm on each side of the truss section.</p> <p>The inurmescent coating was applied to nominal 500 microns.</p>

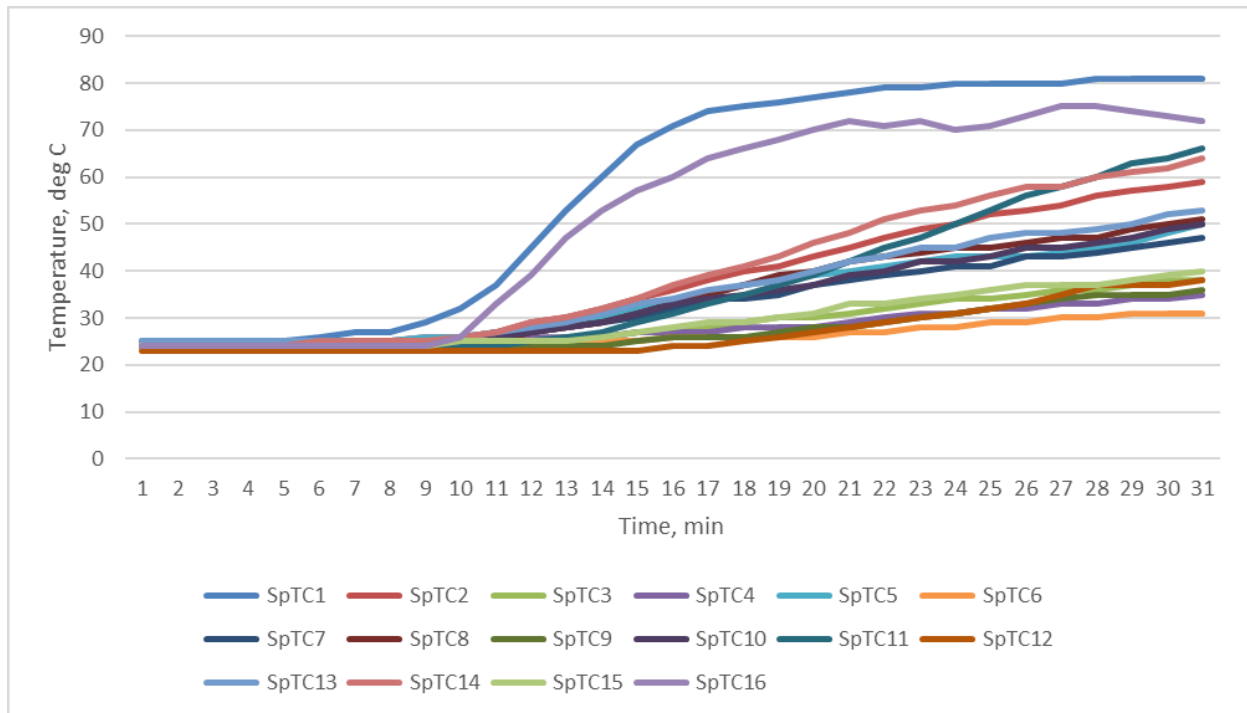
### Specimen A Thermocouples Readings

<b>Structural adequacy</b>	<b>Not applicable</b>
<b>Integrity</b>	<b>No failure 30 minutes</b>
<b>Insulation</b>	<b>No failure 30 minutes</b>

Specimen	TC#	THERMOCOUPLE LOCATION DESCRIPTION
A	1	Separating element, 25mm above upper chord
A	2	Separating element, 25mm right of the upper chord
A	3	Upper chord, top side, 25mm from separating element
A	4	Upper chord, right side, 25mm from separating element
A	5	Separating element, 25mm left of gap, 50mm below upper chord
A	6	Timber stud, centre of timber inside gap, 50mm below upper chord
A	7	Separating element, 25mm right of gap, 50mm below upper chord
A	8	Separating element, 25mm left of gap, mid-height of timber stud
A	9	Timber stud, centre of timber inside gap, mid-height of timber stud
A	10	Separating element, 25mm right of gap, mid-height of timber stud
A	11	Separating element, 25mm left of gap, 50mm below upper chord
A	12	Timber stud, centre of timber inside gap, 50mm above lower chord
A	13	Separating element, 25mm right of gap, 50mm above lower chord
A	14	Separating element, 25mm right of the lower chord

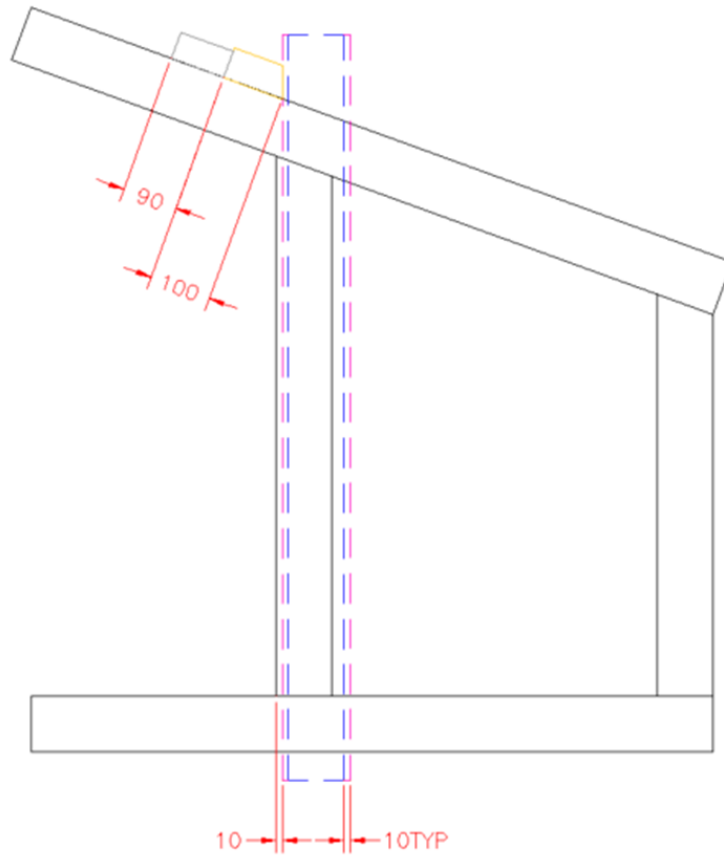
## 10.2 Specimen B

B	Service	Timber penetration
	Service Details	Timber (1.2), Fire Board (5.1), Intumescent Paint (3.1)
	Aperture Size	Width / Height (W/H): 45mm x 1110mm
	<b>Local Fire-stopping Protection</b>	
	Application	Asymmetrical
Protection Used	<p>A generic truss was constructed using timber (1.2) to be installed in the separating element. The dimensions of these truss sections can be seen below. The truss section was installed within the separating element gaps, fixed using framing nails. The centre stud of the truss protruded 20mm from the exposed face of the timber studs of the separating element. A section of timber was used to create a purlin on the top of the truss structure, located 100mm from the exposed face of the separating element. A section of fire board (5.1) was cut to fit between the purlin section and the separating element. Once plasterboard had been installed on both faces, intumescent paint was applied to the exposed truss stud, fire board, purlin, upper chord and lower chord. The plasterboard was also coated 100mm on each side of the truss section.</p> <p>The intumescent coating was applied to nominal 500 microns.</p>

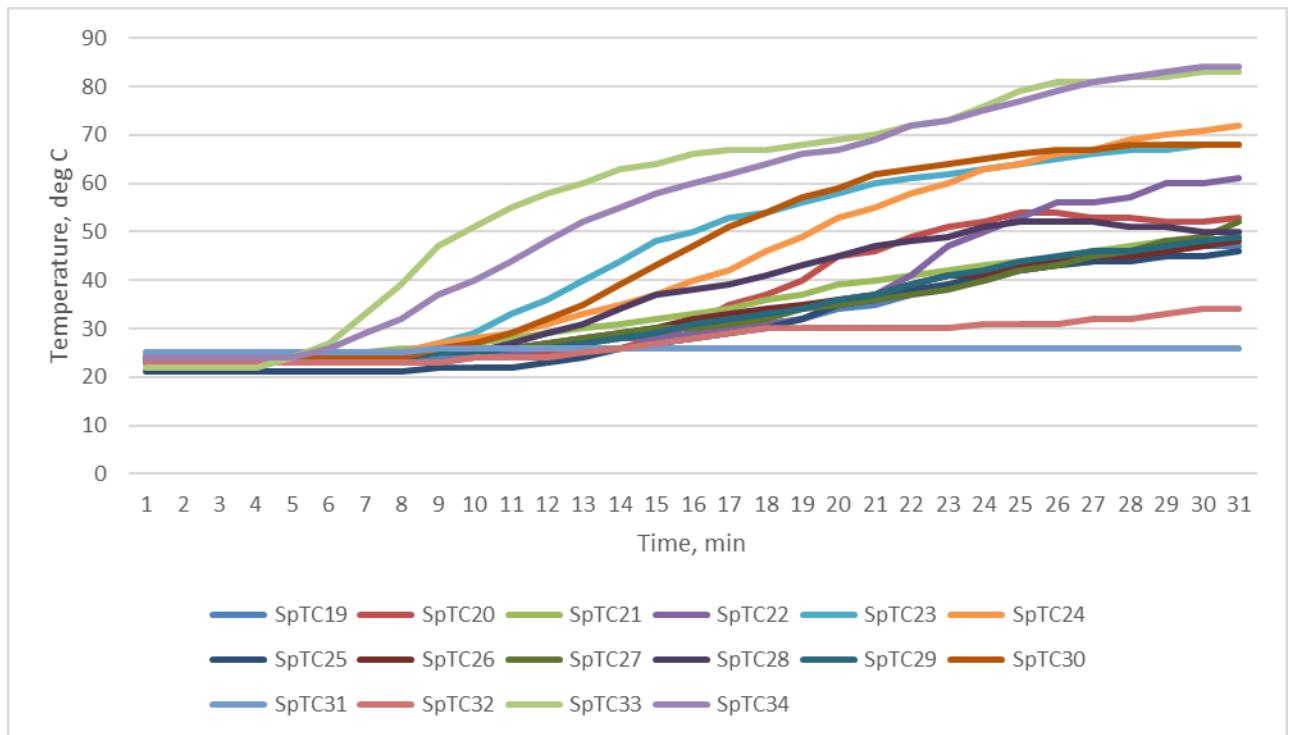
### Specimen B Thermocouples Readings

<b>Structural adequacy</b>	<b>Not applicable</b>
<b>Integrity</b>	<b>No failure 30 minutes</b>
<b>Insulation</b>	<b>No failure 30 minutes</b>

A	15	Lower chord, top side, 25mm from separating element
A	16	Lower chord, right side, 25mm from separating element
B	17	Separating element, 25mm above upper chord
B	18	Separating element, 25mm right of the upper chord
B	19	Upper chord, top side, 25mm from separating element
B	20	Upper chord, right side, 25mm from separating element
B	21	Separating element, 25mm left of gap, 50mm below upper chord
B	22	Timber stud, centre of timber inside gap, 50mm below upper chord
B	23	Separating element, 25mm right of gap, 50mm below upper chord
B	24	Separating element, 25mm left of gap, mid-height of timber stud

B	25	Timber stud, centre of timber inside gap, mid-height of timber stud
B	26	Separating element, 25mm right of gap, mid-height of timber stud
B	27	Separating element, 25mm left of gap, 50mm below upper chord
B	28	Timber stud, centre of timber inside gap, 50mm above lower chord
B	29	Separating element, 25mm right of gap, 50mm above lower chord
B	30	Separating element, 25mm right of the lower chord
B	31	Lower chord, top side, 25mm from separating element
B	32	Lower chord, right side, 25mm from separating element
SE	33	Separating element, mid width of separating element, 400mm from top edge
SE	34	Separating element, mid width of separating element, 400mm from bottom edge
