Test report # PF23015

Client: Tech Coatings NZ Limited

**Fire resistance test for the timber penetrations
through the wall**

Test method: AS 1530.4:2014

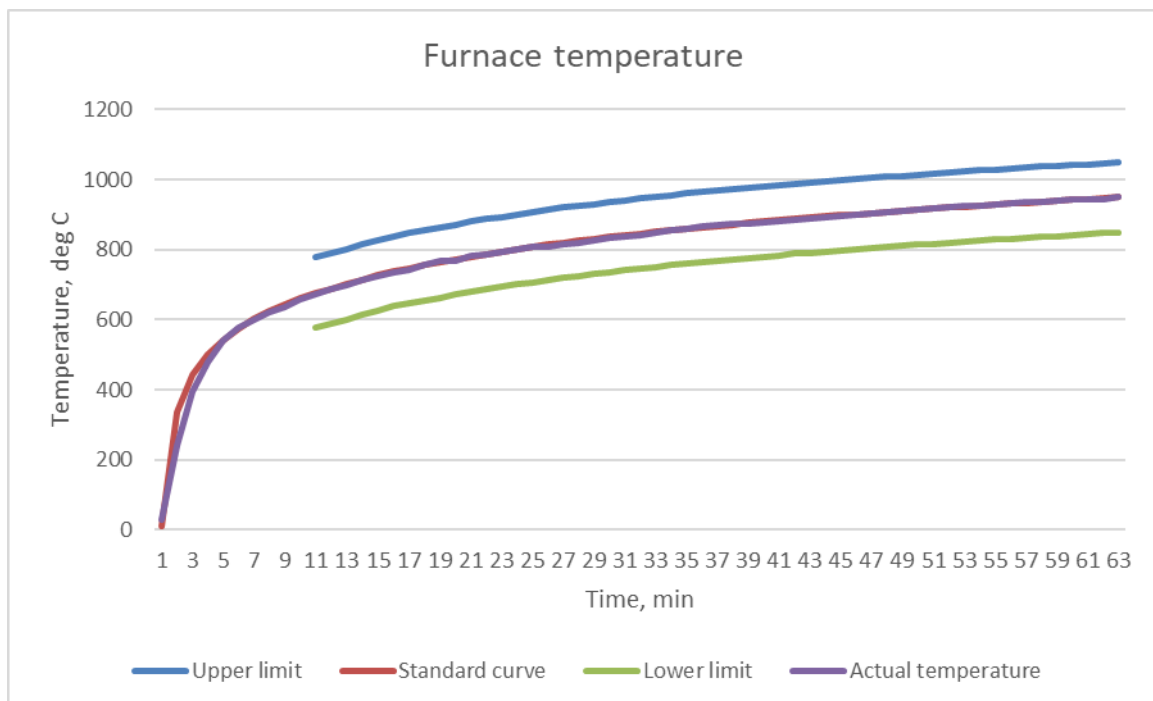
6.1 Furnace Temperature

The furnace was controlled to follow the temperature/time relationship specified in AS 1530.4-2014.

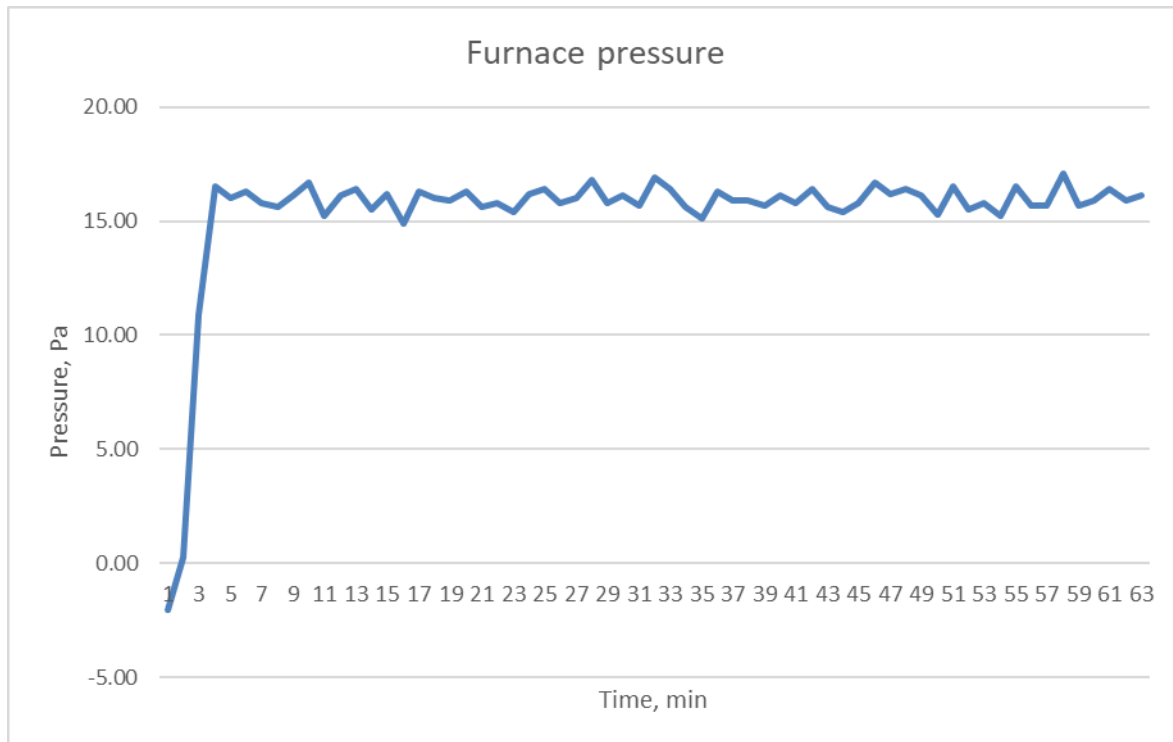
6.3 Pressure Readings

The probe was located 500mm above the furnace floor.

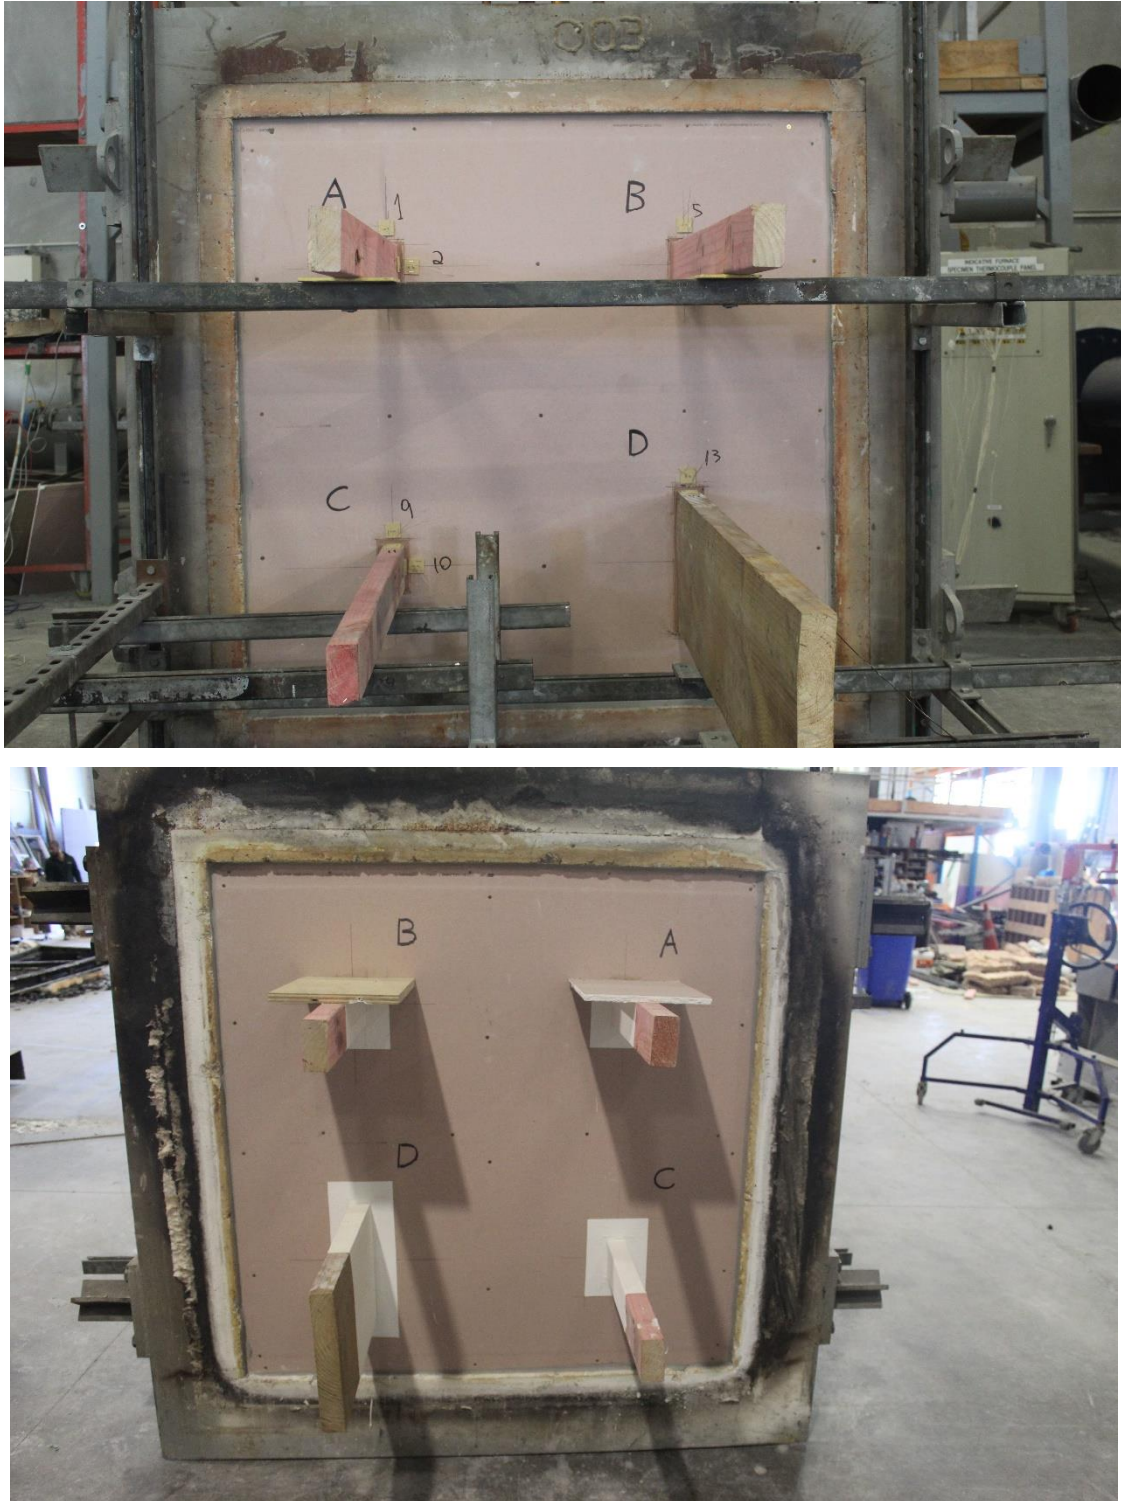
Fig.1 – Test specimens. Unexposed (top) and exposed (bottom) face.

Separating Element		
1.1	Item / Product Name	Timber Frame and Fr plasterboard separating element
	Measurements	Width / Height (W/H): 1200 x 1200mm
		Thickness (T): 116mm
Installation	<p>The separating element was constructed by the laboratory. The separating element consisted of a timber top and bottom plate, three studs and two nogs (1.2). The top plate, bottom plate and two studs were fixed to the perimeter of the refractory frame. The additional stud was installed at 600mm centres. The nogs were installed at 600mm centres. All timber was fixed using framing nails (4.1) Each face of the timber frame was then lined with one layer of plasterboard (1.3), fixed with screws (4.2) at 300mm centres. The apertures were then cut from the plasterboard, with one aperture centred in each quarter of the timber frame.</p>

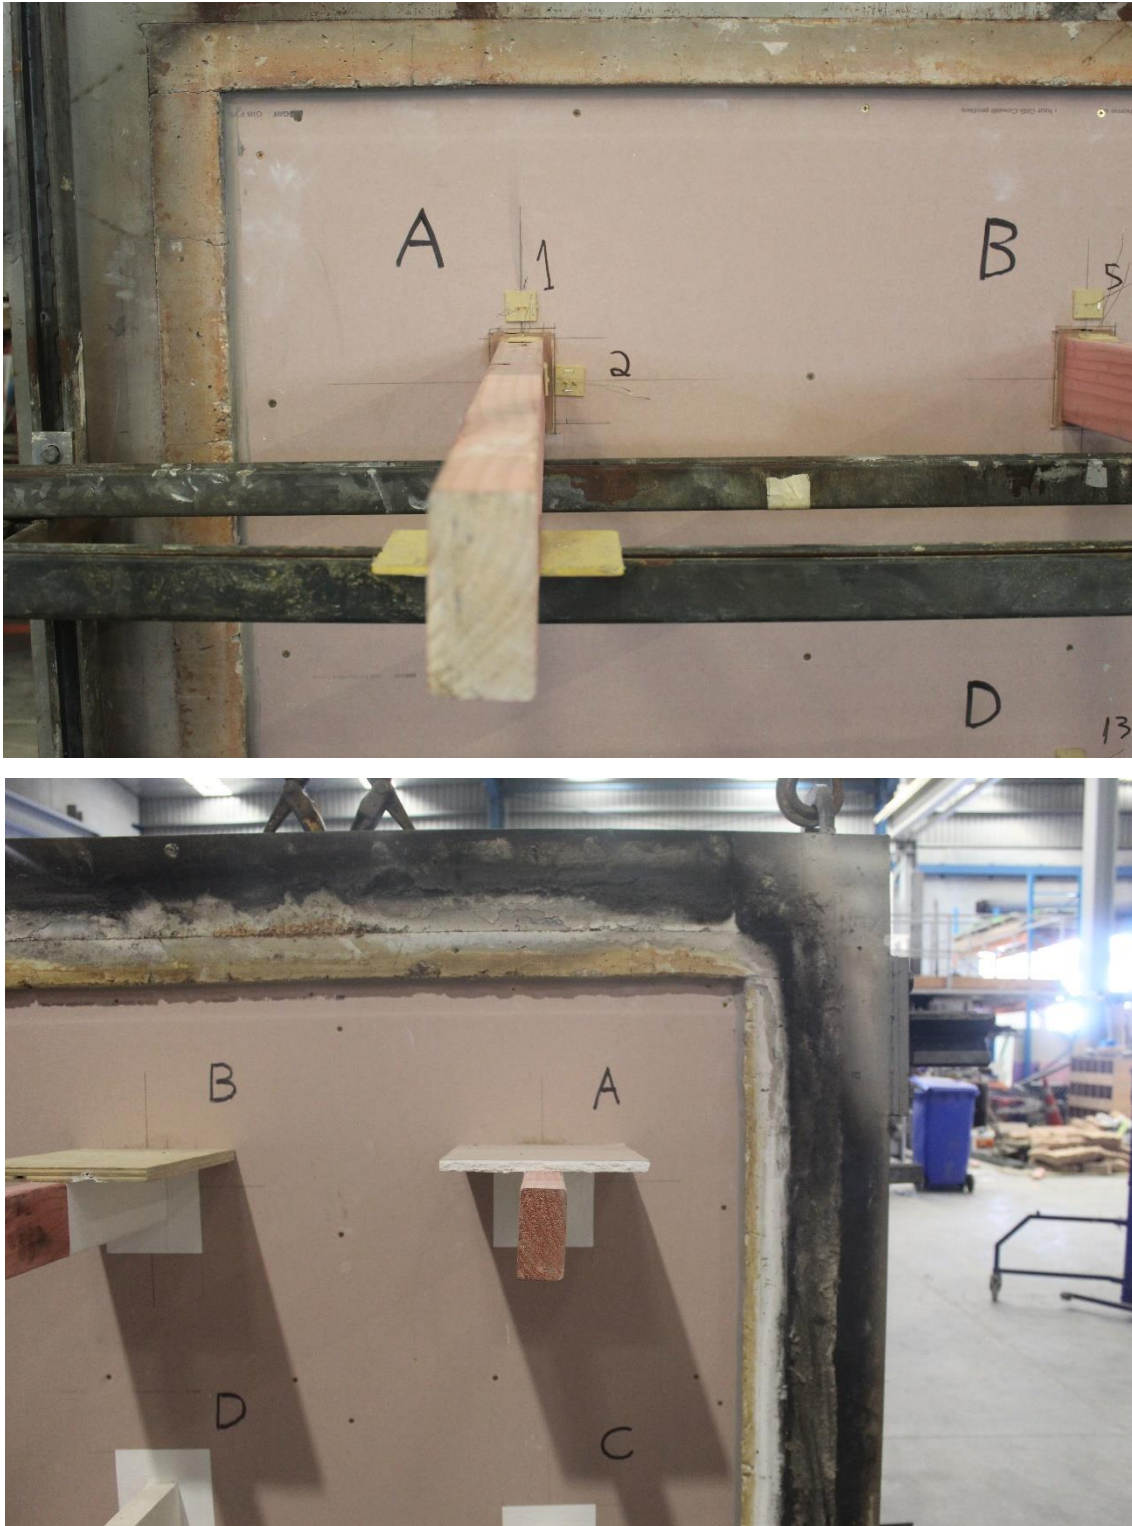
Fig.2 – Specimen A. Unexposed (top) and exposed (bottom) face.

Penetration System		
A	Service	90x45mm Timber Purlin with 13mm FR plasterboard on the top (fire side only)
	System Details	Purlin (2.1), Sealant (3.1), Coating (3.2), Screws (4.2), Plasterboard (5.1)
	Service Support	Unistrut structure at 300mm and 1000mm
	Aperture Size	62mm x 105mm
	Annular Spacing	Min: 5mm Max: 10mm
	Local Fire-stopping Protection	
	Application	Asymmetrical
	Protection Used	<p>The aperture was cut from the separating element, through both faces of the plasterboard. The purlin (2.1) was passed through the aperture, extending 500mm from the exposed face. A bead of sealant (3.1) was applied between the purlin and the separating element, flush with the plasterboard, resulting in a 13mm depth and 5 to 10mm width seal around the service in the annular gap. A plasterboard pattress (5.1) was then cut to 300mm x 200mm, and fixed with three screws (4.2) to the top of the timber purlin on the exposed face. The pattress was flush with the separating element, and overhung the width of the purlin evenly.</p> <p>A coat of FBL-100 coating (3.2) was applied to the purlin and the pattress, with a WFT measurement of 1000µm. The coating was applied to all visible sides of the purlin. The coating was applied to the underside of the pattress, measuring 50mm either side of the purlin. The coating extended 300mm from the exposed face.</p>

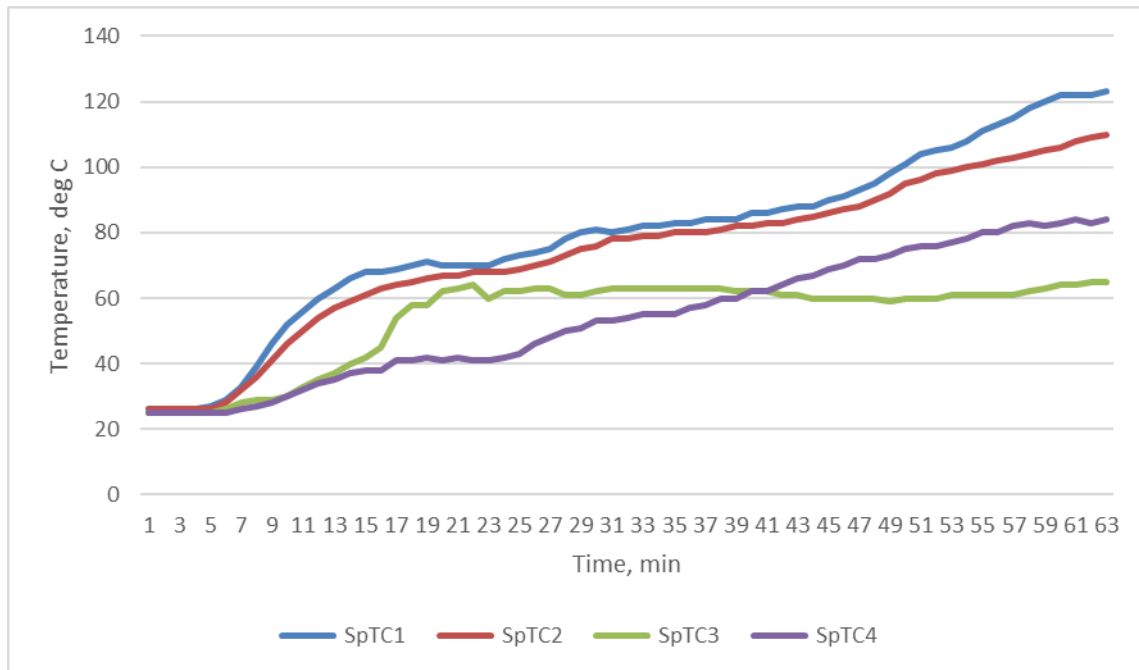
Structural adequacy	Not applicable
Integrity	No failure at 62 min
Insulation	No failure at 62 min

Fig. 3 – Specimen A. Thermocouples data

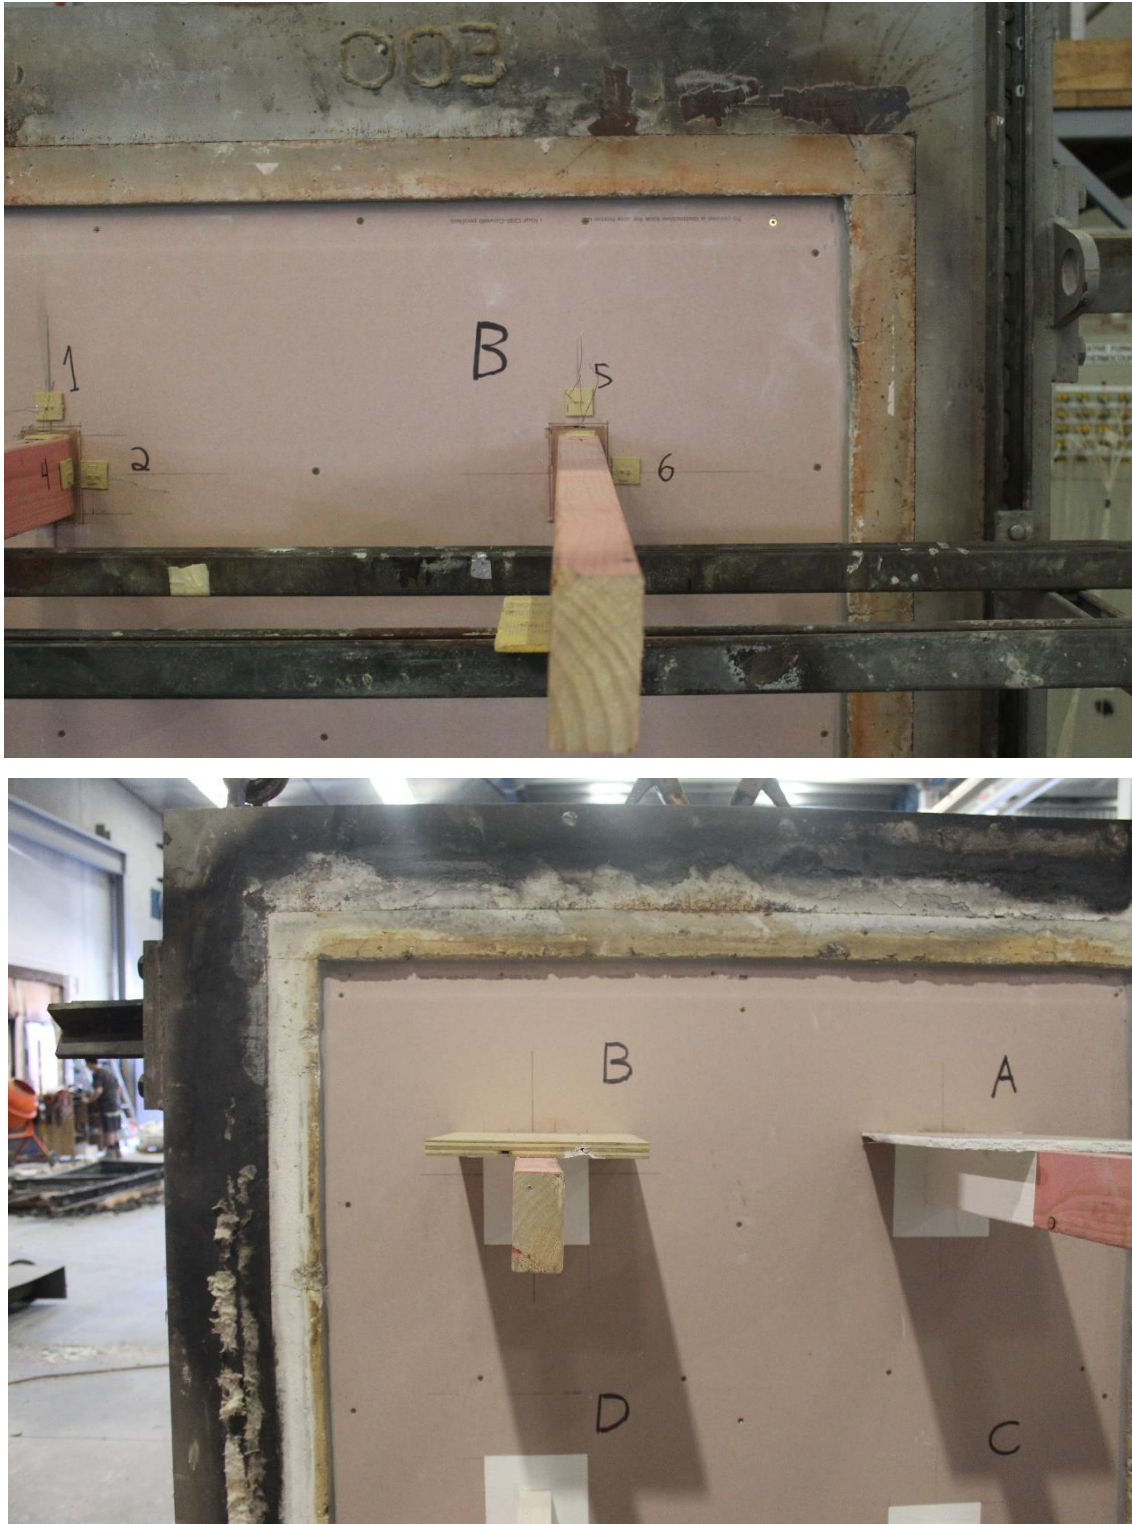
Fig. 4 – Specimen B. Unexposed (top) and exposed (bottom) face.

Penetration System		
B	Service	90x45mm Timber Purlin with 19mm plywood on the top (fire side only)
	System Details	Purlin (2.1), Sealant (3.1), Coating (3.2), Screws (4.2), Plywood (5.2)
	Service Support	Unistrut structure at 300mm and 1000mm
	Aperture Size	62mm x 105mm
	Annular Spacing	Min: 5mm Max: 10mm
	Local Fire-stopping Protection	
	Application	Asymmetrical
	Protection Used	<p>The aperture was cut from the separating element, through both faces of the plasterboard. The purlin (2.1) was passed through the aperture, extending 500mm from the exposed face. A bead of sealant (3.1) was applied between the purlin and the separating element, flush with the plasterboard, resulting in a 13mm depth and 5 to 10mm width seal around the service in the annular gap. A plywood pattress (5.2) was then cut to 300mm x 200mm, and fixed with three screws (4.2) to the top of the timber purlin on the exposed face. The pattress was flush with the separating element, and overhung the width of the purlin evenly.</p> <p>A coat of FBL-100 coating (3.2) was applied to the purlin and the pattress, with a WFT measurement of 1000µm. The coating was applied to all visible sides of the purlin. The coating was applied to the underside of the pattress, measuring 50mm either side of the purlin. The coating extended 300mm from the exposed face.</p>

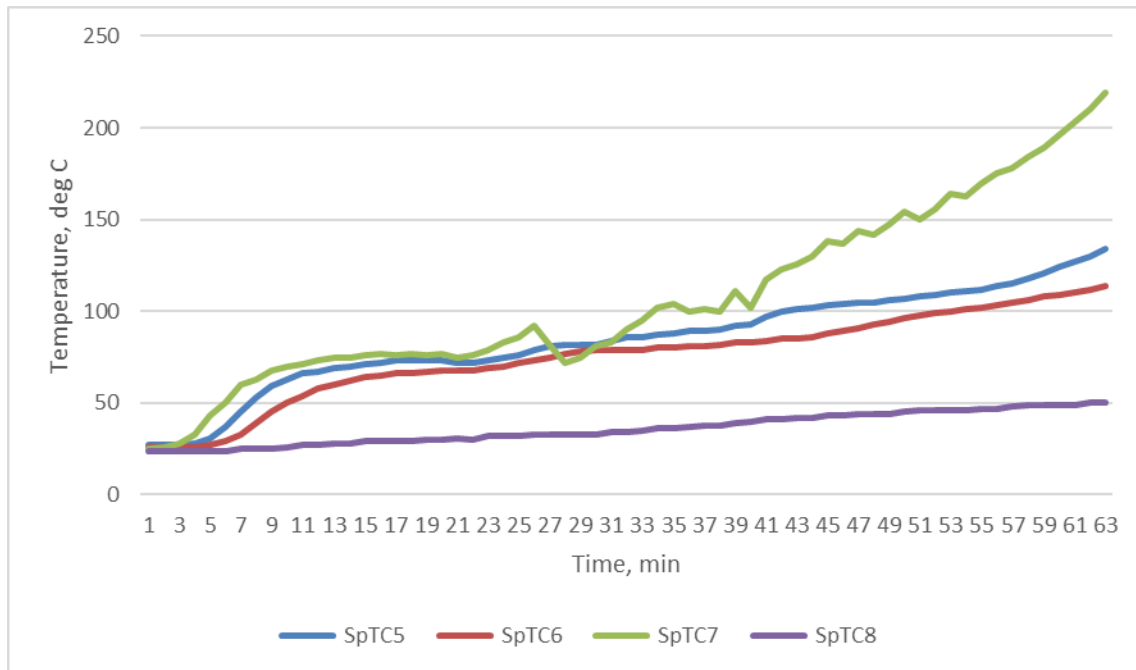
Structural adequacy	Not applicable
Integrity	No failure at 62 min
Insulation	60 min

Fig. 5 – Specimen B. Thermocouples data.

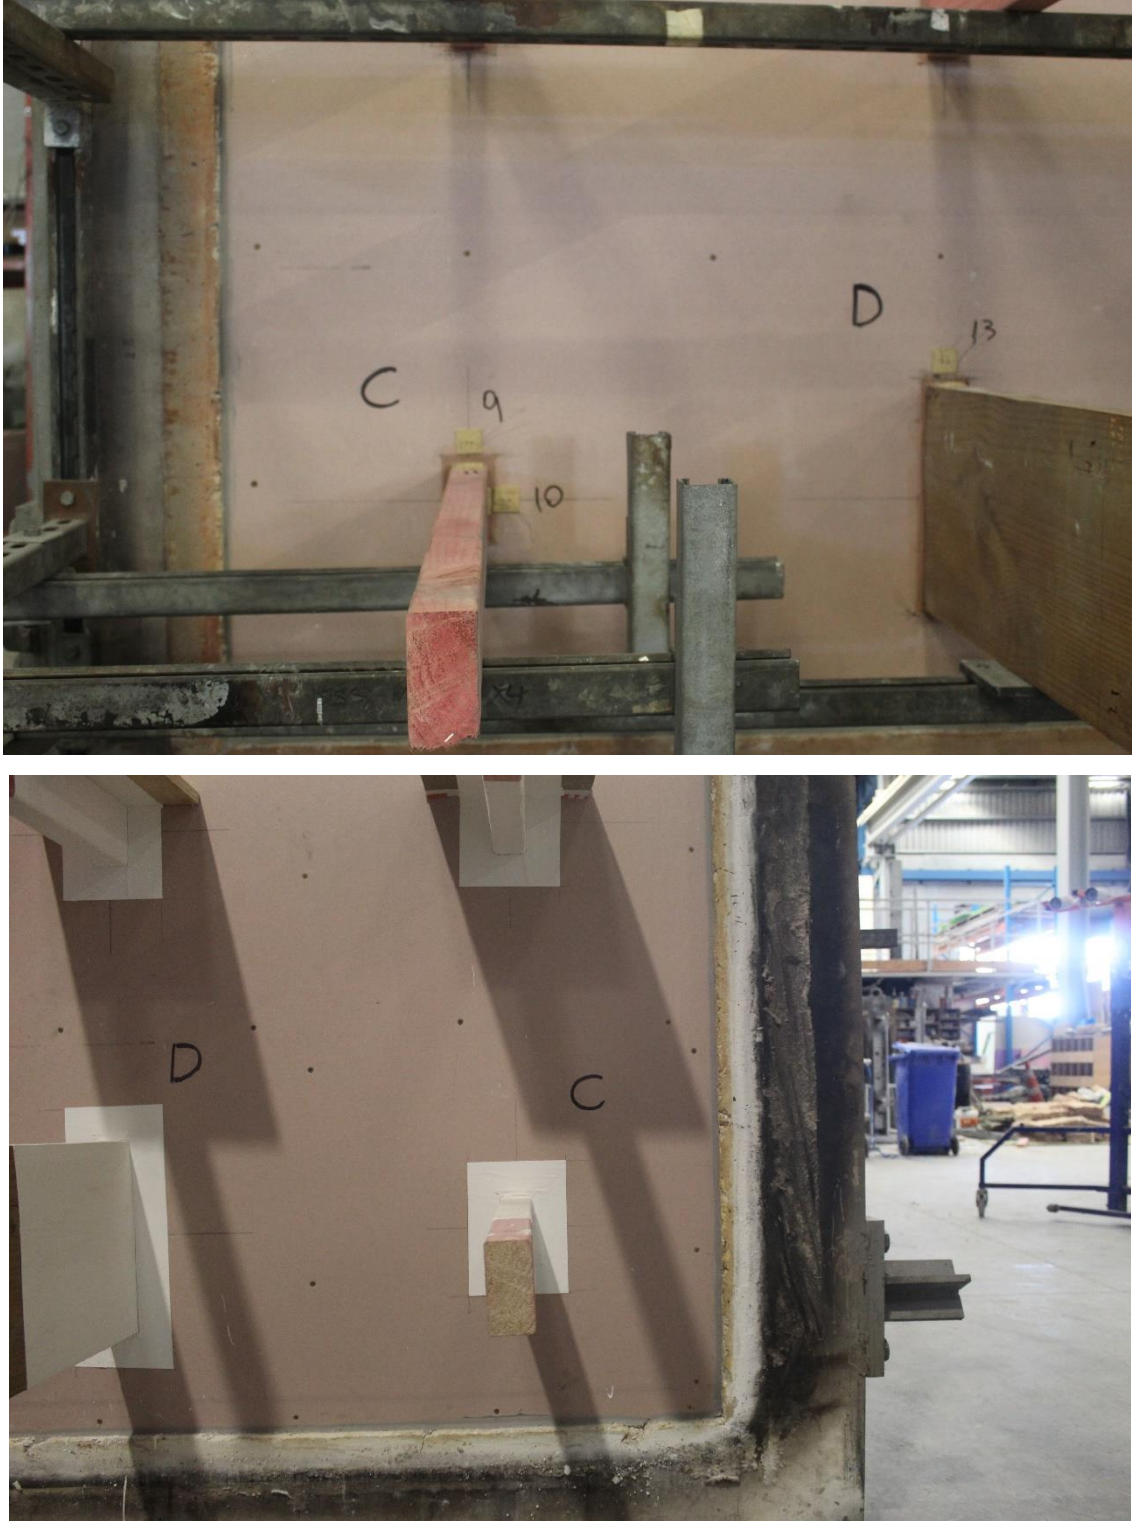
Fig. 6 – Specimen C. Unexposed (top) and exposed (bottom) face.

Penetration System		
C	Service	90x45mm Timber Purlin
	System Details	Purlin (2.1), Sealant (3.1), Coating (3.2)
	Service Support	Unistrut structure at 300mm and 1000mm
	Aperture Size	62mm x 105mm
	Annular Spacing	Min: 5mm Max: 10mm
	Local Fire-stopping Protection	
	Application	Asymmetrical
	Protection Used	<p>The aperture was cut from the separating element, through both faces of the plasterboard. The purlin (2.1) was passed through the aperture, extending 500mm from the exposed face. A bead of sealant (3.1) was applied between the purlin and the separating element, flush with the plasterboard, resulting in a 13mm depth and 5 to 10mm width seal around the service in the annular gap.</p> <p>A coat of FBL-100 coating (3.2) was applied to the purlin and the pattrass, with a WFT measurement of 1000µm. The coating was applied to all sides of the purlin. The coating extended 300mm from the exposed face.</p>

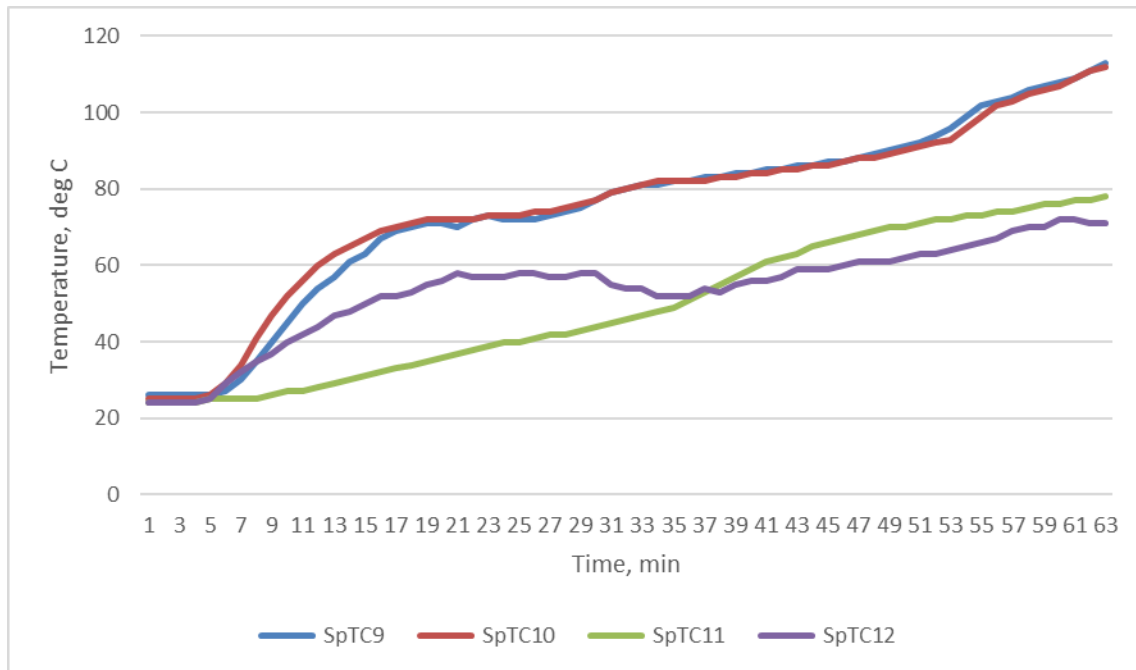
Structural adequacy	Not applicable
Integrity	No failure at 62 min
Insulation	No failure at 62 min

Fig. 7 – Specimen C. Thermocouples data.

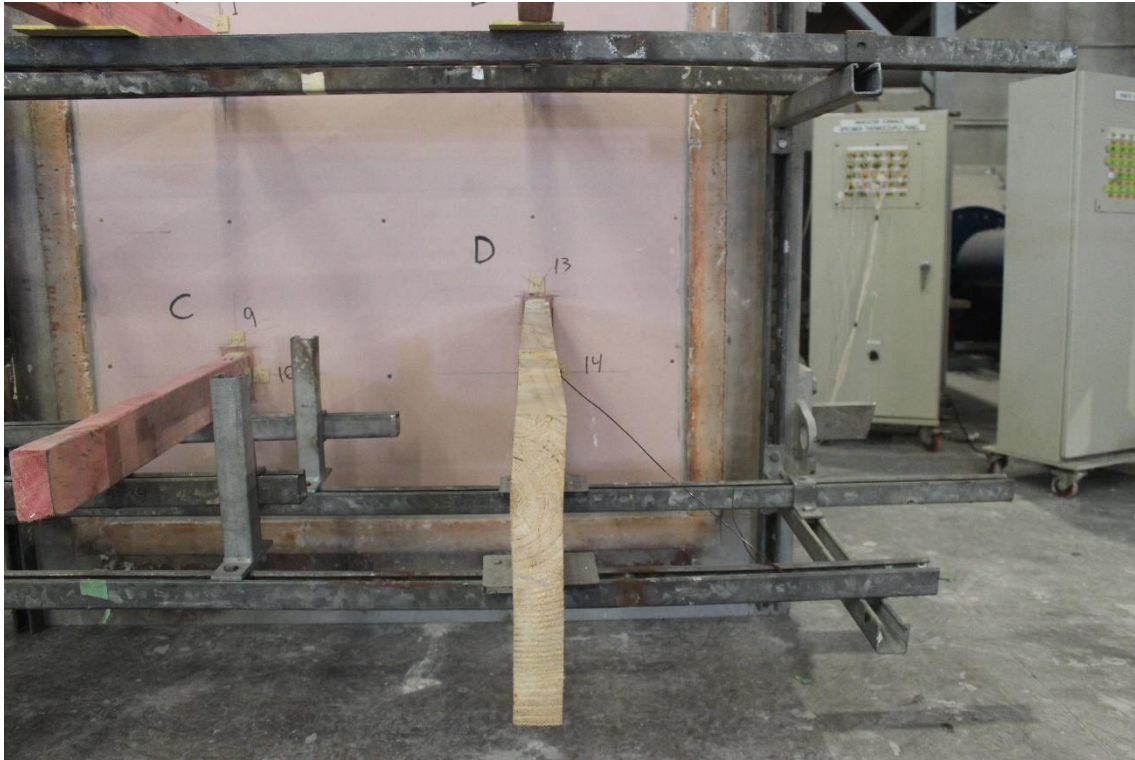
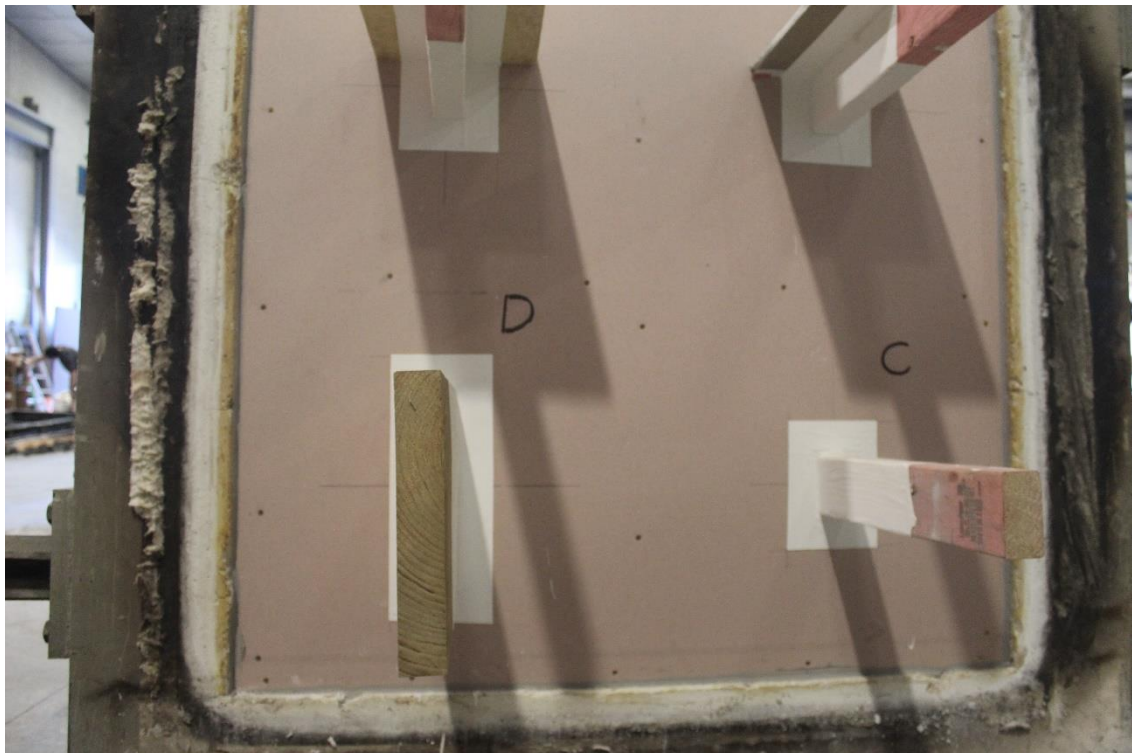
Fig. 8 – Specimen D. Unexposed (top) and exposed (bottom) face.

Penetration System		
D	Service	283x45mm Timber Purlin
	System Details	Purlin (2.2), Sealant (3.1), Coating (3.2)
	Service Support	Unistrut structure at 300mm and 1000mm
	Aperture Size	62mm x 300mm
	Annular Spacing	Min: 5mm Max: 10mm
Local Fire-stopping Protection		
	Application	Asymmetrical
	Protection Used	<p>The aperture was cut from the separating element, through both faces of the plasterboard. The purlin (2.2) was passed through the aperture, extending 500mm from the exposed face. A bead of sealant (3.1) was applied between the purlin and the separating element, flush with the plasterboard, resulting in a 13mm depth and 5 to 10mm width seal around the service in the annular gap.</p> <p>A coat of FBL-100 coating (3.2) was applied to the purlin and the pattrass, with a WFT measurement of 1000µm. The coating was applied to all sides of the purlin. The coating extended 300mm from the exposed face.</p>

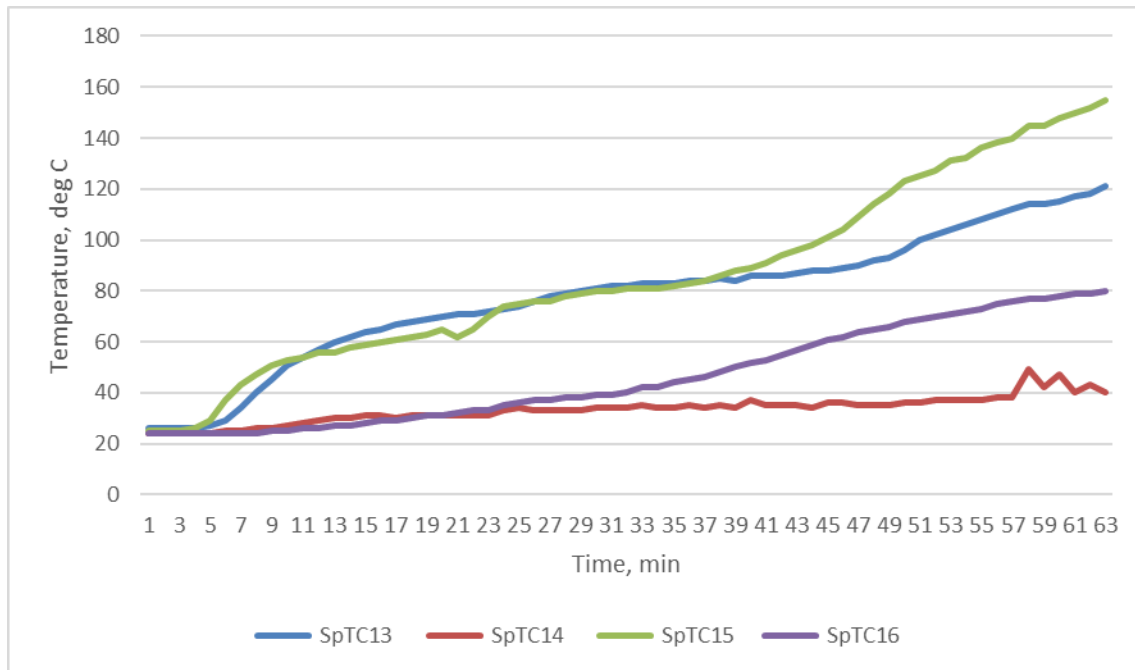
Structural adequacy	Not applicable
Integrity	No failure at 62 min
Insulation	No failure at 62 min

Fig. 9 – Specimen D. Thermocouples data.

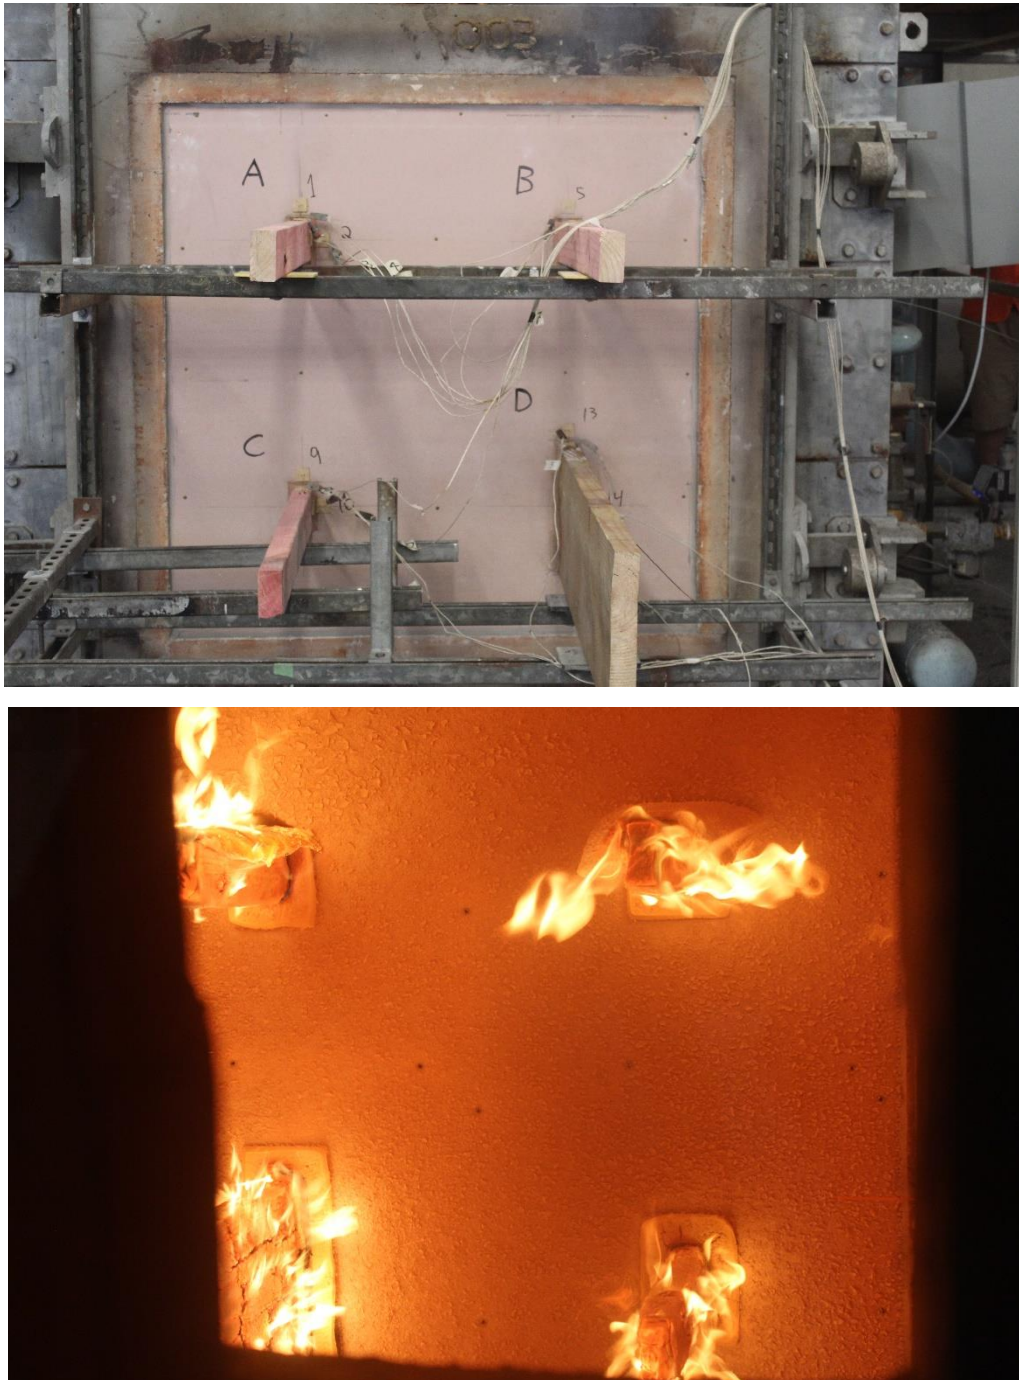
Fig. 10 – 30 minutes

Time Minutes	Test Face	SP#	Observations
4	U	B	Smoke from top of timber purlin
5	U	D	Smoke from top of timber purlin
9	E	ALL	Expansion of coating on specimens
9	E	ALL	Combustion of timber purlins
13	U	A	Smoke from top of timber purlin
16	U	D	Moisture from right side of specimen
20	E	A	Plasterboard Pattress on top of purlin has fallen from specimen
29	U	C	Smoke coming from bottom of timber purlin
30	U	A	Discolouring on left side of purlin
30	U	D	Moisture from all sides of purlin
38	U	D	Discolouring at bottom of purlin
41	U	B	Discolouring at top of purlin
44	E	A, C	Sections of timber purlin have fallen from specimen
48	U	A, D	Further smoke from purlin
62			TEST DISCONTINUED

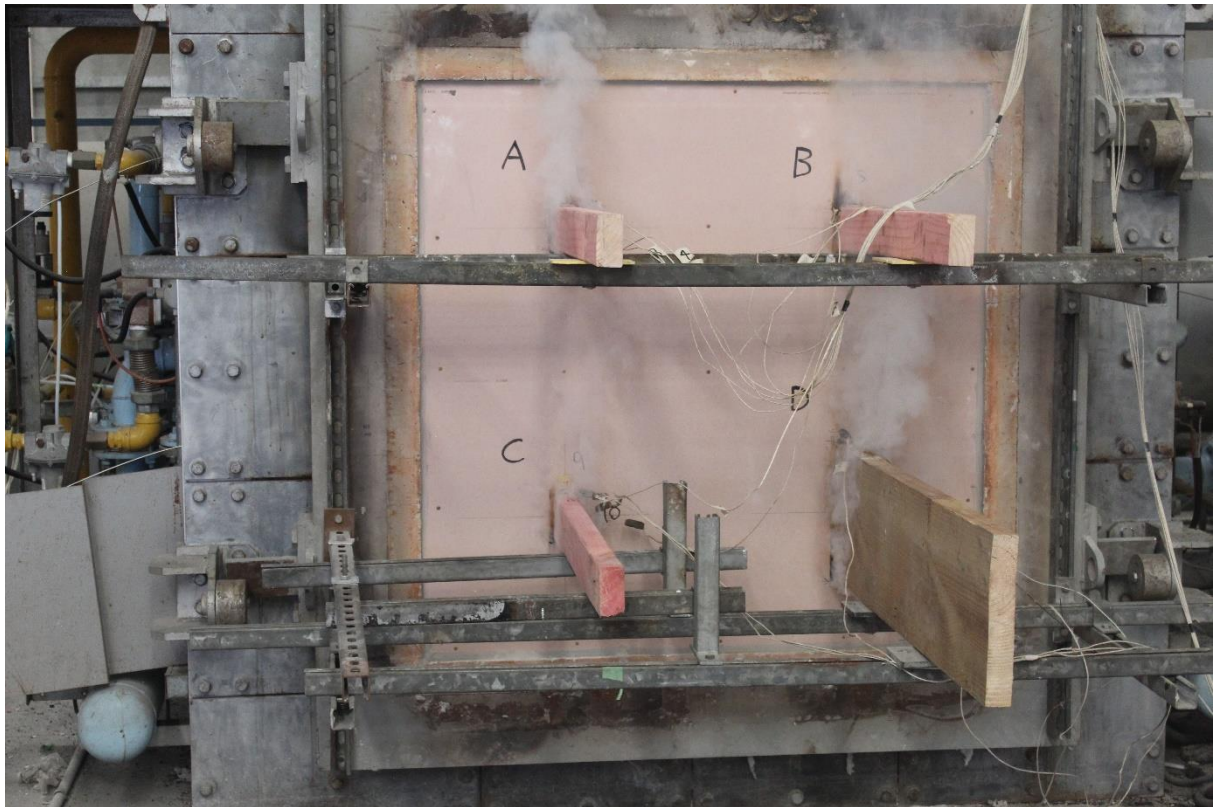
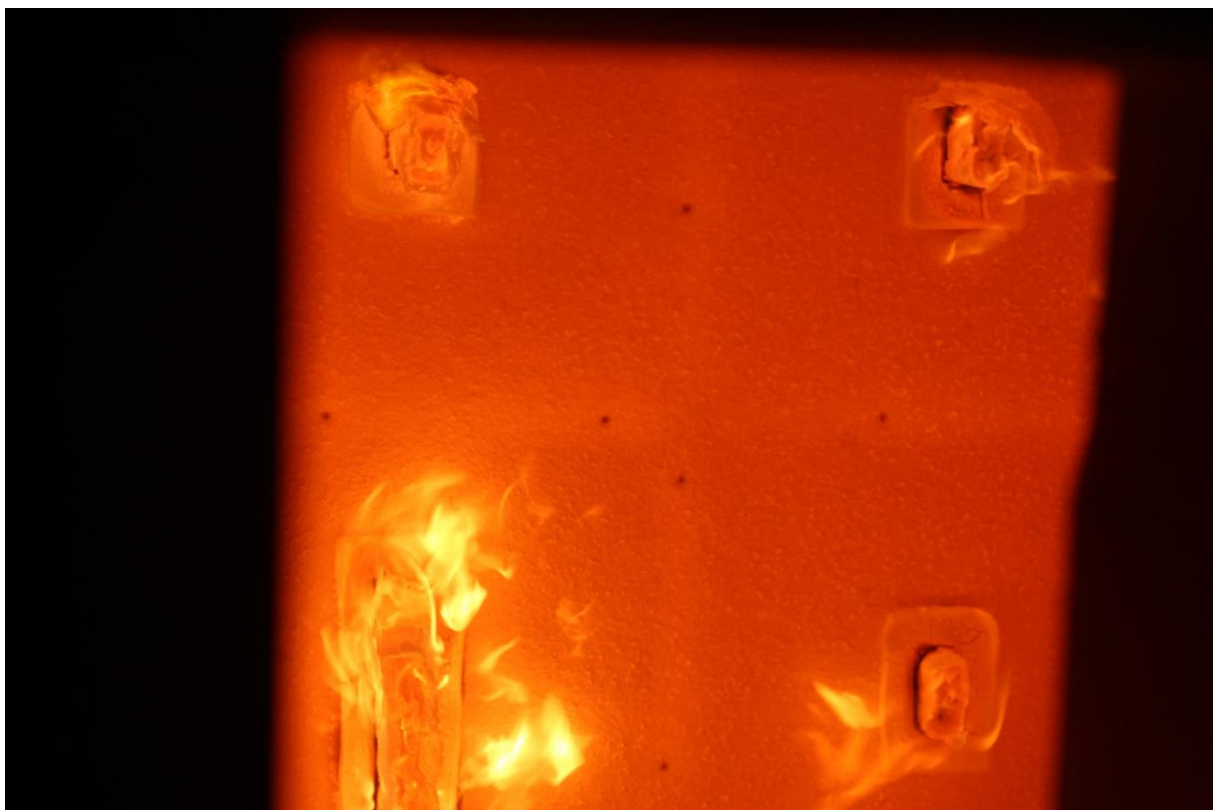
Fig. 11 – 60 minutes

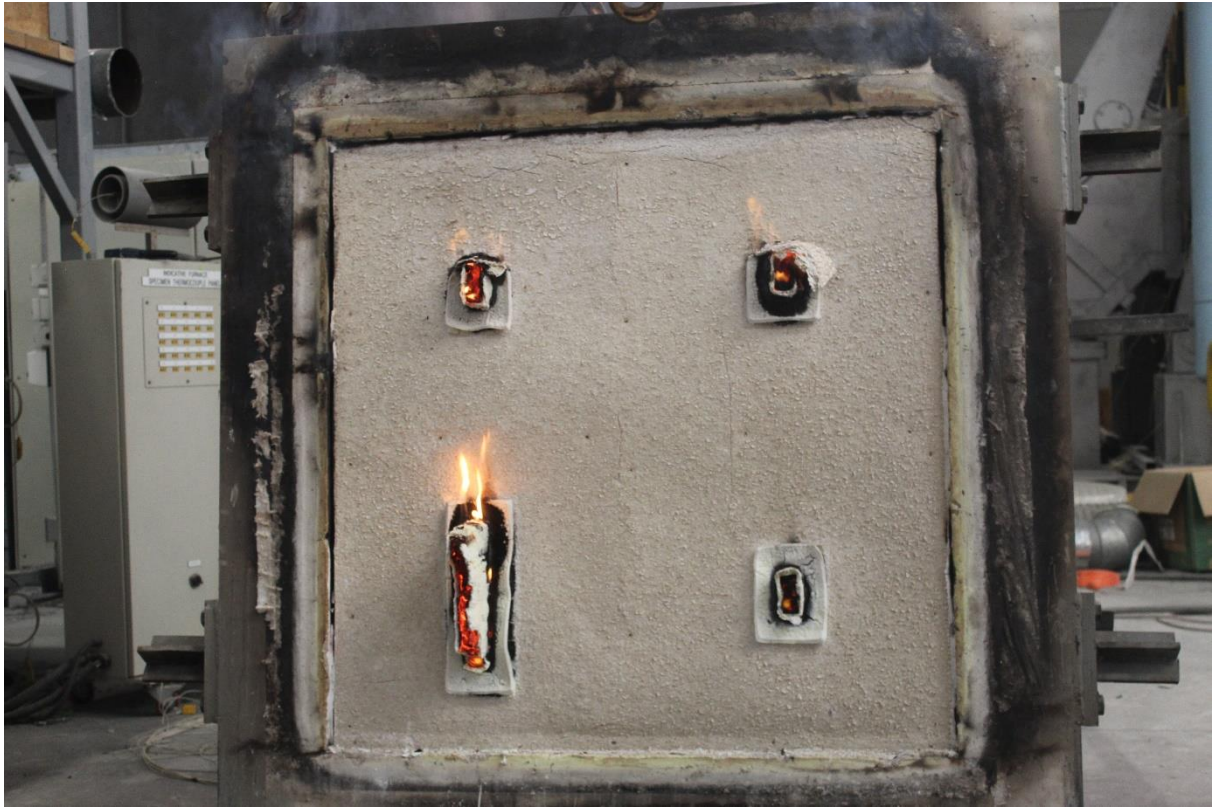
Fig. 12 – After the test
