# Regulatory Information Report

**RIRF24069**

**Fire resistance test for penetrations through  
the vertical separating element**

Client:	Agnitek Pty Ltd
Test method:	AS1530.4-2014
Report Date:	15/07/2024
Test number:	PF24069

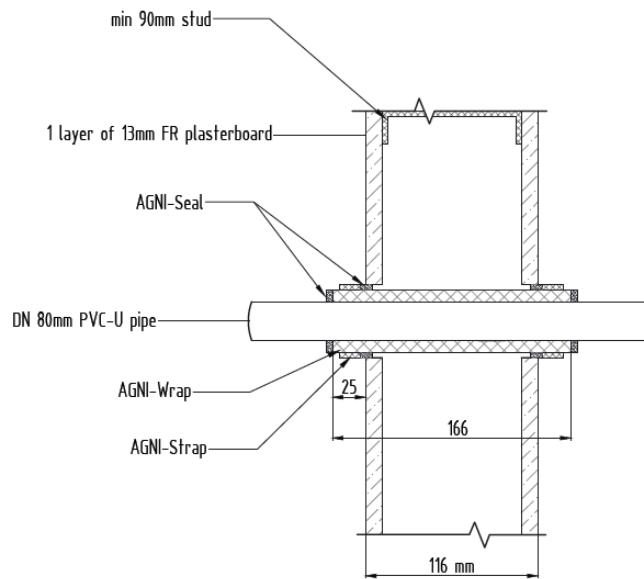
## 5.5 Specimen 5

Service penetration details	
Service	DN80 PVC-U DWV Pipe
Service Support	Unistrut structure at 530mm and 1515mm on non-fire side Steel Track at 300mm on fire side
Aperture Diameter	94mm
Annular Spacing	Min: 3.5mm, Max: 8mm

Local Fire-stopping system	
Application	Symmetrical – installed on both faces of separating element
System description	50mm AGNI-Wrap secured around pipe with no overlap, using a cable tie. AGNI-Wrap inserted in annular space, extending 25mm (nominal) into aperture. AGNI-Seal sealed AGNI-Wrap and separating element joint. 5mm (nominal) AGNI-Seal installed between AGNI-Wrap and pipe.

Structural adequacy	Not applicable
Integrity	No failure at 70 minutes
Insulation	62 minutes

Time min	Test face	SP#	OBSERVATIONS/REMARKS
53	U	5	Cotton pad test applied for 30 seconds over the red glowing in aperture – PASS
55	U	5	Cotton pad test applied for 30 seconds over the red glowing in aperture – PASS
59	U	5	Cotton pad test applied for 30 seconds over the red glowing in aperture – PASS
70			Test Discontinued

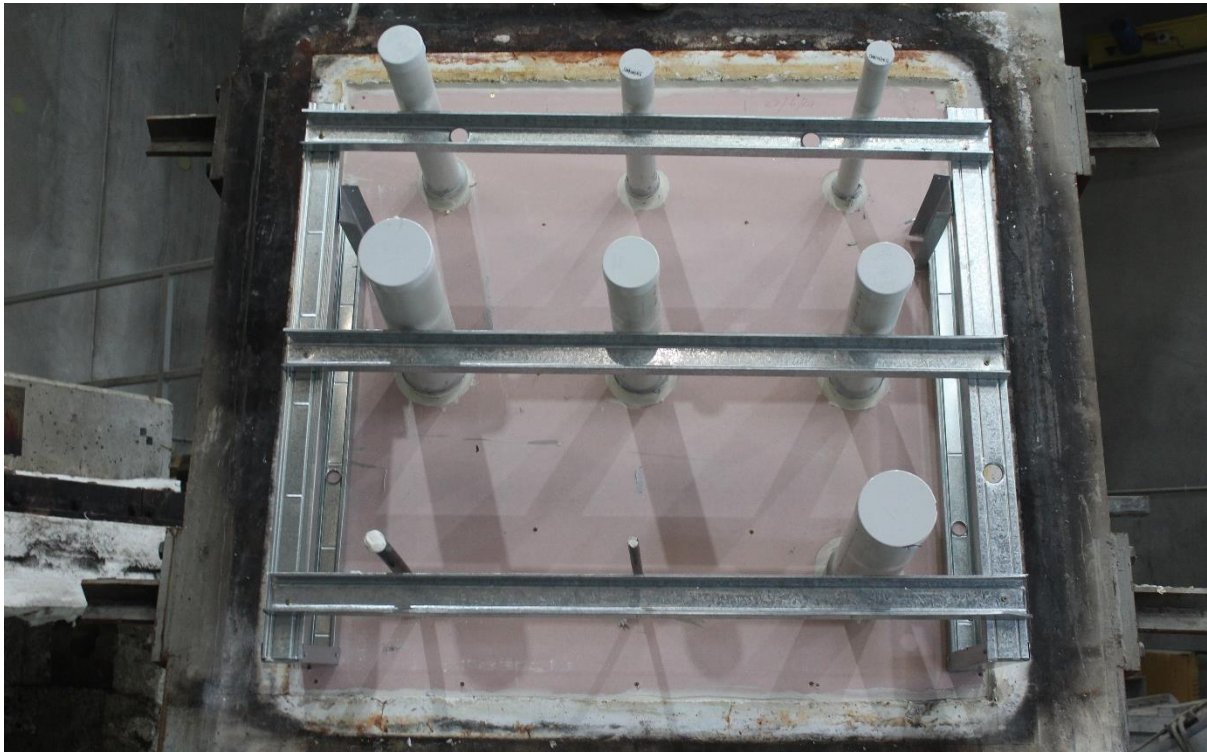
**Figure 12 – Exposed face prior to test commencement**

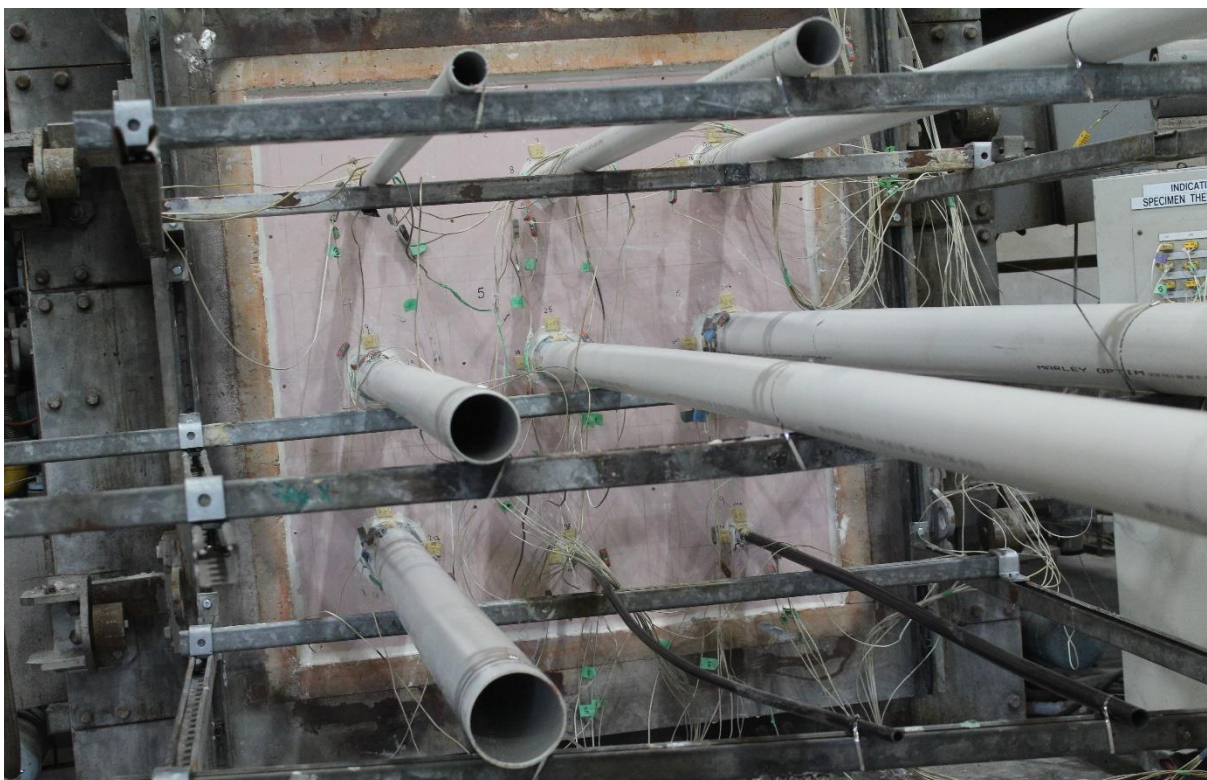
**Figure 13 – Unexposed face prior to test commencement**

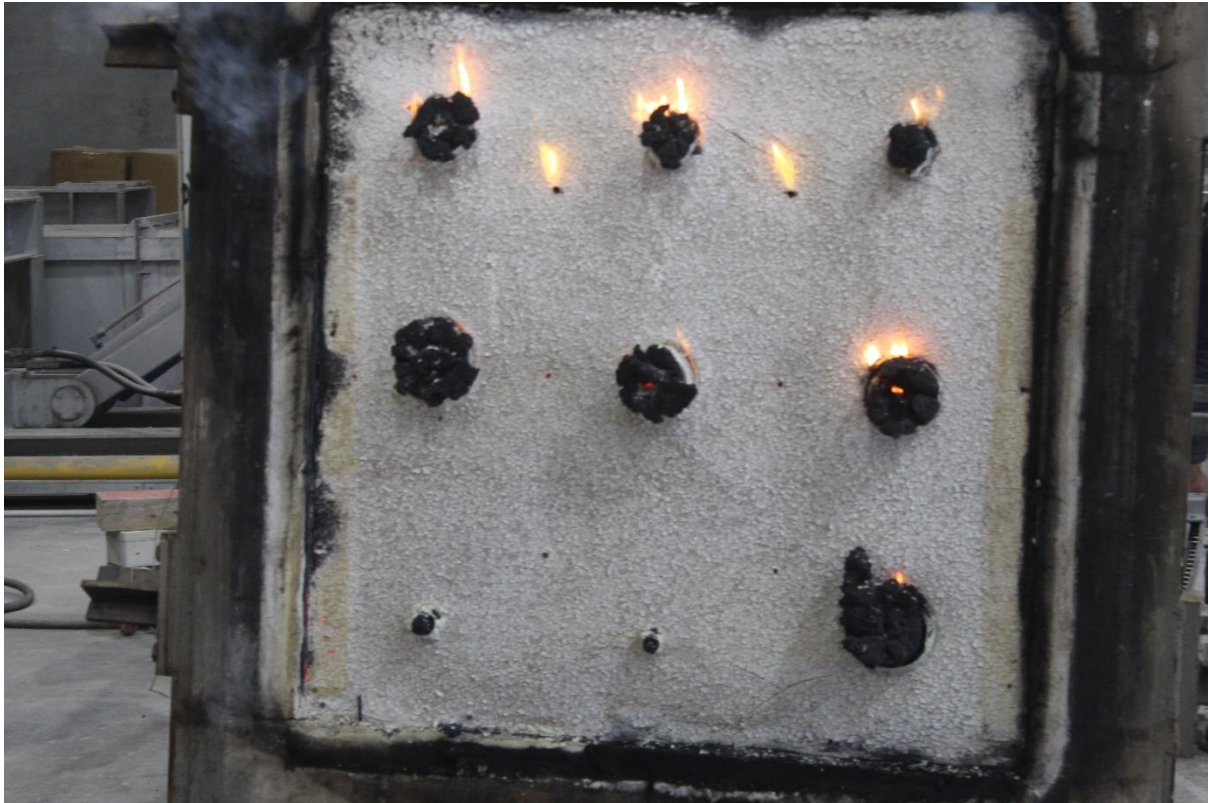
**Figure 21 – Exposed face after the test**
